RECREATION FACILITY REHABILITATION ASSESSMENT

Niagara Power Project FERC No. 2216

New York Power Authority

August 2005

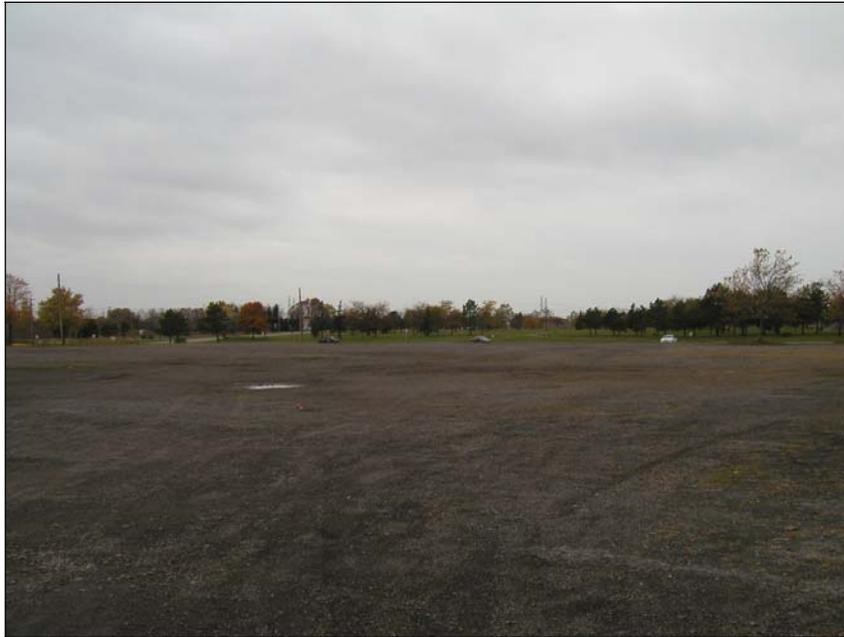
Main Parking Lot

The main parking area is a 375- by 450-foot lot located in the southeast corner of the park. At first glance, the parking lot appears to have a gravel surface, but upon closer inspection old pavement/aggregate matrix is visible in some areas. The pavement is in poor condition with some large pot holes and cracking ([Figure 2.1.1.1-1](#)).

**FIGURE 2.1.1.1-1
MAIN AND BALLFIELD PARKING LOTS, RESERVOIR STATE PARK**

It is recommended that the access driveway, secondary driveway, parking area and walkway be reconstructed. Reconstruction should include analysis of the existing base soils for frost activity, re-grading for surface drainage, crowning the access driveways, landscaping, installation of catch basins and drainage system, designated ADA parking, signage, curb cuts, walkways, repaving and striping.

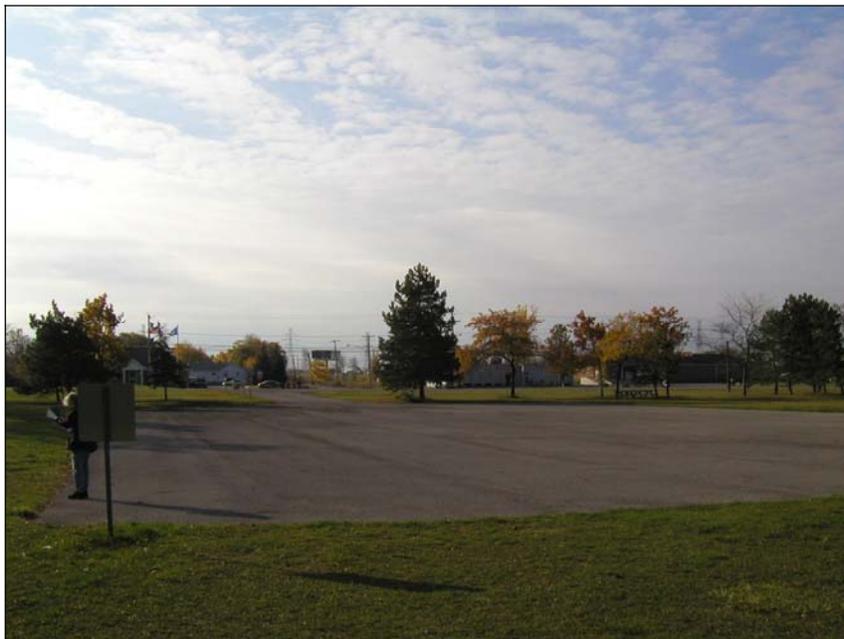
Ballfield Parking Lot

The ballfield parking area is a 120- by 225-foot lot located in the south-center of the park. The pavement surface appears to be 5 to 7 years old and in fair condition ([Figure 2.1.1.1-1](#)). The pavement is a coarse stone asphalt binder material from which most of the asphalt has evaporated exposing the aggregate.

Park Officials stated the parking lot is heavily used for adult town softball leagues. The lot size is inadequate and cars park along Witmer Road and on the grass adjacent to the lot during softball season. If the parking lot were striped, it could accommodate about 60 vehicles with a single center row.

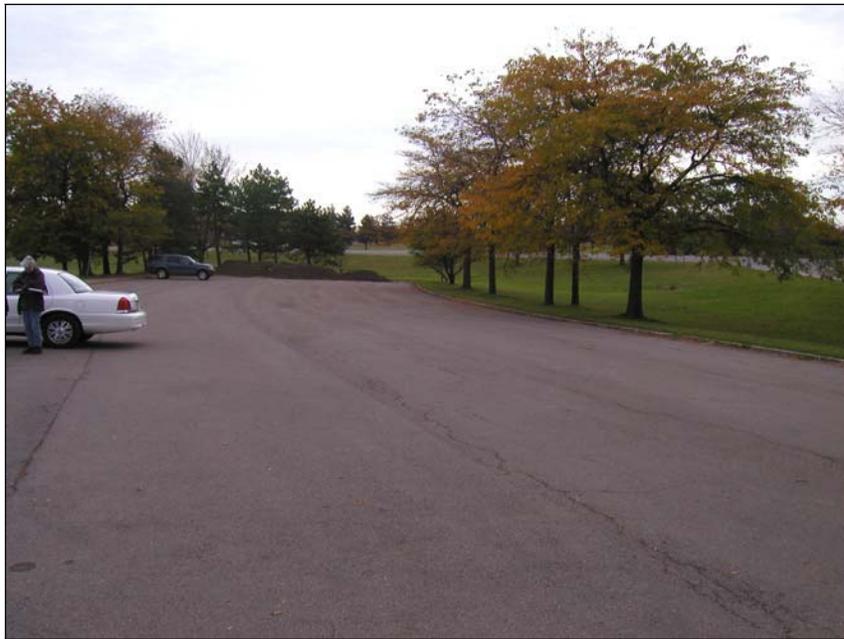
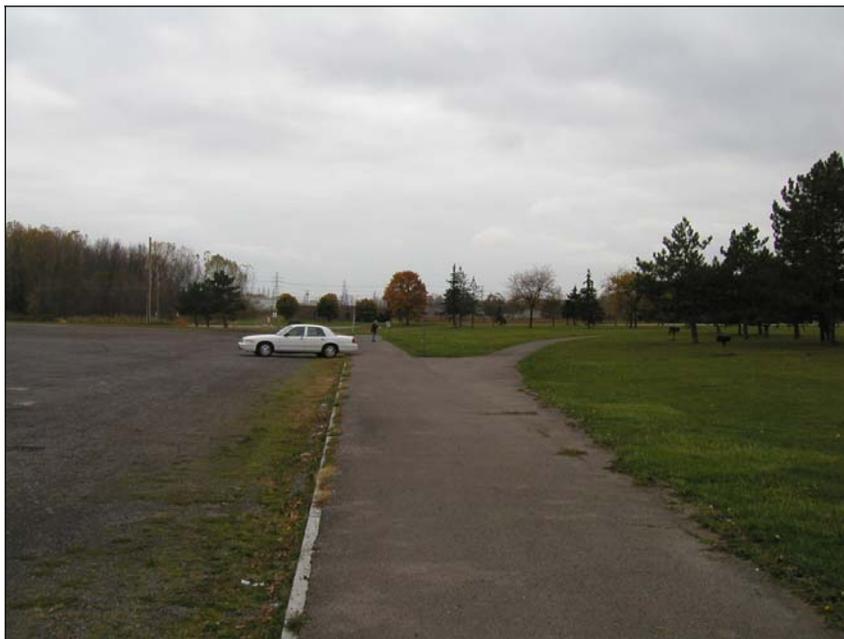
Soccer/Sledding Parking Area

**FIGURE 2.1.1.3-1
SOCCER/SLEDDING PARKING AREA, RESERVOIR STATE PARK**

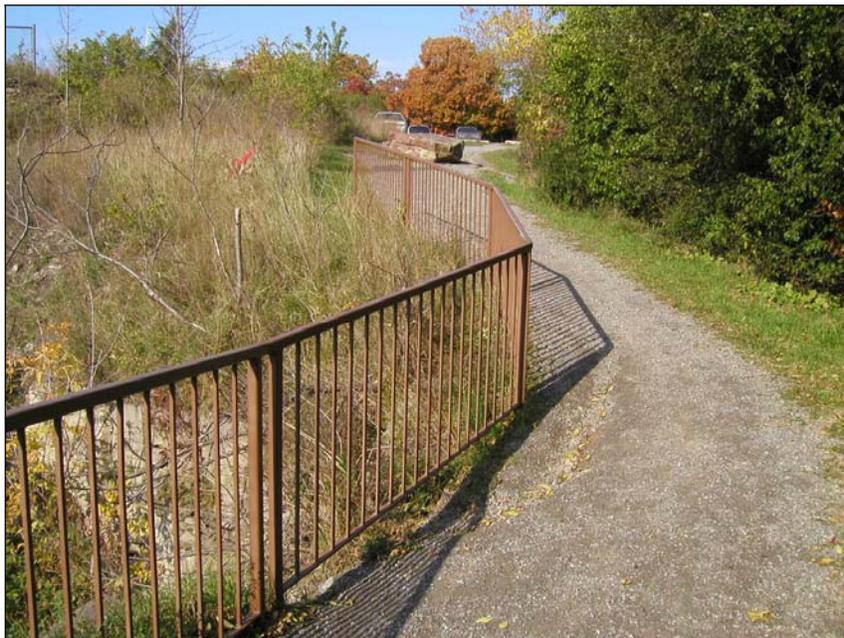
Railing and Surface Erosion at Lewiston Branch Gorge Trail Trailhead

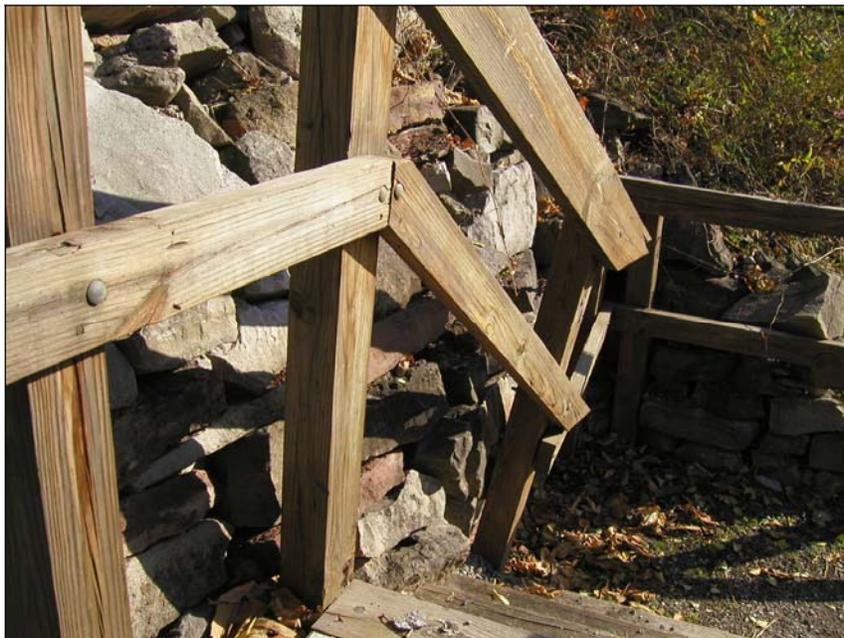
Portion of Staircase 2 Showing Damaged Railing

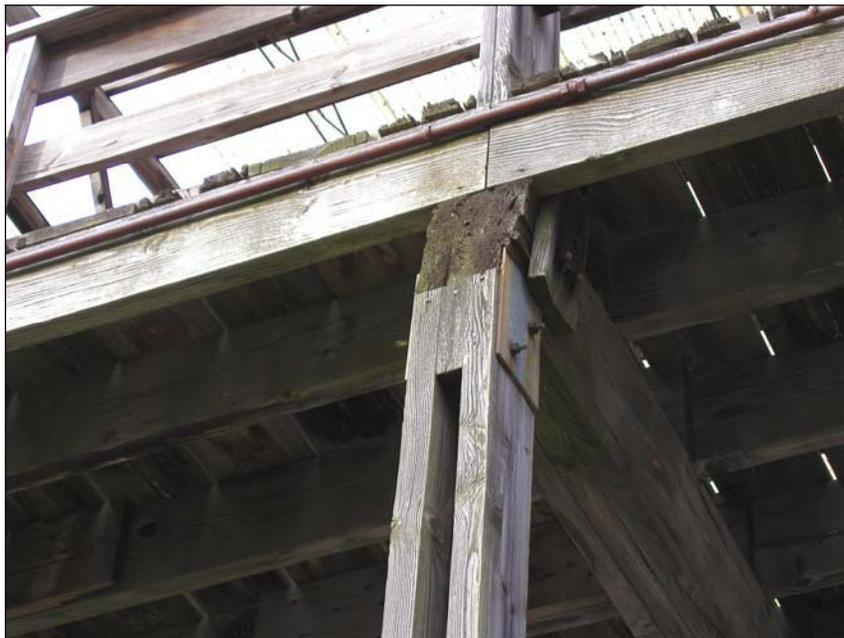
Deck Truss under the El, Showing Deterioration

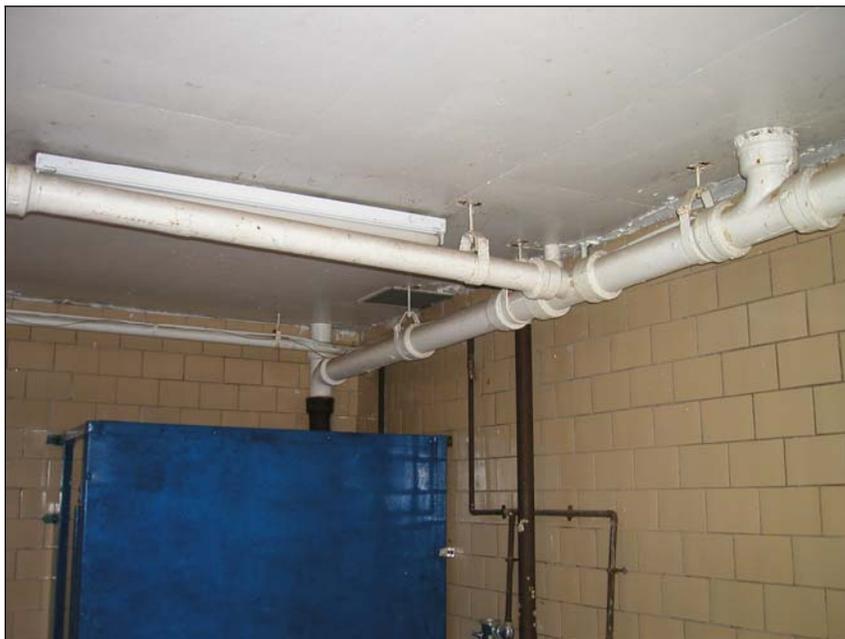
Exposed Plumbing in Men's Room

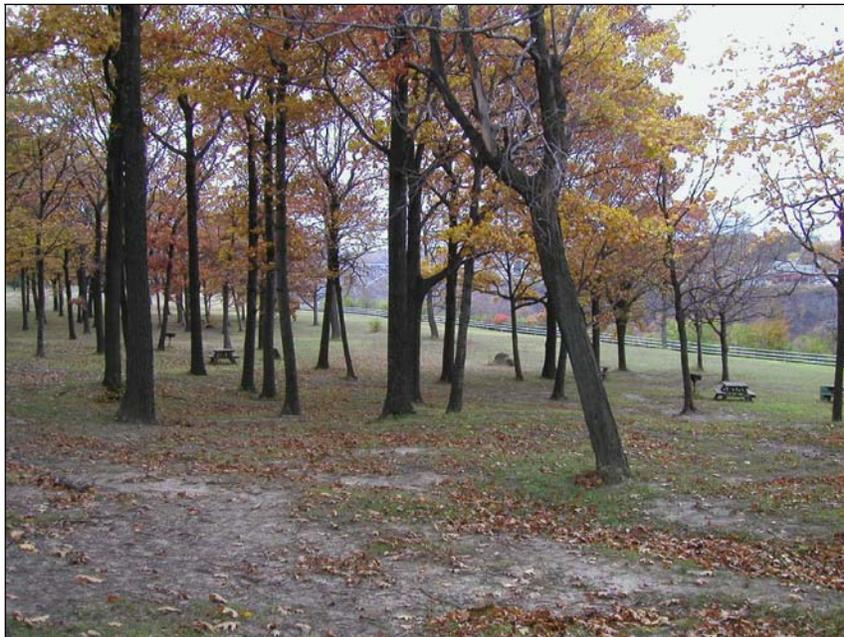
Erosion on Lawn to North of Restroom Building
