Fish Attraction Structure Habitat Improvement Project: 2012 Monitoring Report

Niagara Power Project (FERC No. 2216)

**KLEINSCHMIDT ASSOCIATES AND
RIVEREDGE ASSOCIATES**

February 2013

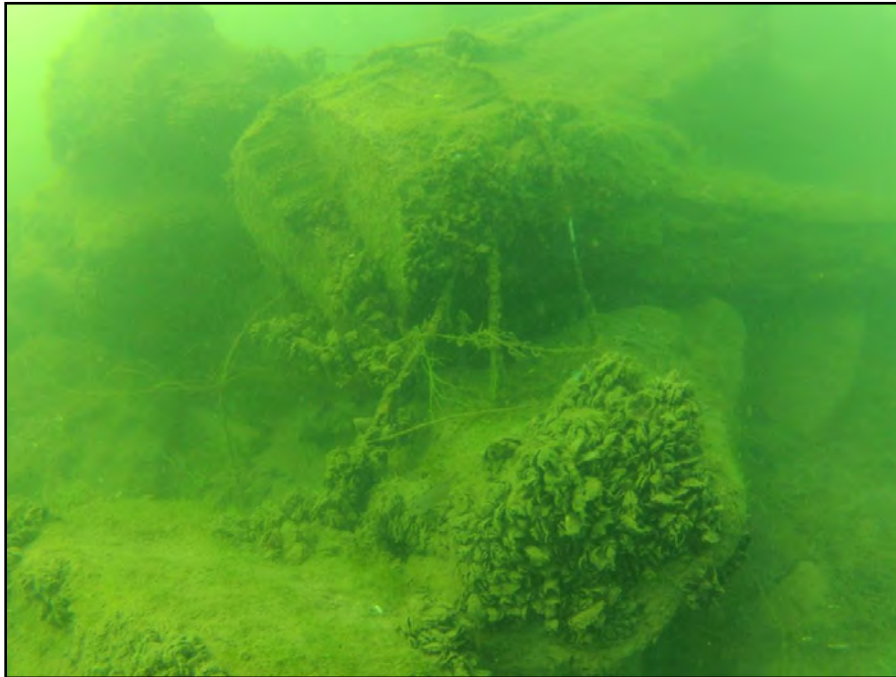
General condition of the structures, four years after construction, was fair at the stone and log groin and good at the other three locations. The crest of the shallow water stone and log groin structure appeared to have been leveled out and both logs embedded into the structure were absent. Minor cable rusting and one broken cable were noted at the Motor Island rock slope; however, the three logs remained embedded within the structure ([Figure 2](#)). In general, parts of the structures sheltered from the current were coated with silt, contained fine sediment deposits, and supported zebra mussels, while areas exposed to the current were relatively clear ([Figure 3](#)).

FIGURE 2. ANCHORED LOG AT MOTOR ISLAND ROCK SLOPE

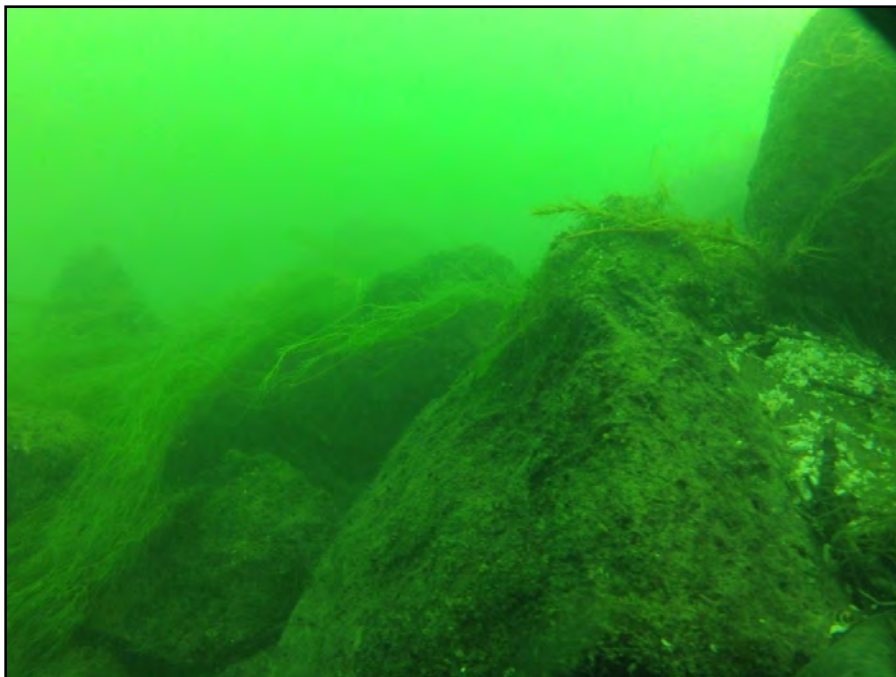
FIGURE 3. ROCK WING STRUCTURE UPSTREAM OF THE SOUTH GRAND ISLAND BRIDGE

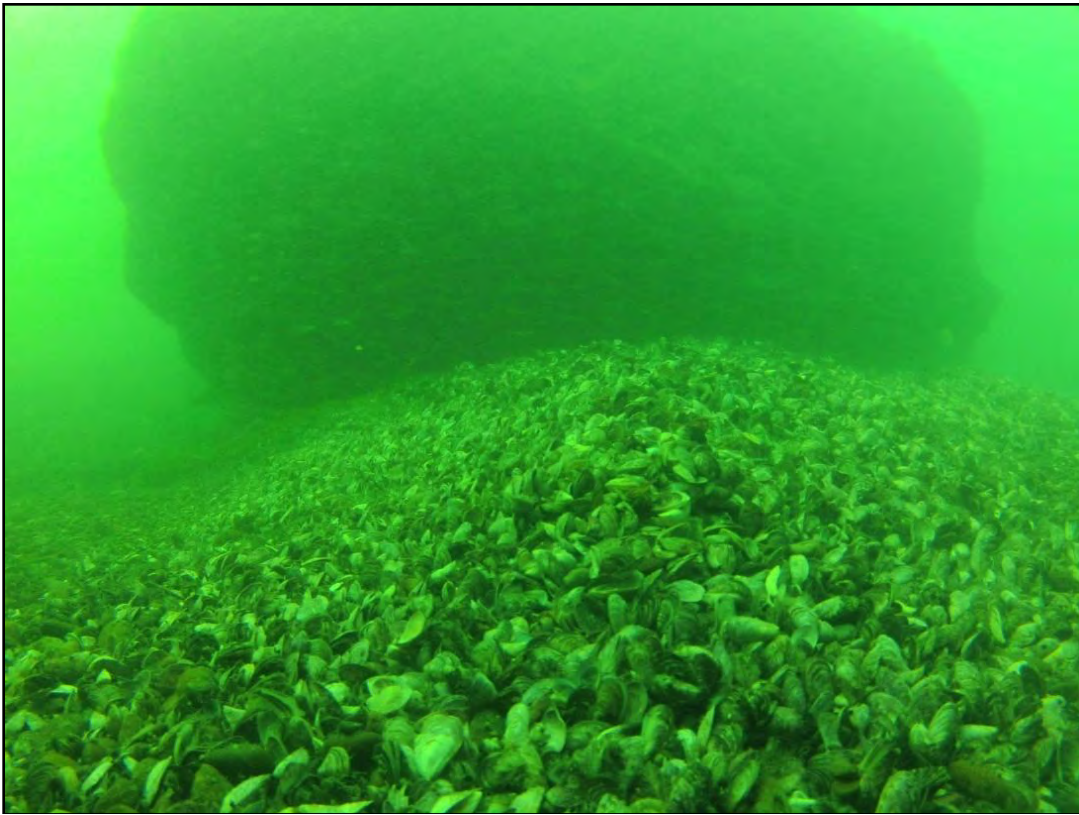
Embeddedness, or the degree to which small particles fill in the spaces around larger rocks, describes the amount of habitat space available to benthic macroinvertebrates and small fish in a coarse substrate and can be an indicator of substrate mobility. Embeddedness was highest at the rock wing “saddleback” structure, where sand and zebra mussel shells had accumulated in many of the deeper voids between the individual rocks; however, the ends of the rock wing have many protrusions that are exposed and available for habitat use (Figure 3). The Motor Island rock slope had minimal accumulation of zebra mussel shells and silt. In the boulder field, there is some scour at the base of the rocks, with zebra mussel shells and sand accumulating on the downstream side of the boulders (Figure 4).

FIGURE 4. ACCUMULATED GRAVEL AND SHELLS DOWNSTREAM OF A BOULDER IN THE BOULDER FIELD STRUCTURE

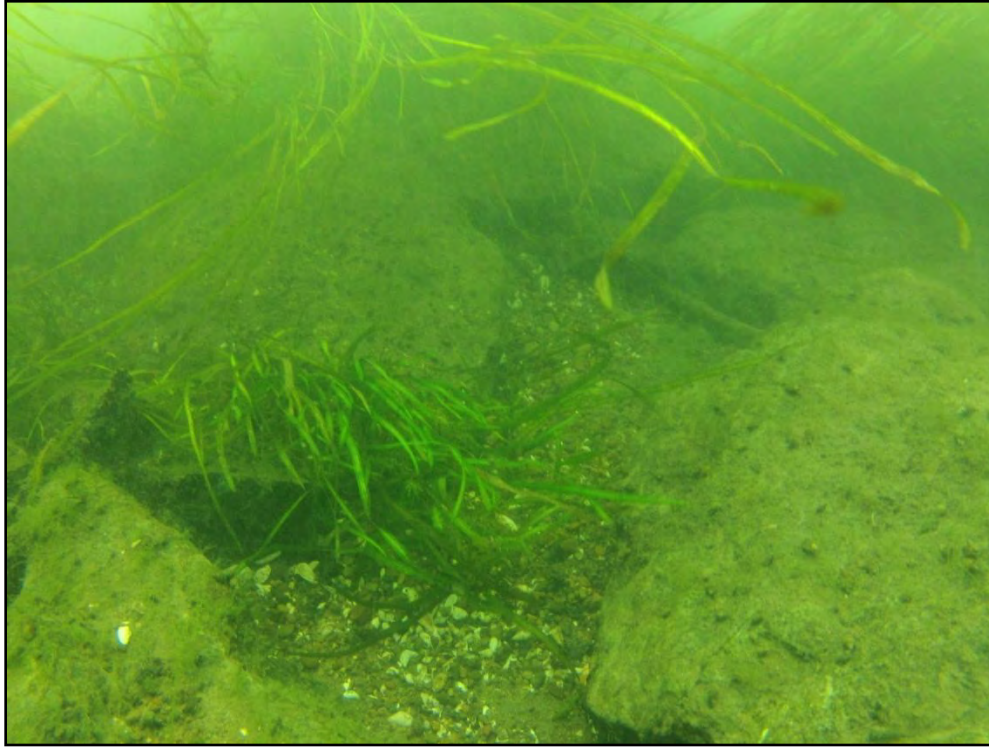
Fouling of the structures was primarily a result of algal build up, debris (small woody debris, aluminum beverage cans, fishing gear, and plastic trash), and zebra mussels. Wild celery (*Vallisneria americana*), a type of submerged aquatic vegetation that provides valuable habitat, was observed growing around the rock slope and the stone and log groin (Figure 5).

FIGURE 5. SAV GROWING AMONG THE BOULDERS AT THE STONE AND LOG GROIN
