Ecological Standing Committee Meeting

2012 HIP Activities Summary

NIAGARA POWER PROJECT

RELICENSING IMPLEMENTATION

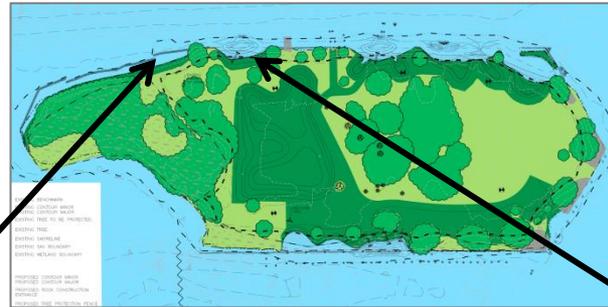
Wetland habitat
behind berm

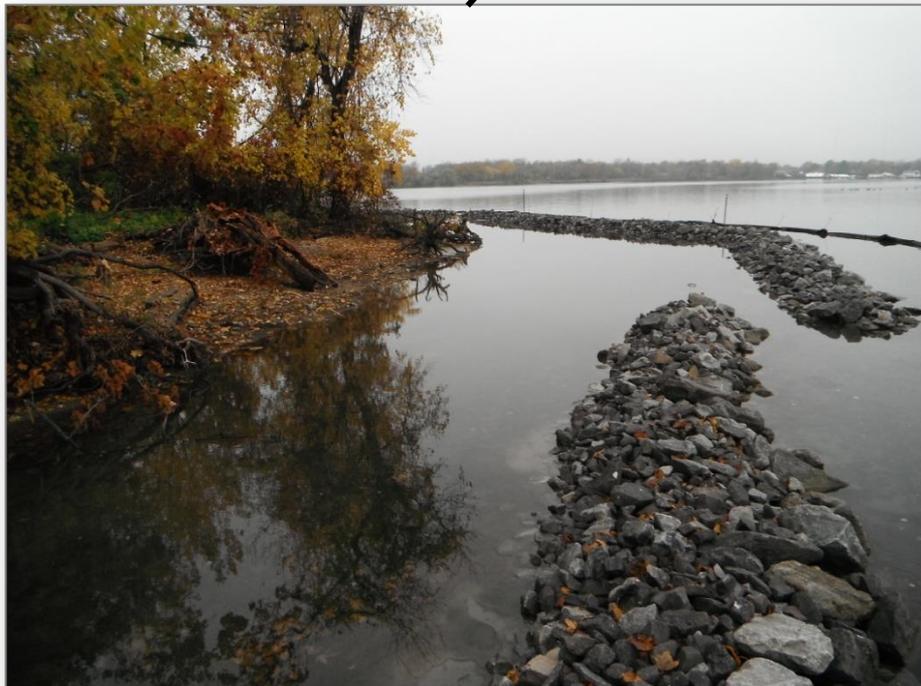
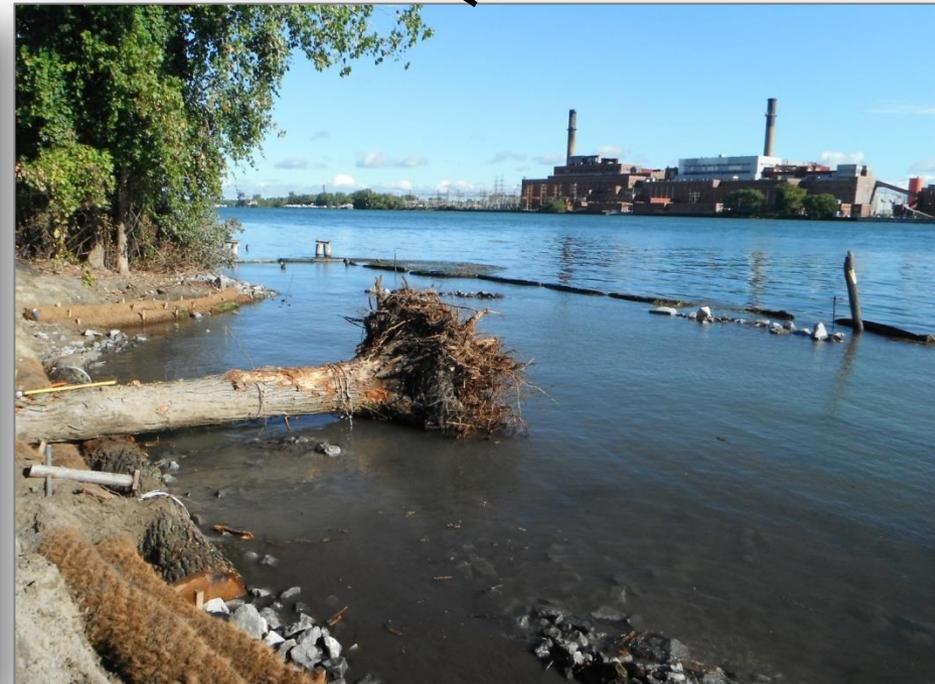
Habitat logs and
protective berms

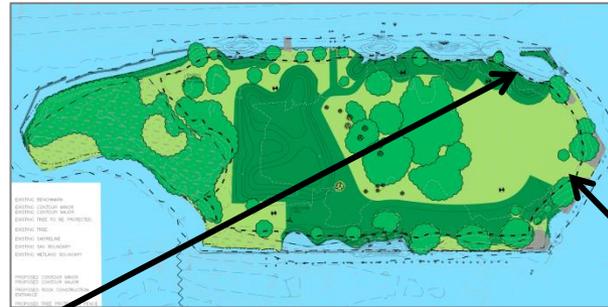
Shallow wetland area

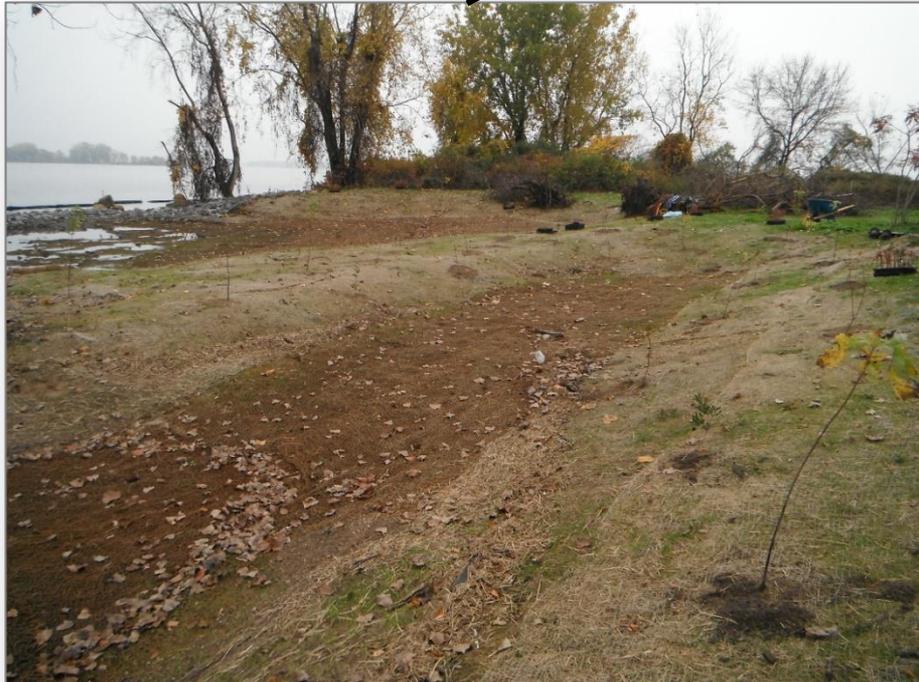
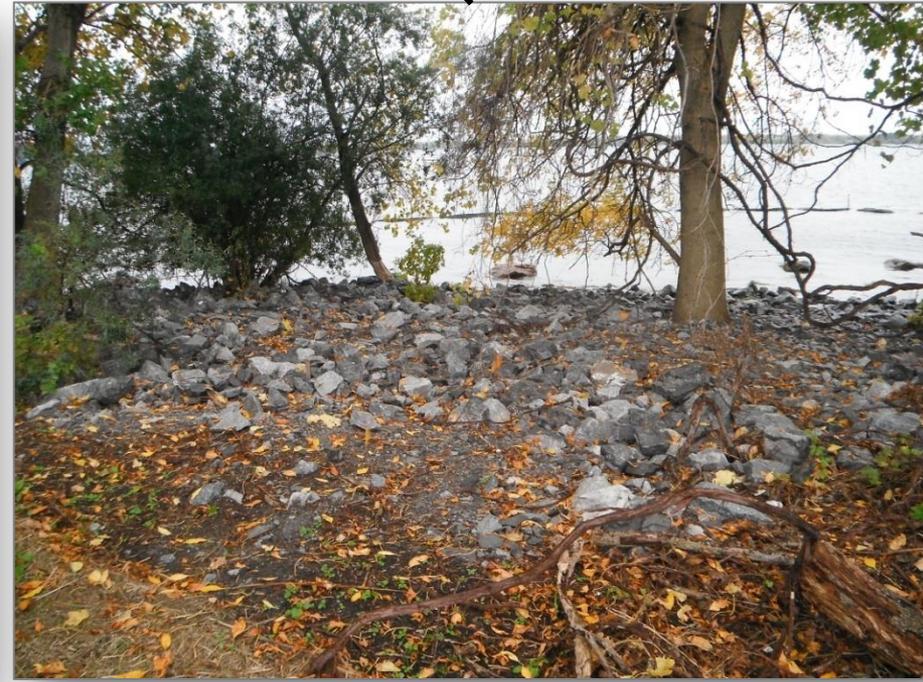
Root protection at upstream end of the island

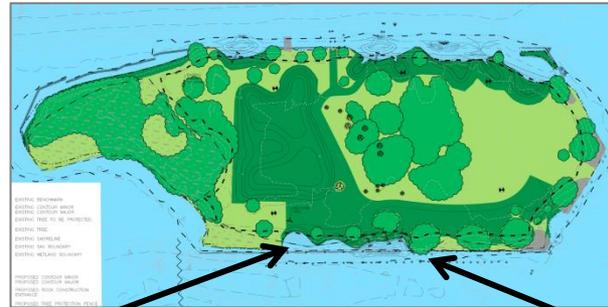
Protected pools
behind existing
cribwall

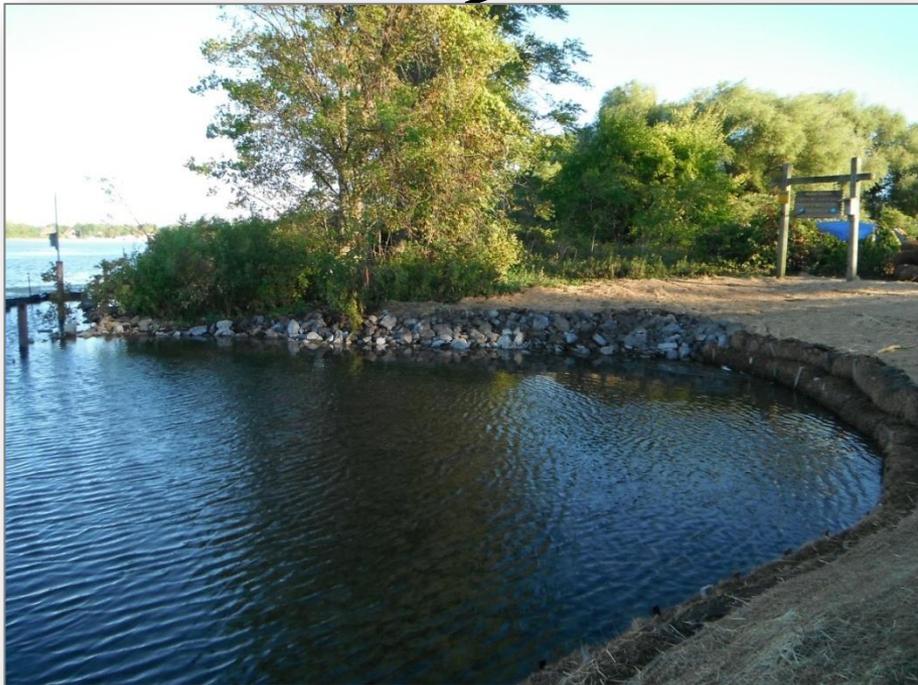
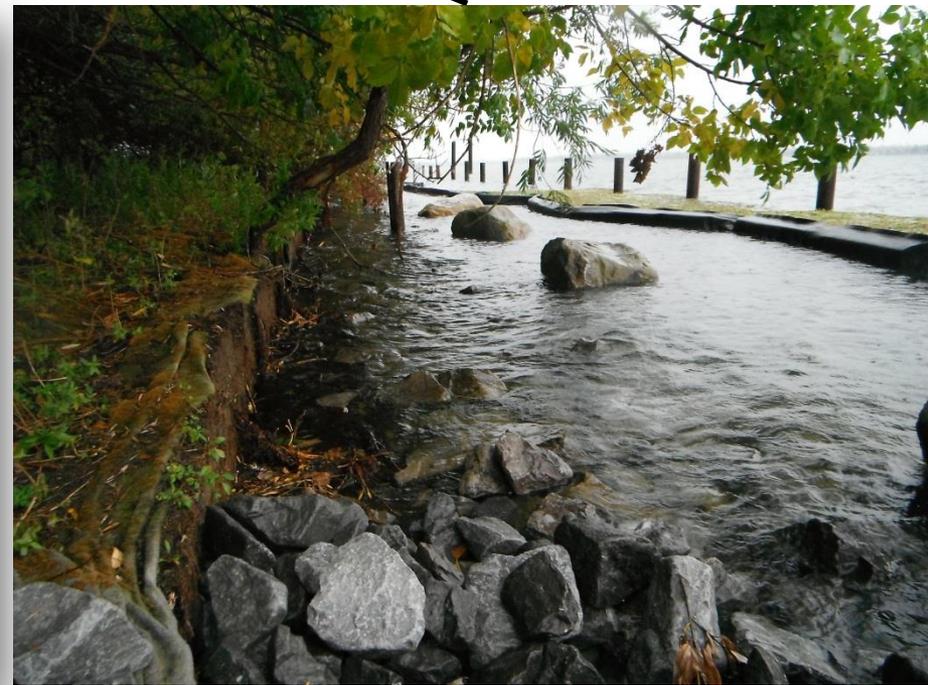
Rounded ice
protection
boulders

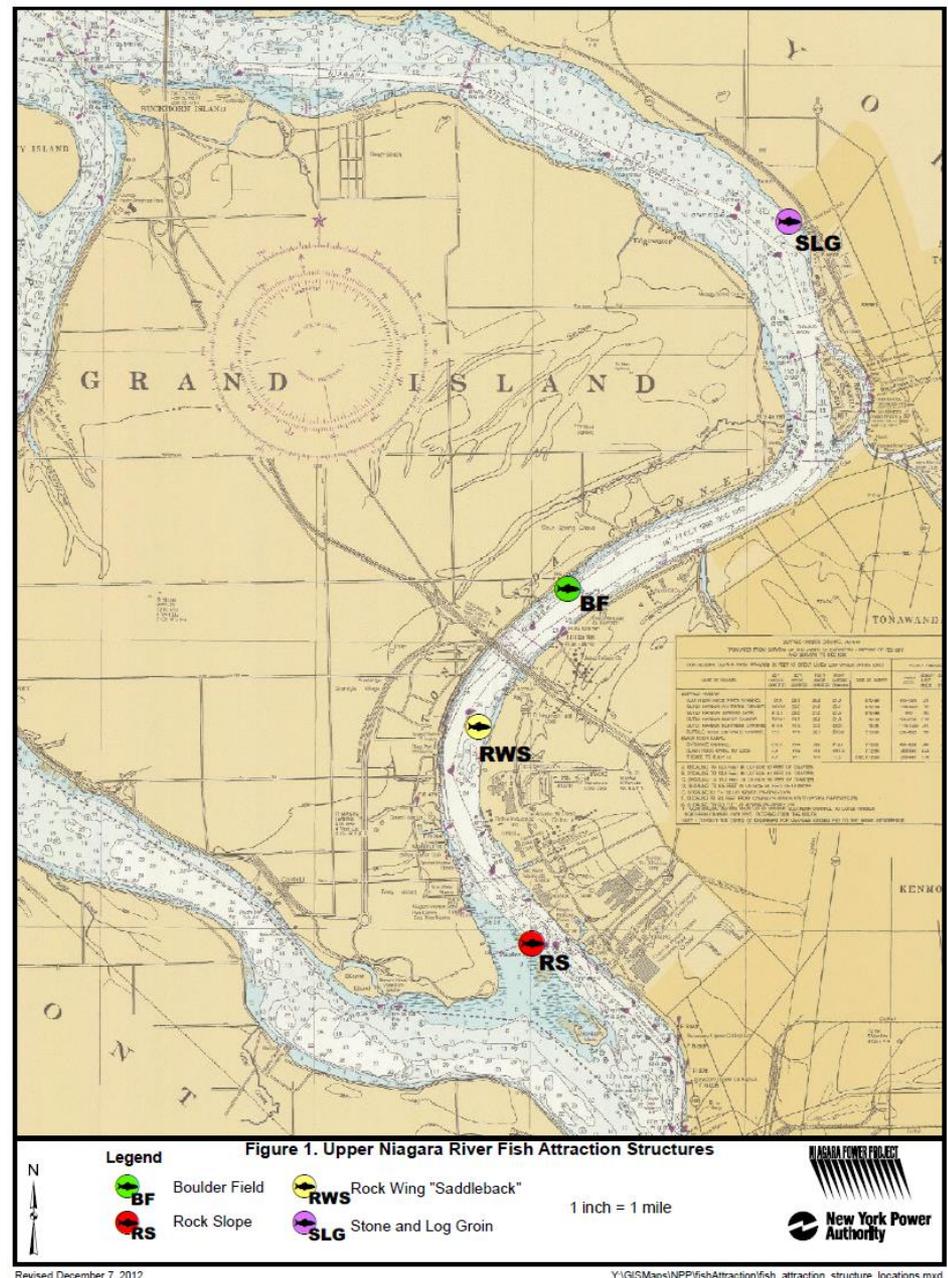
Figure 1. Upper Niagara River Fish Attraction Structures

- Gratwick Park – Shallow Water Stone and Log Groin
- Downstream of the South Grand Is. Bridge - Boulder Field
- Upstream of the South Grand Is. Bridge, near Cherry Farms – Rock Wing
- Motor Island – Rock Slope

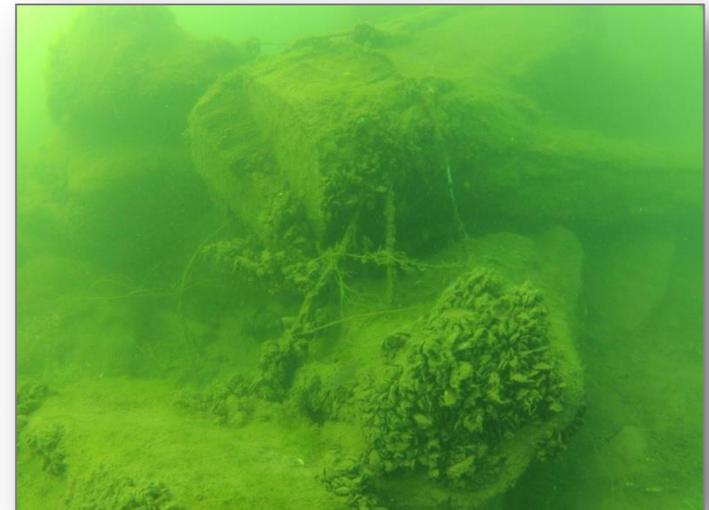
**Log at Motor Is.
Rock Slope**

- Structures mostly intact and stable four years after installation
 - Stone and Log Groin – logs lost, top of pile flattened
- Provide good large-object cover
 - Smallmouth bass at all structures; musky at Boulder Field
- Some scour and deposition of sediment
- SAV growing in/near most structures
- Increased fish diversity since 1st year monitoring

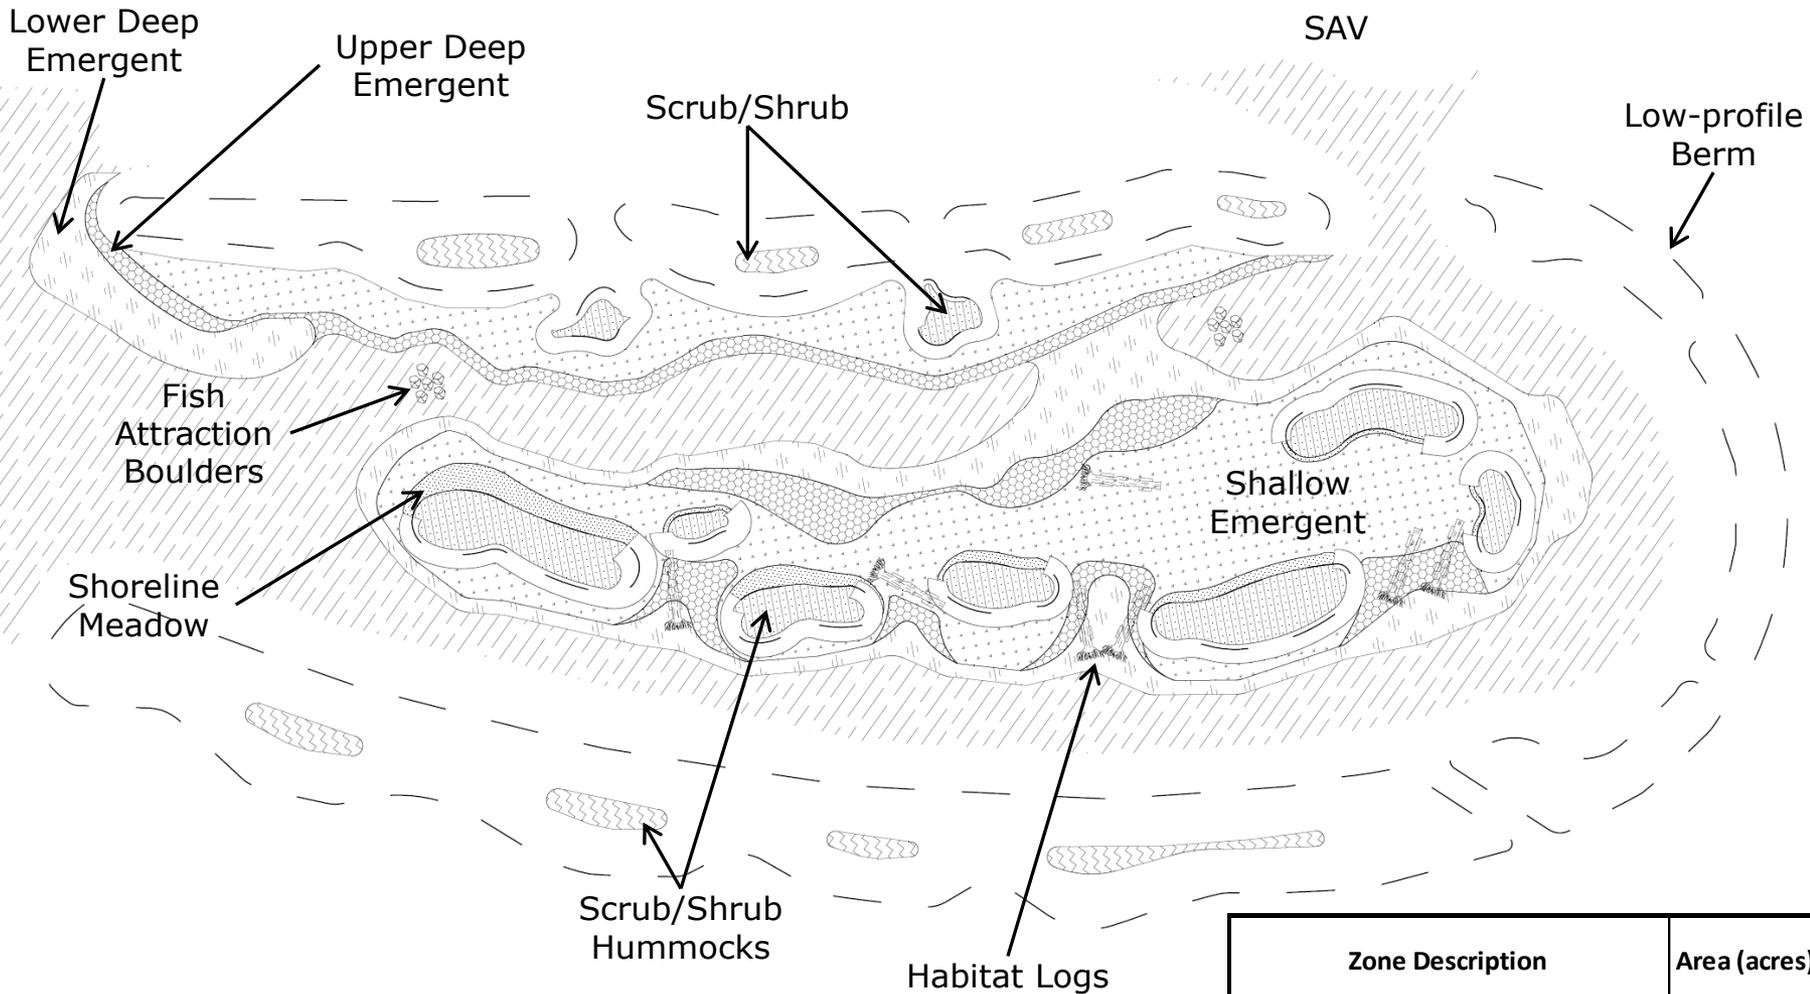
Habitat Zones

Zone Description	Area (acres)
Breakwater Scrub/Shrub Hummocks	0.04
Interior Scrub/Shrub Hummocks	0.10
Shoreline Meadow	0.03
Shallow Emergent	0.34
Upper Deep Emergent	0.12
Lower Deep Emergent	0.21
SAV	1.18

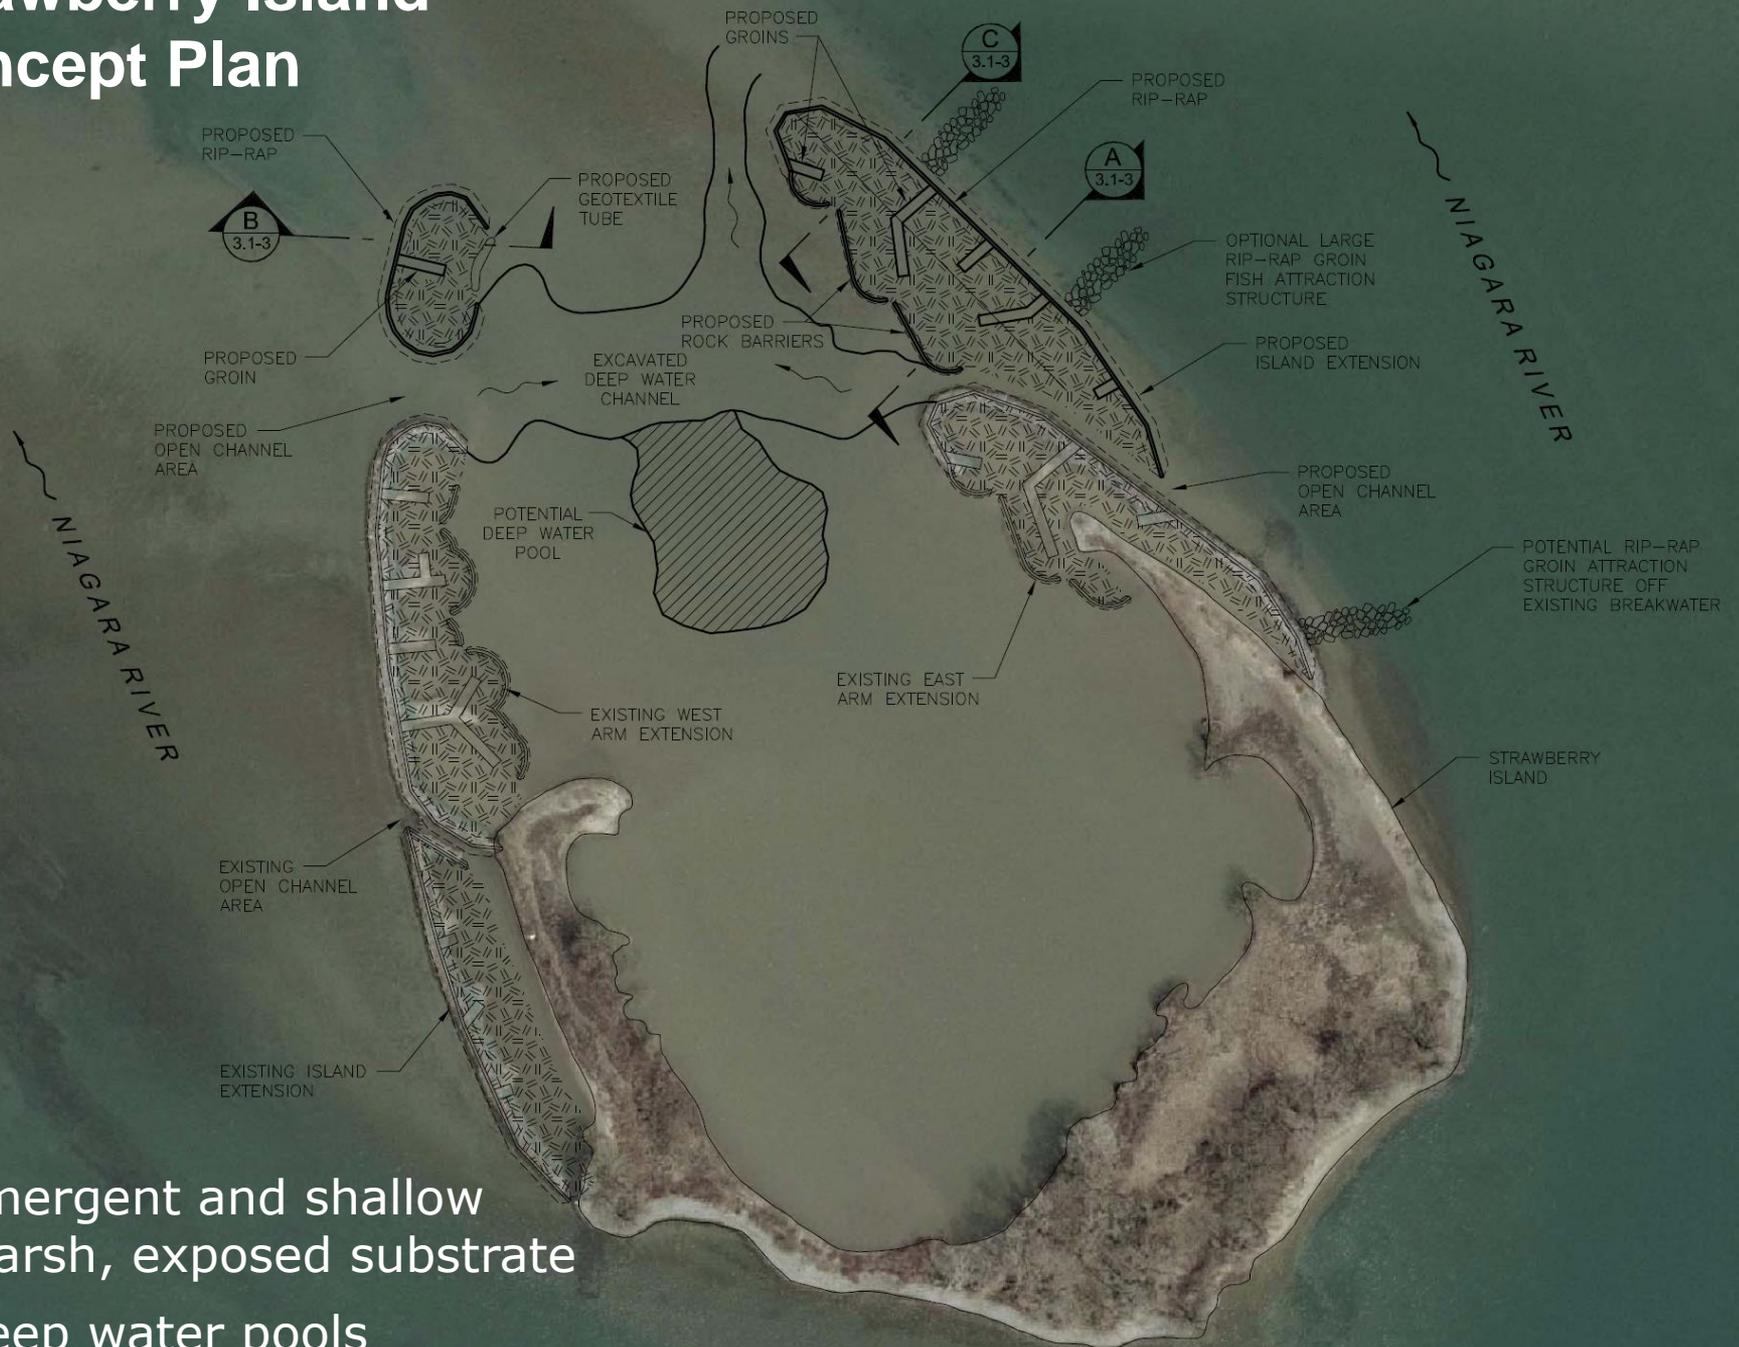
Strawberry Island – Concept Plan

- Emergent and shallow marsh, exposed substrate
- Deep water pools
