ADDENDUM TO THE RECREATIONAL FACILITY USE AND CAPACITY INVESTIGATION

Niagara Power Project FERC No. 2216

New York Power Authority

Kleinschmidt Associates

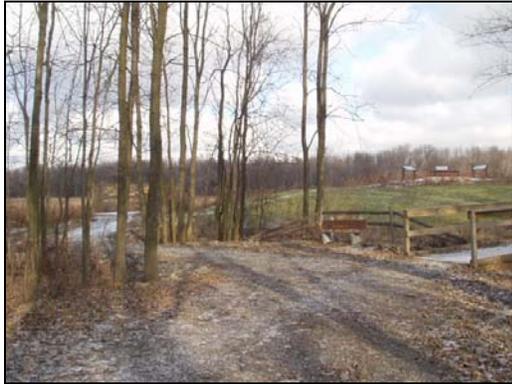
Condition: Overall, Buckhorn Island State Park is in excellent condition. The West Overlook site is in very good condition and appears to be newly constructed. This site is fairly basic with a well marked, paved parking area in good condition and with good circulation. There is also one ADA compliant parking space. The benches, trail head, and signage are also in good condition. The trail is well maintained and is stable and wide enough to be ADA compliant.

East Overlook is also in good condition overall with a gravel parking lot and a well-maintained nature trail. None of the spaces in the gravel lot are identified as ADA parking. The parking area has good circulation and fences and barriers are in good condition. This site provides a wide gravel trail and boardwalk system in good condition which provides access to wildlife blinds and a viewing platform. The gravel trail and boardwalk are ADA compliant and the wildlife blinds have adequate space for wheelchairs. There is also a trailhead for the hiking/biking trail system that is well marked and in good condition.

Woods Creek is also rated in good overall condition with a well constructed wood fishing pier and a paved and marked parking area in good condition and with good circulation. Woods Creek provides one ADA compliant parking space. The guardrail fence along the perimeter of the parking area is observed to be in fair condition and in need of repair in some places. The path at Woods Creek is hard pack, in good condition, and wide enough to accommodate wheelchair

access and the fishing pier is ADA compliant. There is also a trailhead at Woods Creek and, although it is identified and in good condition, it does not appear able to accommodate wheelchair access. There is also a gravel parking area in good condition on the opposite side of River Road at this site, although there are no ADA designated parking spaces at this site. The boat launch itself is in fair condition being a simple gravel shore launch and is not ADA compliant.

The parking area at the park office is assessed to be in poor condition. The trail head at this site is well marked and well maintained in good condition and is ADA compliant.

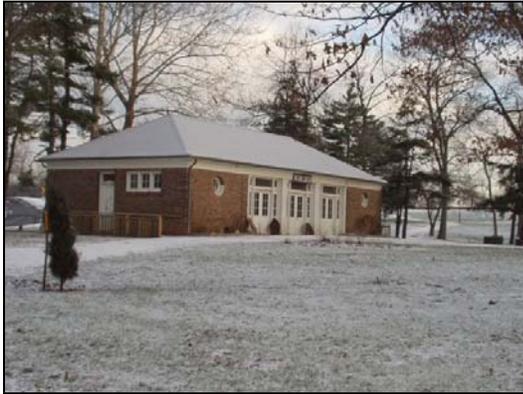
Condition: Overall, this site is in excellent condition. Many of the park facilities are spread out among the parks 950 acres and were assessed collectively. It is important to note that indoor facilities and structures were closed at the time of this evaluation. As such, only the condition of the exterior of buildings and structures were evaluated.

In total, there were nine identified picnic shelters and numerous picnic areas and tables. Picnic facilities were identified as being in good condition and are ADA compliant. In addition to the picnic shelters, there was a newly constructed golf club pavilion overlooking the boardwalk, in very good condition and ADA compliant. Six restrooms were identified and inventoried, ranging in exterior condition from fair to good. Again, as the restroom facilities were closed; interior condition and ADA compliance were not able to be evaluated.

Other buildings and structures for which only the exterior was evaluated include concession stands, the meeting house, maintenance buildings and the River Lea Historic Farmhouse. Concession stands, including the golf club house and pro shop, are in good exterior condition but could not be assessed for ADA compliance. Maintenance buildings are also well maintained outside. No determination of ADA compliance was made for these facilities. The River Lea Historic Farmhouse was in fair condition outside. The parking lot at the River Lea Farmhouse is in fair condition; it provides two ADA parking spaces. The Farmhouse itself does not appear to be ADA compliant from the outside.

There were numerous overlooks, walkways, and viewing platforms ranging in condition from good to fair. The viewing platform in Area 4 appears to have been a concession stand at one point and is in fair condition. Other scenic overlook platforms throughout the park are in good condition overall and the boardwalk in Area 1 appears to be newly constructed and is very well maintained. The walkways, nature trails, and bike paths are in good condition overall and are well marked and maintained. Most appear to be ADA compliant.

There were three playgrounds identified and inventoried during the site visit. One playground in Area 4, adjacent to the park office, is in fair condition. The other two playgrounds, one in Area 1 and another in Area 3, appear to be newer and are in good condition. None of the playgrounds are ADA compliant.

The marina at Beaver Island State Park consists of several docks and piers, all of which were not in the water at the time of this evaluation. It is estimated that there are approximately 50 slips at this marina and the marina is assessed to be in fair to good condition overall. The marina was determined to not be ADA compliant. There are also two canoe launches at the park, both of which are listed in poor condition, are overgrown with brush and trees, and are not ADA compliant. There is additional bank access throughout the park, such as the half mile sandy beach, that is in good condition overall but is not ADA compliant.

Organized sporting facilities, such as the golf course, driving range, and baseball and soccer fields were all determined to be in good condition. It does not appear that the sporting fields are ADA compliant, however, the golf course and driving range may be. As the golf course was closed, ADA compliance could not be determined for this facility. The basketball courts were observed to be in fair condition.

The parking areas at Beaver Island State Park are spread out across the park and range in condition from good to poor. All of the parking lots have good circulation, good signage, and fencing and barriers are in good condition. Most parking lots are asphalt and in fair to good condition, specifically the parking lots serving Area 4, Area 5, and the golf course appear to be in good condition and all provide ADA parking spaces. The gravel overflow lot serving the golf course, however, is in poor condition and does not have any ADA compliant parking. The two large parking lots in Area 1, providing a total combined parking capacity of over 1,200 vehicles, are in fair condition with visible pavement cracks, minor wear, and a few potholes. ADA compliant parking is available at these lots. The lot serving the meeting house and pavilion is ADA compliant and in good condition. Roads traversing the park are asphalt and are mostly in good condition.

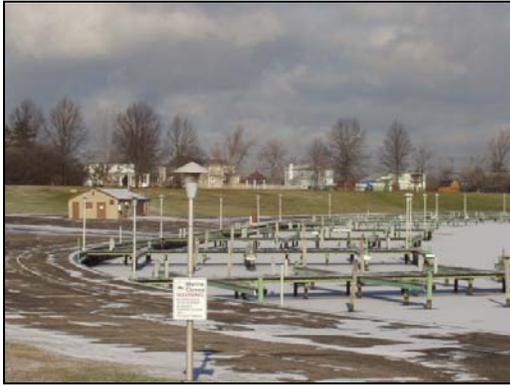
Big Six Mile Creek Marina

Condition: Overall, this facility is in good condition. The parking lot at this facility is paved and in good condition with good circulation and signage; it does not provide designated ADA parking spaces. The docks, piers and boat launch are all identified as being in fair condition. Although there is no designated ADA parking and the docks are not marked as such, the docks and piers appear to be wide enough to accommodate wheelchair access. Only the exterior of the concession building, which houses the store and restrooms, was assessed and determined to be in fair condition.

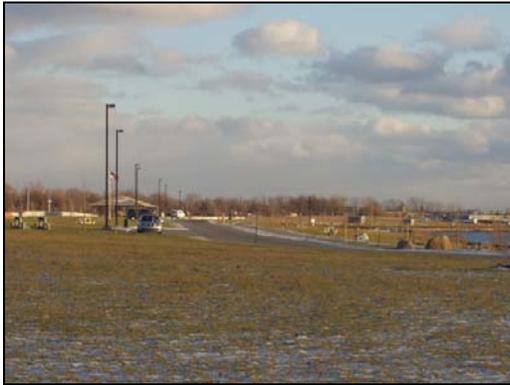
Gratwick Park

Condition: Overall, this facility is in good condition. The parking lot is paved and in good condition with good circulation. It does not provide designated ADA parking spaces although all spaces are ADA accessible. The Niagara Riverwalk trail is paved and in good condition and is ADA accessible. The numerous benches along the trail are also in good condition. The picnicking facilities are in good condition, but are not ADA compliant. Most picnic tables are located in the greenspace with 12 picnic tables located under a pavilion in good condition but with a concrete foundation that is too high for wheelchair accessibility. The boat launch is in good condition and is ADA accessible. The maintenance building is in good condition on the exterior. The greenspace is mowed and is well maintained.

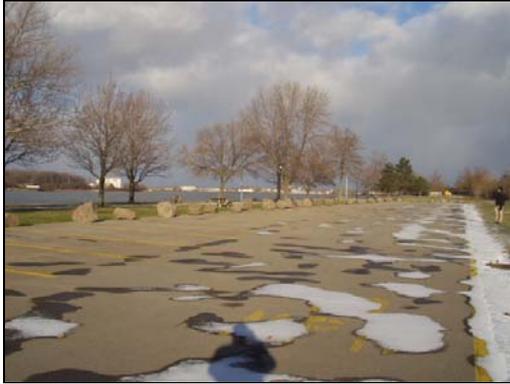
Niawanda Park

Condition: Overall, this site is in excellent condition. The parking lots at this facility are paved and in good condition with good circulation, signage, and fencing. There were two identified ADA parking spaces in the lot adjacent to the amphitheater. The Niagara Riverwalk trail is paved and in good condition and is ADA accessible from this location. The numerous benches along the trail are also in good condition. The picnicking facilities are in good condition and are ADA accessible. The boat launch is in good condition with several accompanying piers in fair condition. There were also several floating docks in good condition that were dry and stacked in one of the parking lots. The recreation season placement of these docks is unknown. It would not appear that the boat launching facilities are ADA accessible. The fishing pier at this park is ADA accessible and in good condition. It is important to note, however, that the fishing pier railing does not allow for ADA reach. These pier railings are too high in some places to

accommodate line casting. The restrooms building is in good condition on the exterior with signage stating that they are ADA accessible. However, a threshold of more than ½” was observed at the entrance to the restrooms. The greenspace at this park is mowed and is well maintained.

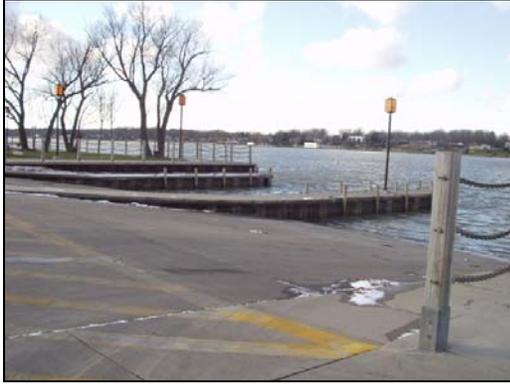
Isle View Park

Condition: Overall, this facility is in excellent condition. The parking lots at this facility are paved and in good condition with good circulation, signage, and fencing. There were five identified ADA parking spaces in the various lots. The Niagara Riverwalk trail is paved and in good condition and is ADA accessible from this location. The numerous benches along the trail are also in good condition. The picnicking facilities are in fair condition and are ADA accessible. The boat launch adjacent to the gazebo is paved and in poor condition. However, the additional two paved double-lane boat launches at the park are in good condition. All of the boat launches appear to be ADA accessible. There are four fishing piers, all in good condition, one of which is ADA accessible. Bank fishing opportunities are also provided along the shoreline of the park which is assessed to be in fair condition due to the terrain and steep nature of the banks.

There are two restroom facilities, one located at the “Cousin Vinny” concession and the other located at the playground. The exterior of both buildings are in good condition. The facilities state that they are ADA accessible, however, the interior of these buildings were not evaluated to confirm this. The maintenance building at this park is in good condition and appears to be ADA compliant. The gazebo is in good condition and is ADA compliant with an adjoining ADA compliant river access dock in good condition. The playground is also in good condition but is not ADA compliant. The greenspace at this park is mowed and is well maintained.

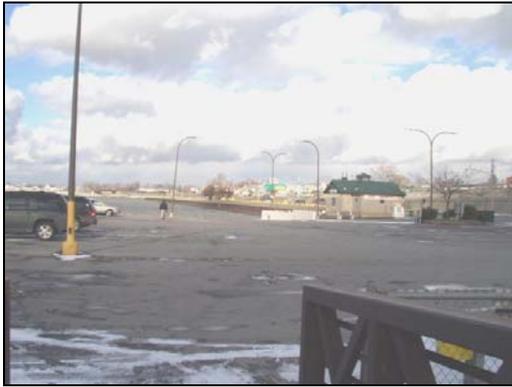
Ontario Street Boat Launch

Condition: Overall, this facility is in good condition. The two parking lots at this facility are paved and in good condition with good circulation. There are no ADA designated parking spaces, although all spaces are equally accessible. Signage is good but the small size of the signs made it difficult to find the site, if one were to rely on roadside signage alone. Riverwalk fencing is in good condition but parking barriers are in fair to poor condition at this site and the main parking lot seawall is in fair condition. The Niagara Riverwalk trail is paved and in good condition at this site, with a pedestrian bridge connecting the boat launch to the trail. The trail is ADA accessible from this location both at the entrance to the site and via the pedestrian bridge. The picnicking facilities are in fair condition and are ADA accessible. The boat launch is paved and in good condition. However, the accompanying docks are in fair condition. The boat launch and docks appear to be ADA accessible.

There are restroom facilities at the “Coney Island Tow Path Snack Bar” concession and the exterior of this building is in good condition structurally but has been vandalized. The ADA accessibility of these facilities was not able to be evaluated.

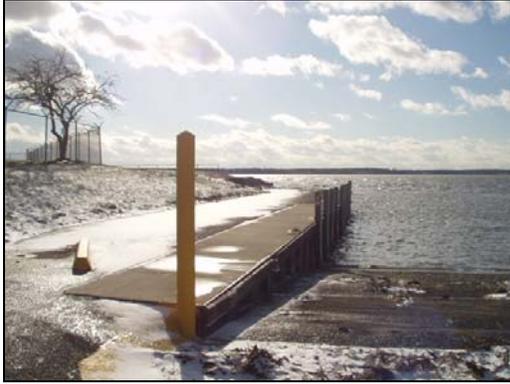
Sheridan Drive Boat Launch

Condition: Overall, this facility is in good condition. The parking lot at this facility is paved and in good condition with good circulation. There are four ADA designated parking spaces. Signage is fair and minimal. The boat launch is paved and in good condition as are the accompanying docks. The boat launch and docks appear to be ADA accessible. Bank access is eroded and there are no fencing or barriers along the river at this site. The entrance booth is in fair condition.

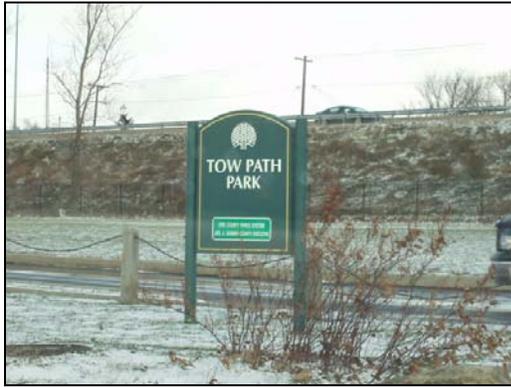
Tow Path Park

Condition: Overall, this facility is in fair condition. The parking lot at this facility is paved but in poor condition with poor circulation. There are no ADA designated parking spaces but the lot is accessible and the Riverwalk trail is ADA accessible at this site. Signage is good. Fencing along the Riverwalk is in good condition. Barriers along the perimeter of the parking lot and along the access road are in poor condition. There was debris and trash in the corner of the parking lot at the time of the site visit and signs of vandalism were evident.

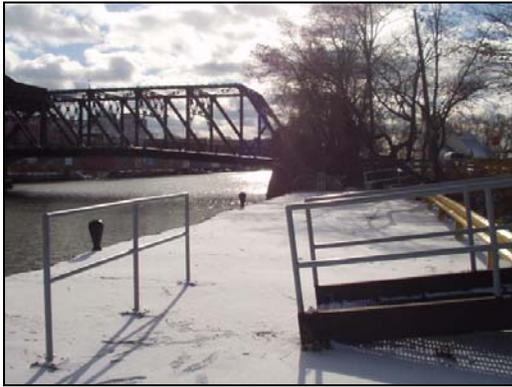
Broderick Park

Condition: Overall, this facility is in good condition. The parking lot is paved with good circulation and in good condition but the paved access road to this facility is in poor condition. Curbing in the parking lot is also in fair condition with some missing and some destroyed. The parking lot is ADA accessible and the Riverwalk trail is ADA accessible at this site. Signage and fencing/barriers at this site are good. The fishing pier at this site, shown in the picture above, is actually a former canal boat pier and is deteriorated.

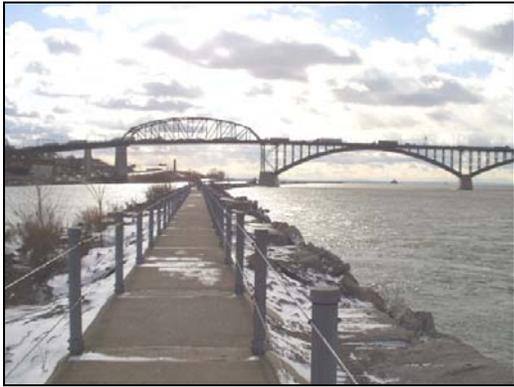
Bird Island Pier

Condition: Overall, this facility is in fair condition. The parking lot at this facility is paved and in good condition but has only fair circulation as it is difficult to access and turn vehicles around at the end of the lot toward the pier. The parking lot has no designated ADA parking spaces but is ADA accessible and the Riverwalk trail is ADA accessible at this site. Signage at this site is good. The fencing along the Riverwalk is in fair condition, with leaning occurring in some areas, and the rock wall barrier at the end of the pier is deteriorated. The fishing pier at this site, shown in the picture above, is in good condition and is ADA accessible.

The picnic facilities at this site are in poor condition with bent and vandalized picnic tables and grills. The picnic shelter has also been vandalized. The picnic tables are ADA accessible, though the shelter is not. Only the exterior of the concession, Pal's Breakwater Café, was evaluated and appears to be in fair condition. The restrooms were not evaluated for ADA compliance. The greenway and landscaping at this site are in good condition.
