NIAGARA POWER PROJECT

RELICENSING IMPLEMENTATION

Ecological Standing Committee Meeting

November 19, 2009

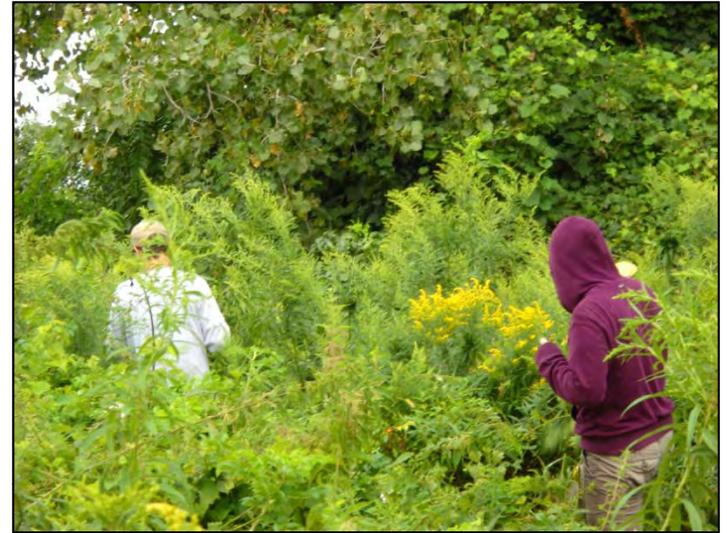
- Collected data on key design constraints
 - Wetland delineation
 - Subsurface soil conditions in areas of excavation
 - Cultural Resources survey
- Continued Preliminary (50%) Design of softer shoreline embayments to provide habitat and prevent erosion

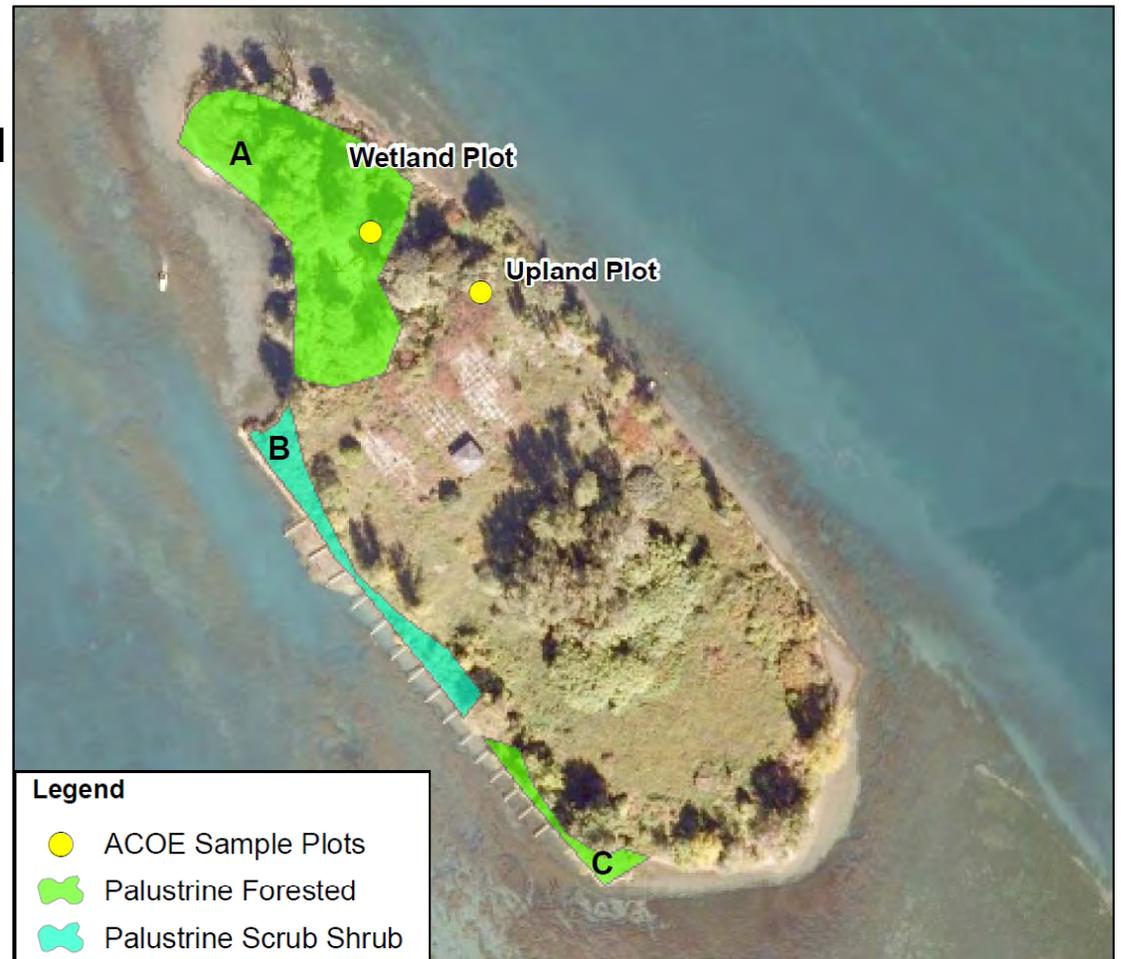
Motor Island (2009)

Wetland delineation survey – August

Preliminary Results:

- A = Mostly forested wetland with shoreline emergent wetland
- B & C = Shoreline scrub-shrub wetland
- Wetlands B and C are not functionally connected or significant
- Wetland A will be avoided in the proposed design

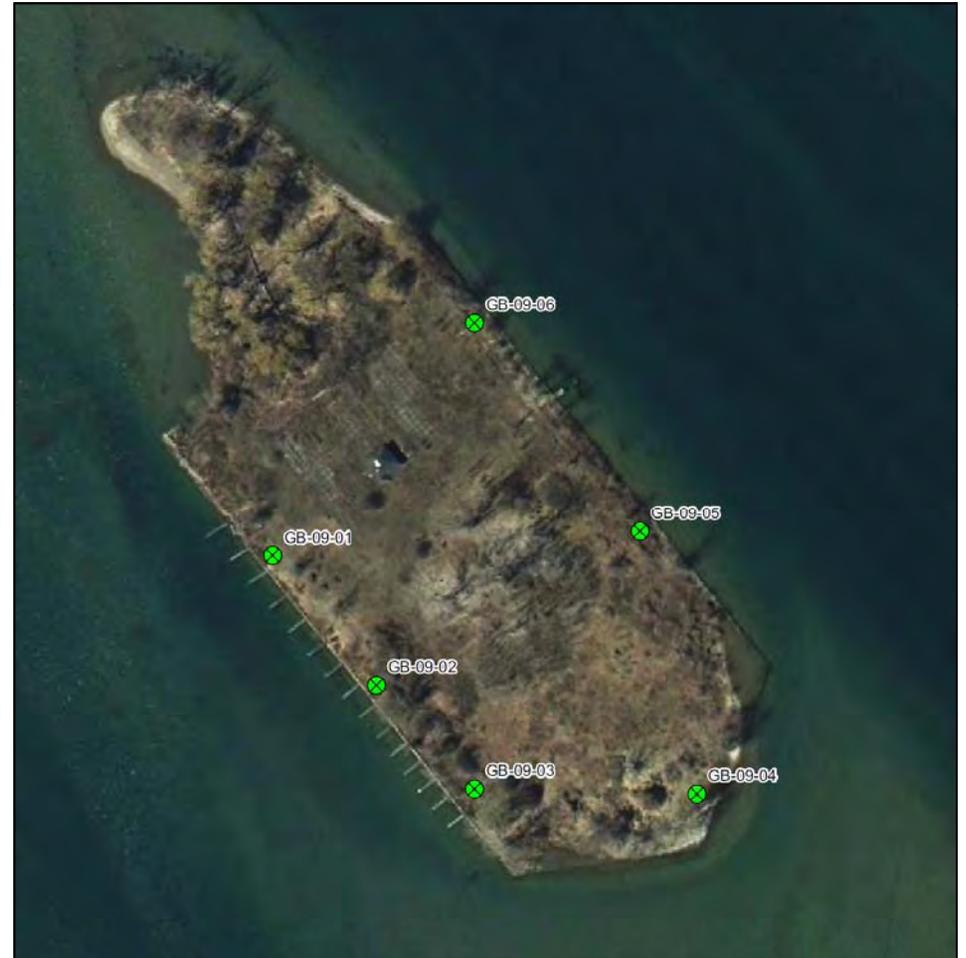
Motor Island (2009)

Geotechnical/environmental soil borings – Sept. 30 & Oct. 1

- Six locations 10 to 11.5 below ground surface
 - Gravelly sand underlain by finer grained sand and silt; some clay in one location
- Lab results – levels below DEC's unrestricted use soil criteria

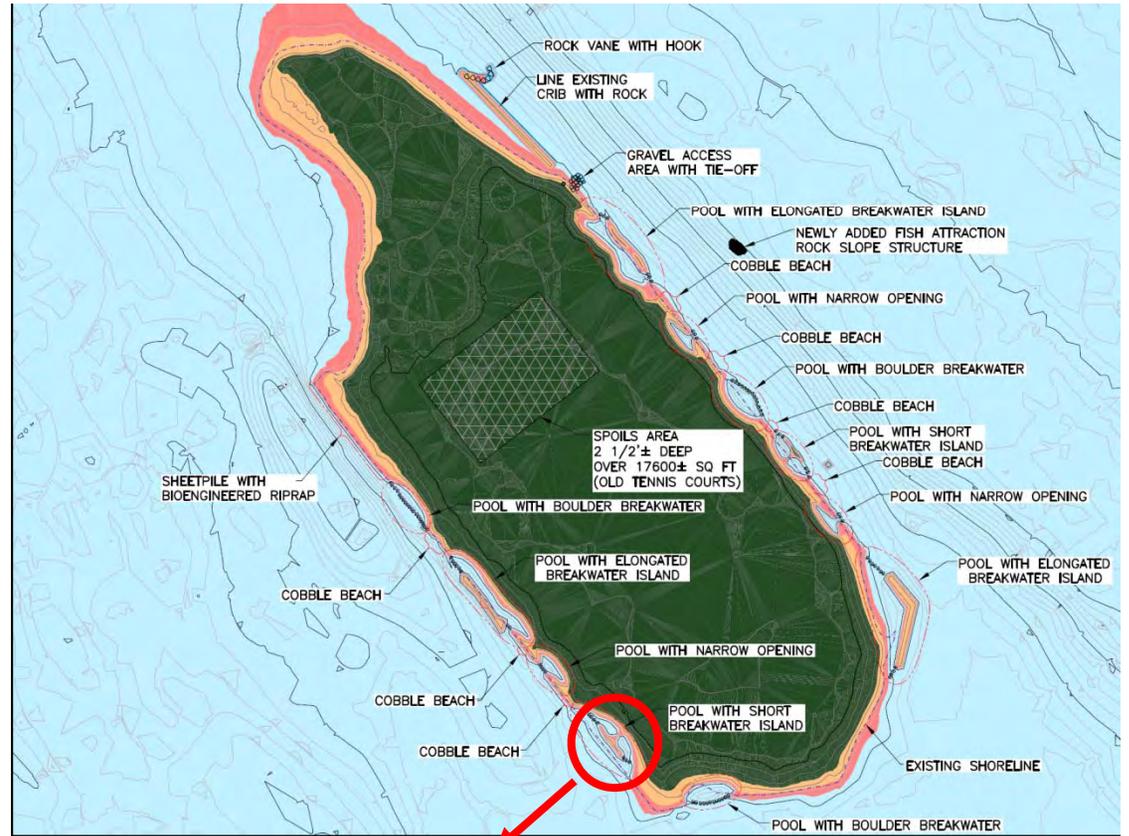
Update designs based on key constraints

Integrate data from wetlands, soils, and cultural resource findings

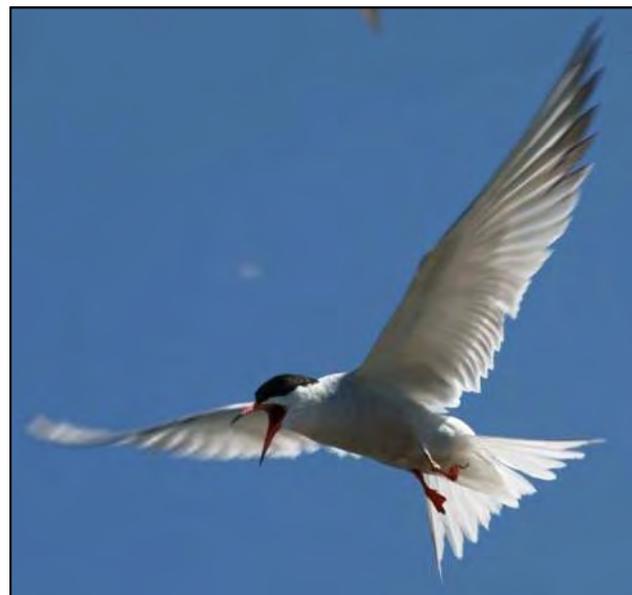
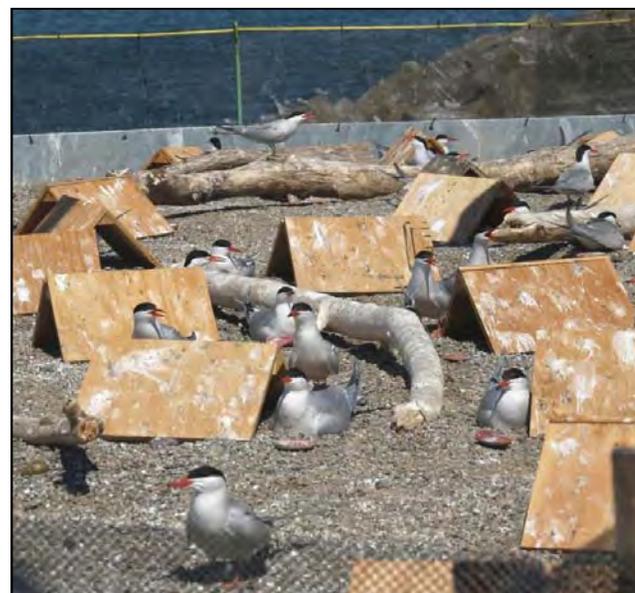
2009 Results: Barge versus End Cell

- Similar in cost for design, engineering, permitting, monitoring
- Barge required several trips for maintenance; end cell none
- Approximately equal number of tern nests/square foot
- Productivity (10 days) higher on End Cell (2.3 vs. 2.0 chicks/nest)
- Installation cost/chick for barge eight times greater than end cell

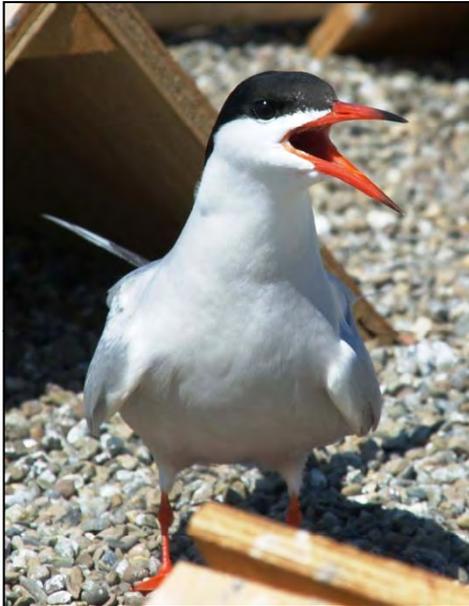
Storms Continued in Fall 2009

- Late September
 - 2 days with gusts over 30 mph
 - 1 day with gusts over 60 mph!
- October
 - 7 days with gusts over 30 mph
 - 2 days with gusts over 40 mph
 - 1 day with gusts over 50 mph

Condition of end cell gravel assessed on October 29, 2009 (barge was removed at the end of August)

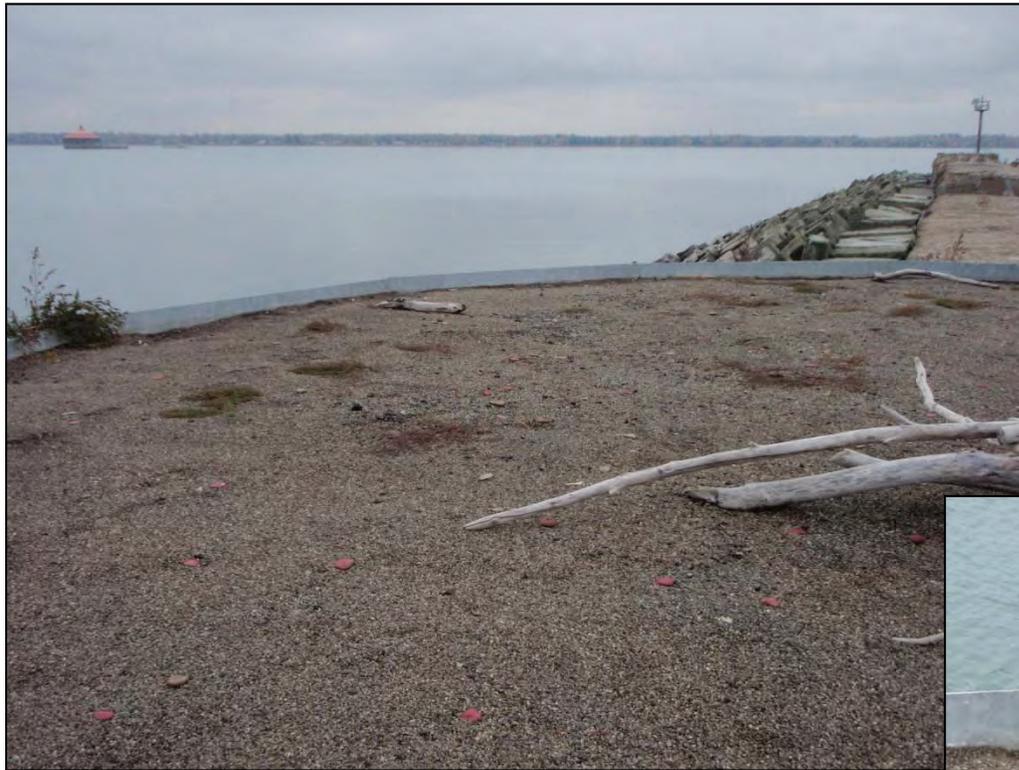
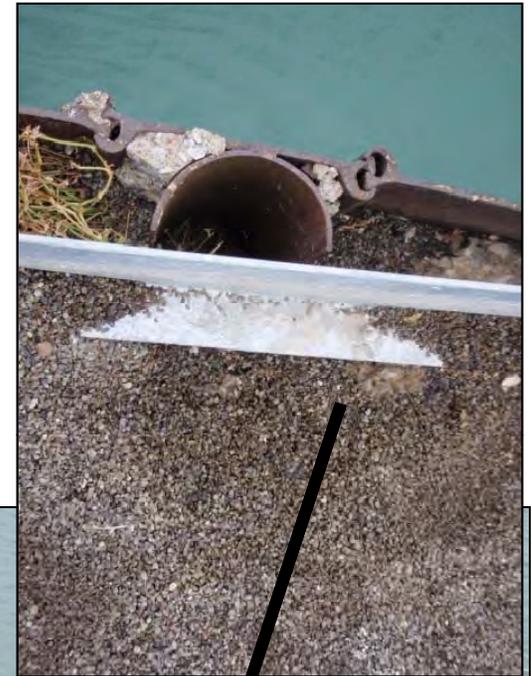
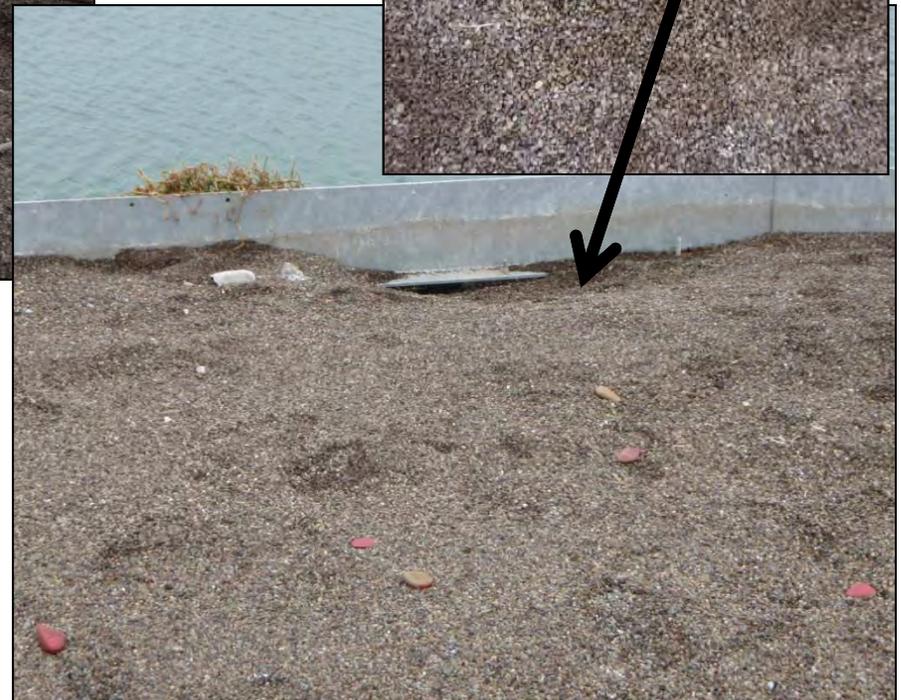
Condition of End Cell - October 29, 2009

- Overall condition excellent
- Some minor shifting of gravel after storms
- Holes will be plugged in April 2010 to prevent gravel loss

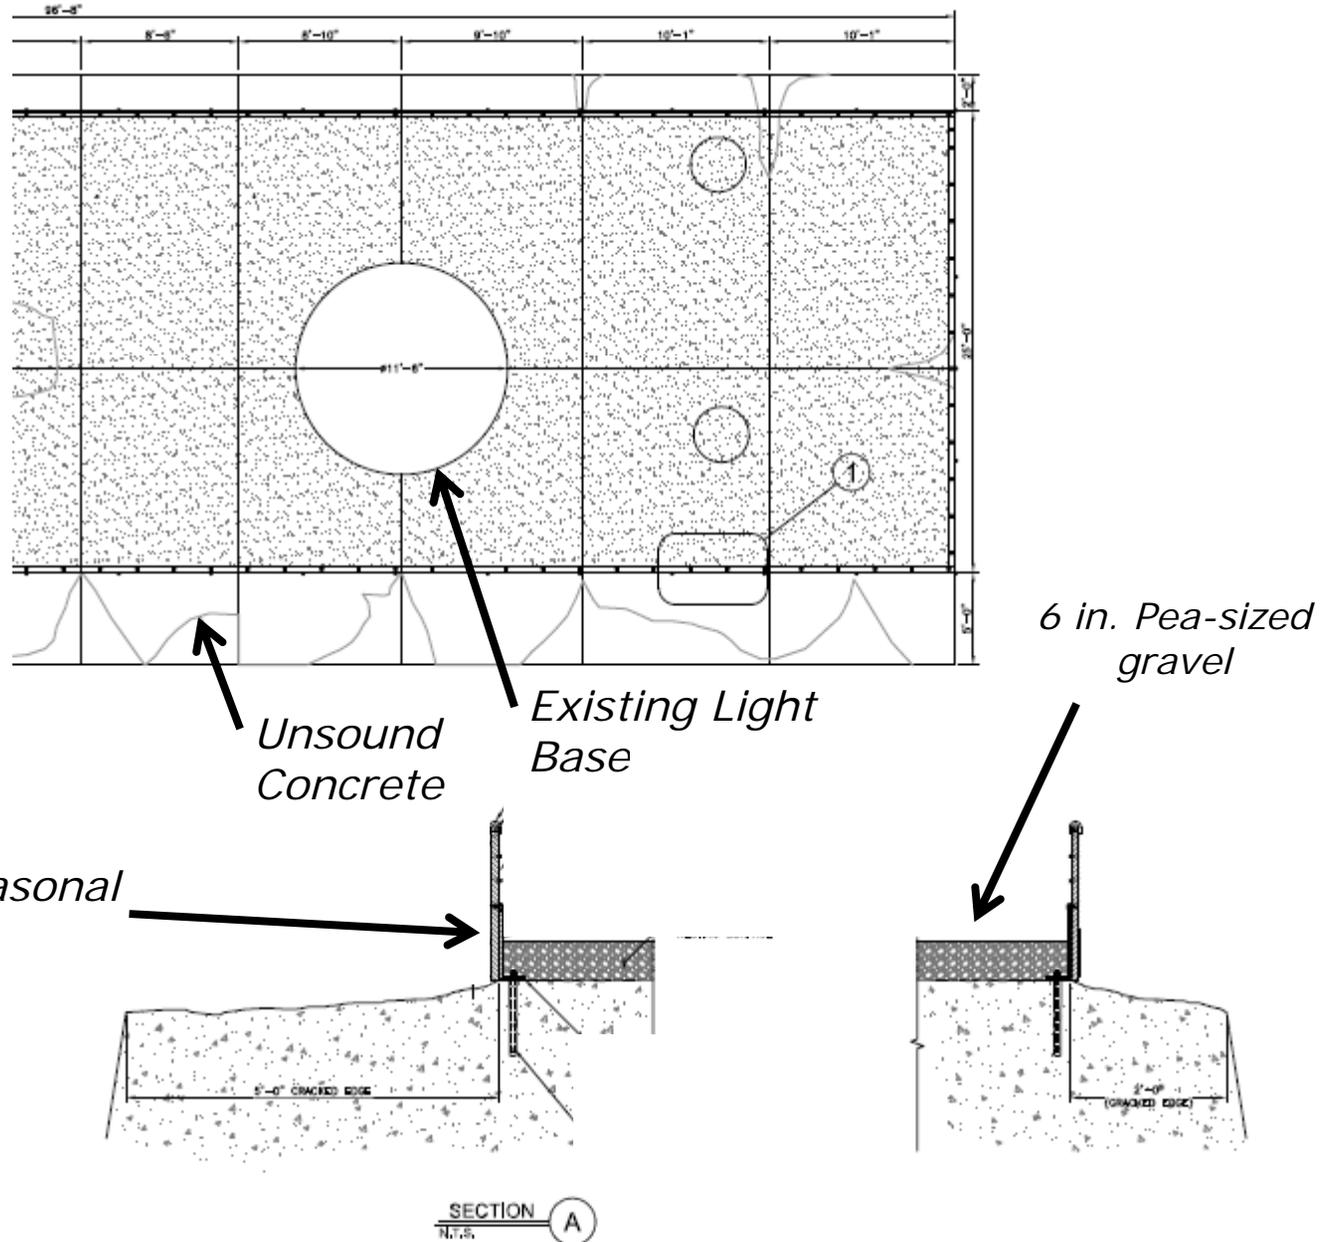
Common Tern Nesting (2010)

Typical Installation

- Based on 2009 installation design

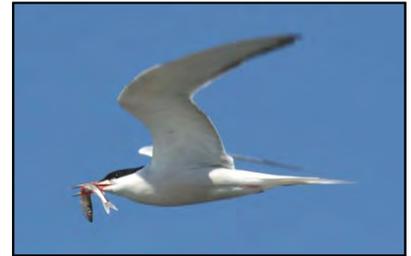
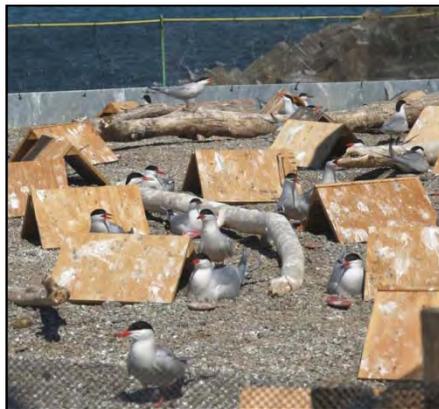
Common Tern Nesting HIP

Permanent habitat provided

| Location | Area (sq ft) | Installation |
| Old Breakwater North – southern end cell | 2,100 | April 2009 |
| North Breakwater – southern end | 2,300 | Spring 2010 |
| Old Breakwater North – northern end | 1,300 | Spring 2010 |
| Old Breakwater South –double end cell | 3,100 | Spring 2010 |
| Total area improved | 8,800 | |

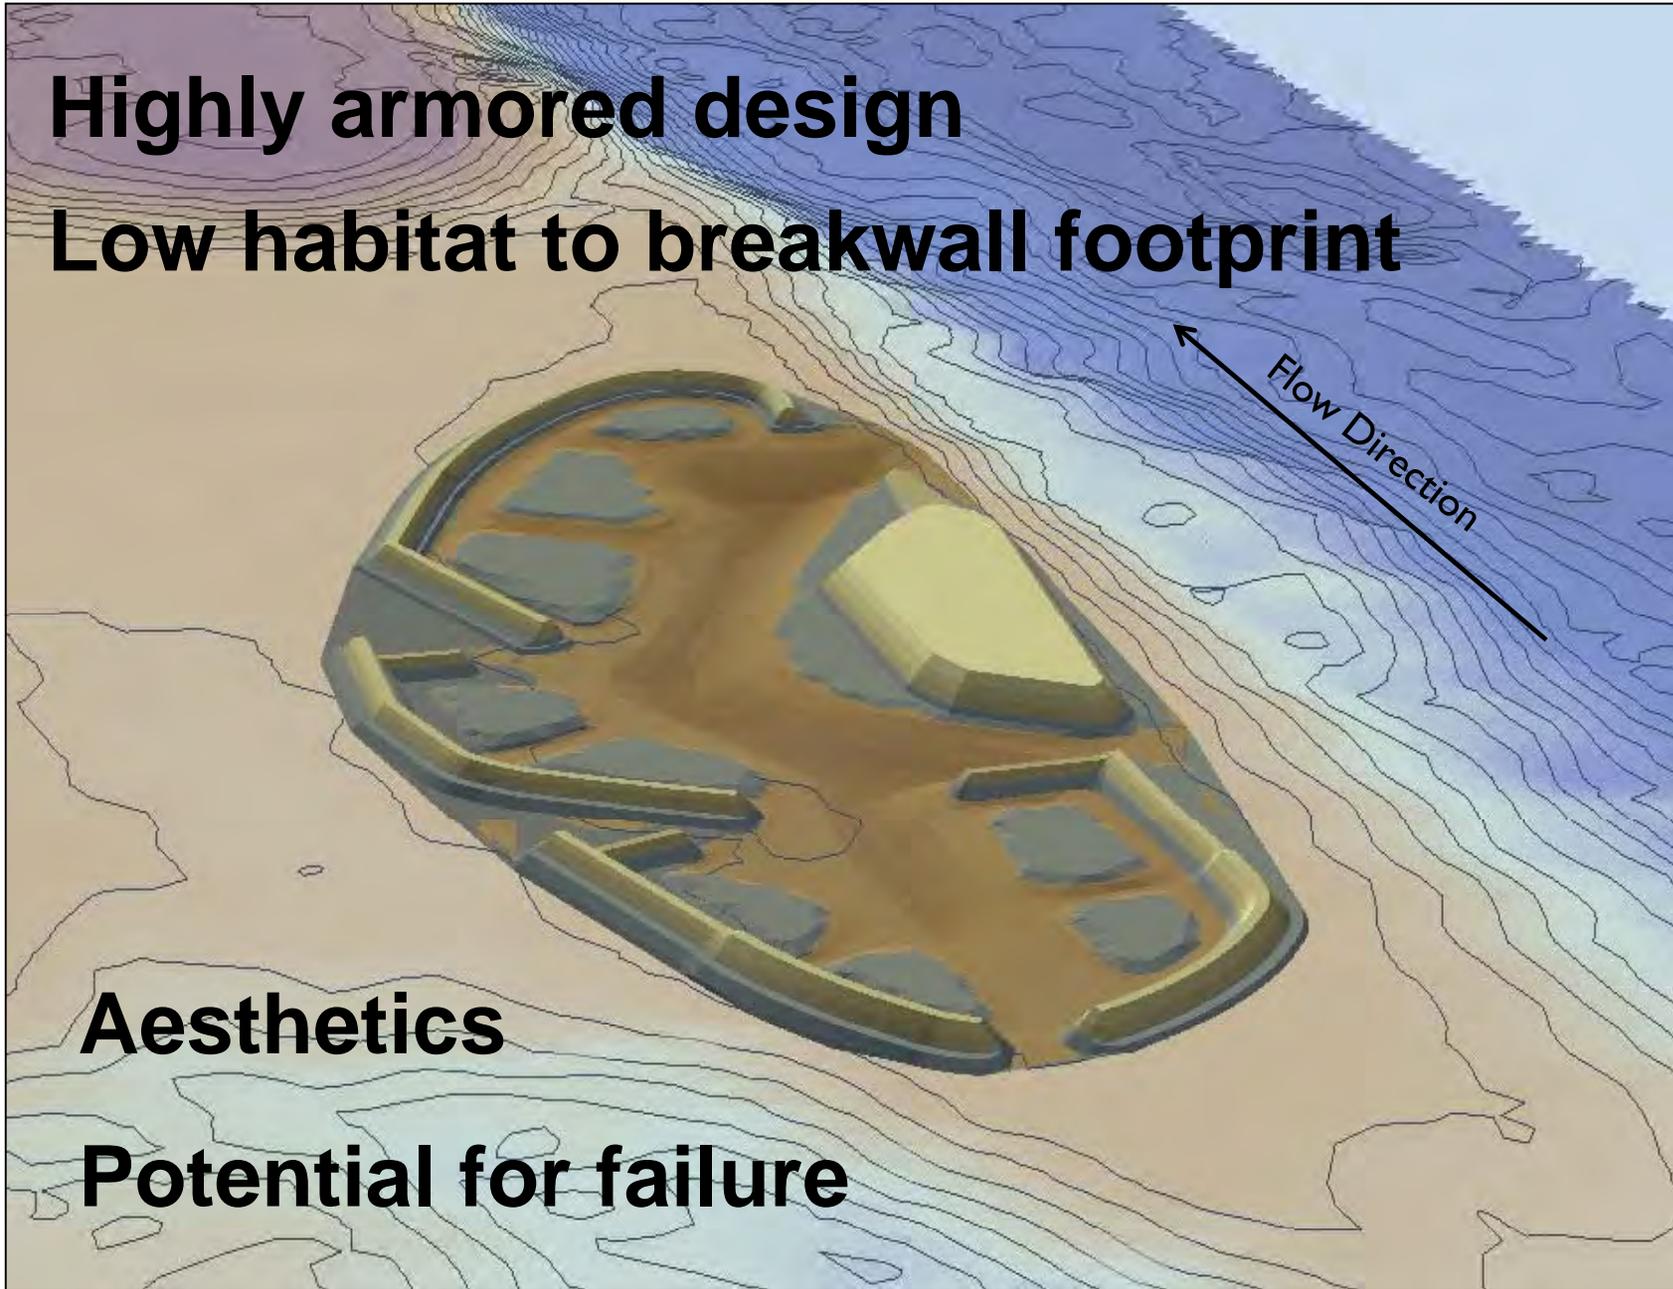
Frog Island – HIP (2009)

- Developing a Preliminary Design
 - Identified and defined a number of design challenges
 - Ice, wind driven waves, combined with a seiche – lots of energy
- Highly armored design
 - Low habitat to breakwall footprint ratio – lots of stone, up to 3 ft out of the water

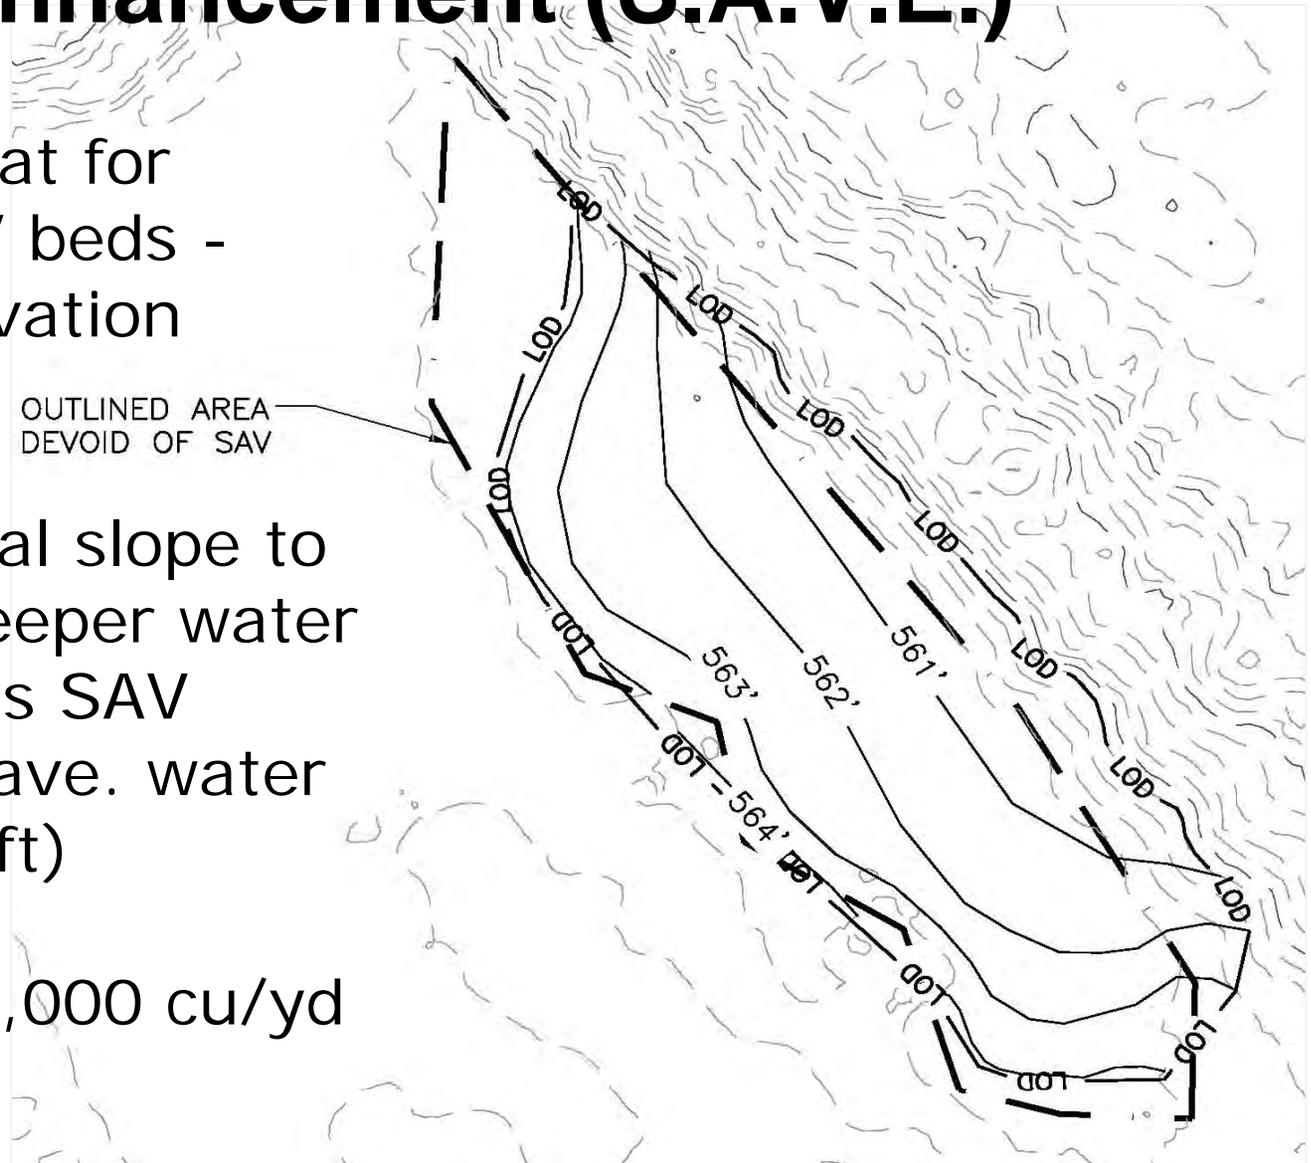
SAV Enhancement (S.A.V.E.)

- Expand habitat for adjacent SAV beds - shallow excavation (about 2 ft)
- Create gradual slope to connect to deeper water for contiguous SAV beds (attain ave. water depth of 3.5 ft)
- Excavate ~ 13,000 cu/yd

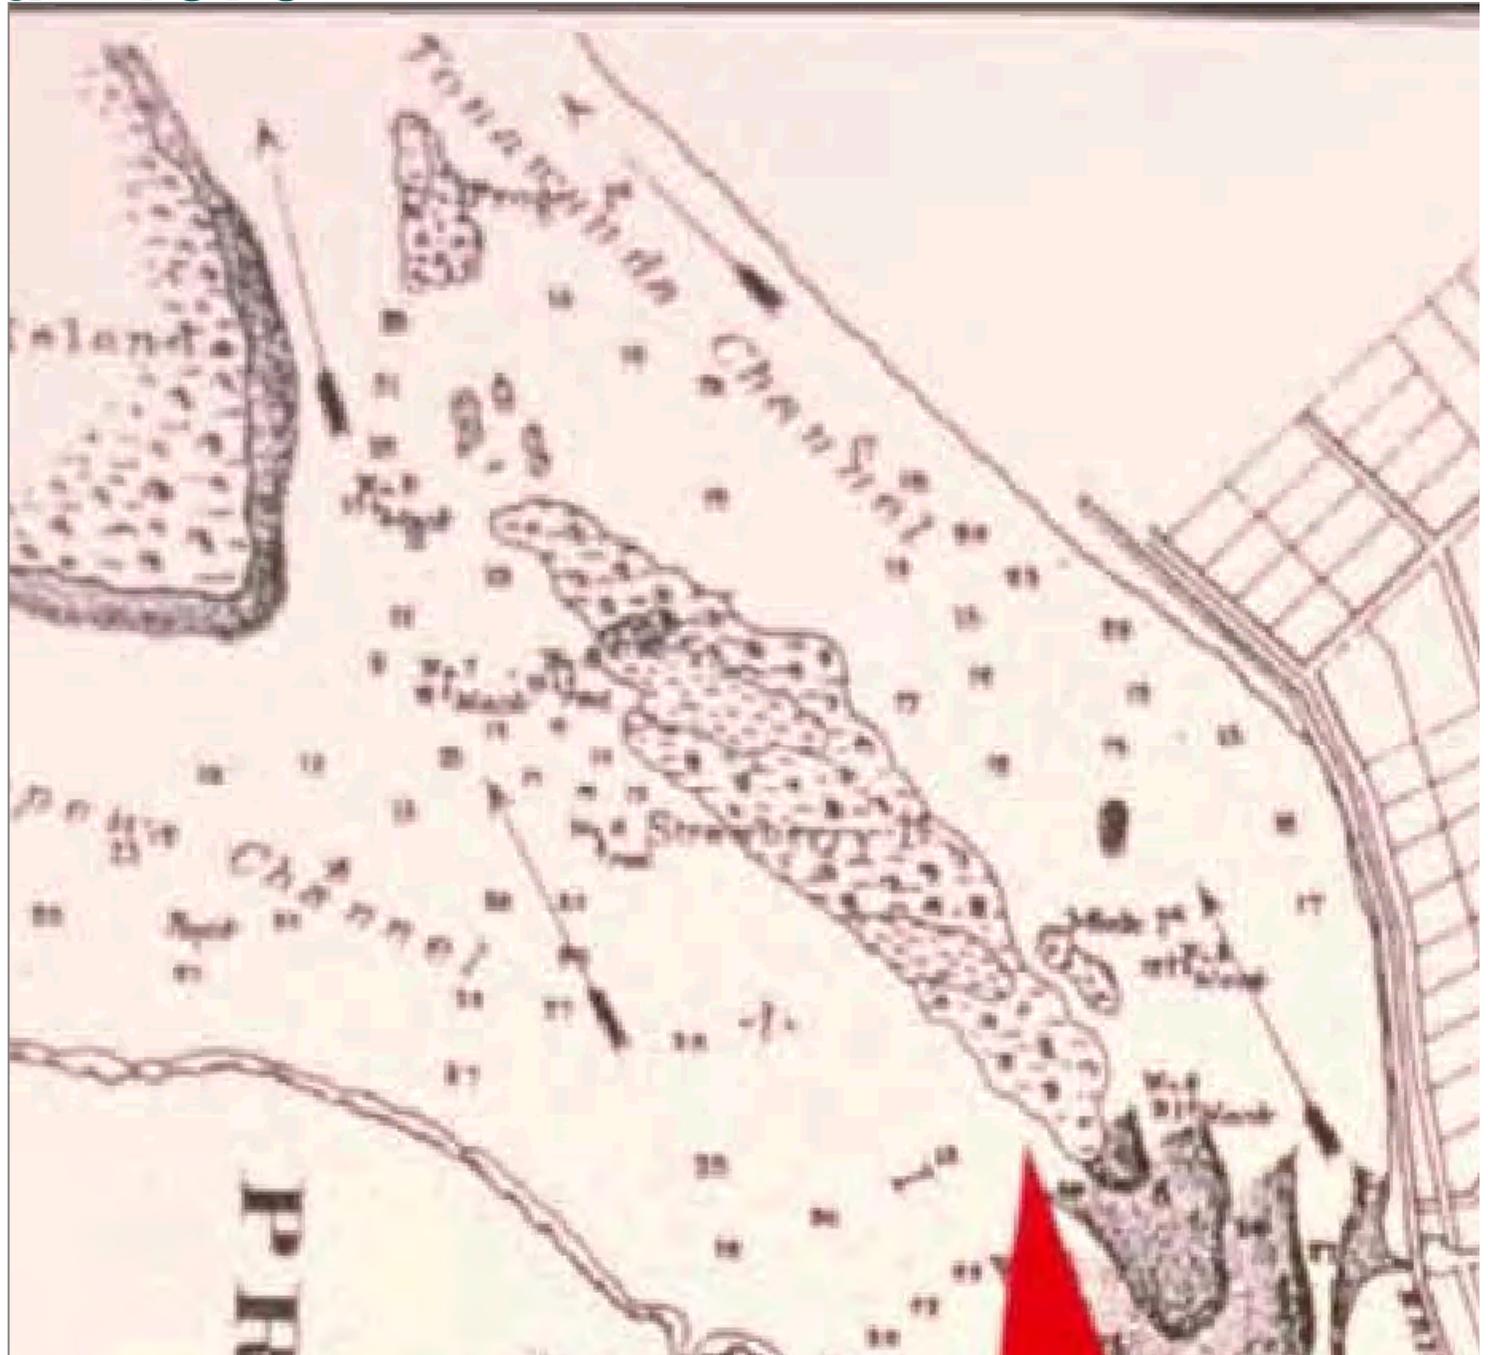
Frog Island - 1870

Average water year

1823 to 1825 –
excavation of
Tonawanda
section of Erie
Canal

Spoils dumped
at Strawberry
Is Complex

Small islands /
wetland area
identified
between
Strawberry and
Motor Is

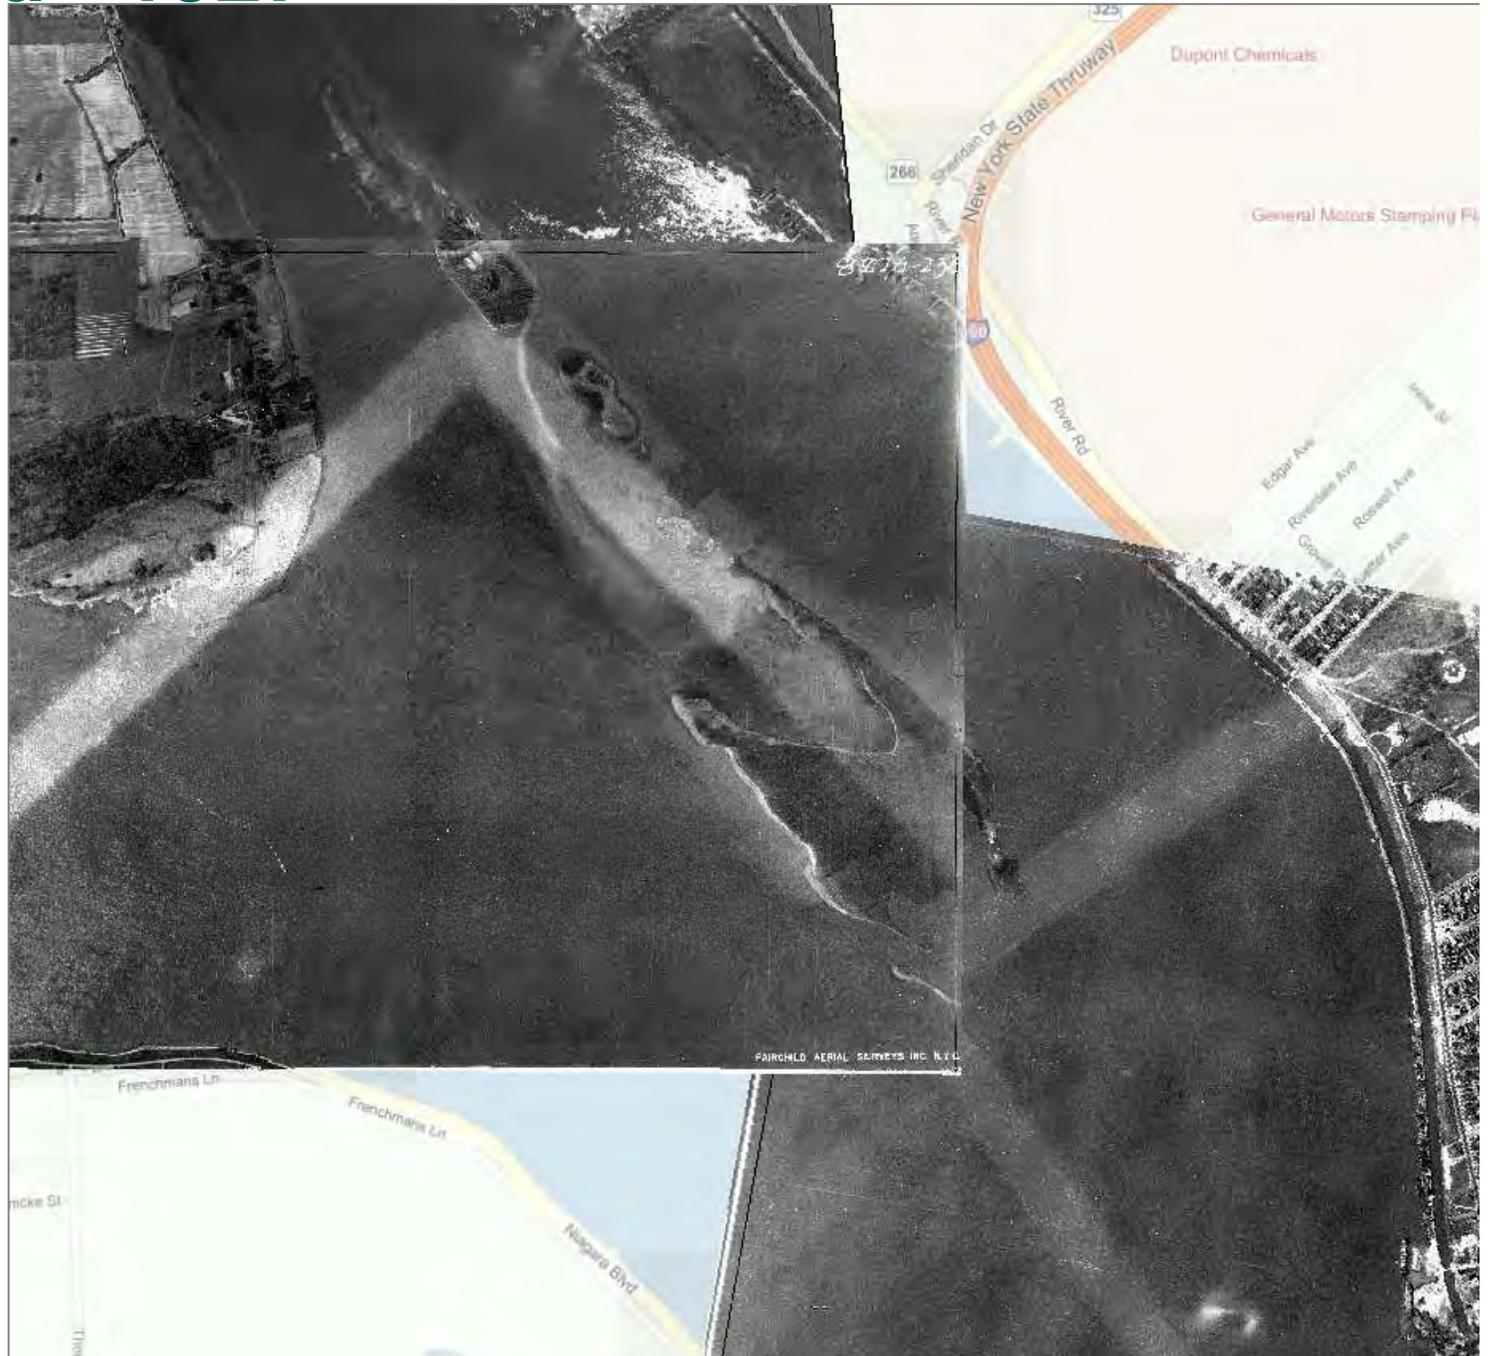
Frog Island - 1927

Below average water year

First aerial

Sand and gravel mining
mid-1920s to
1953

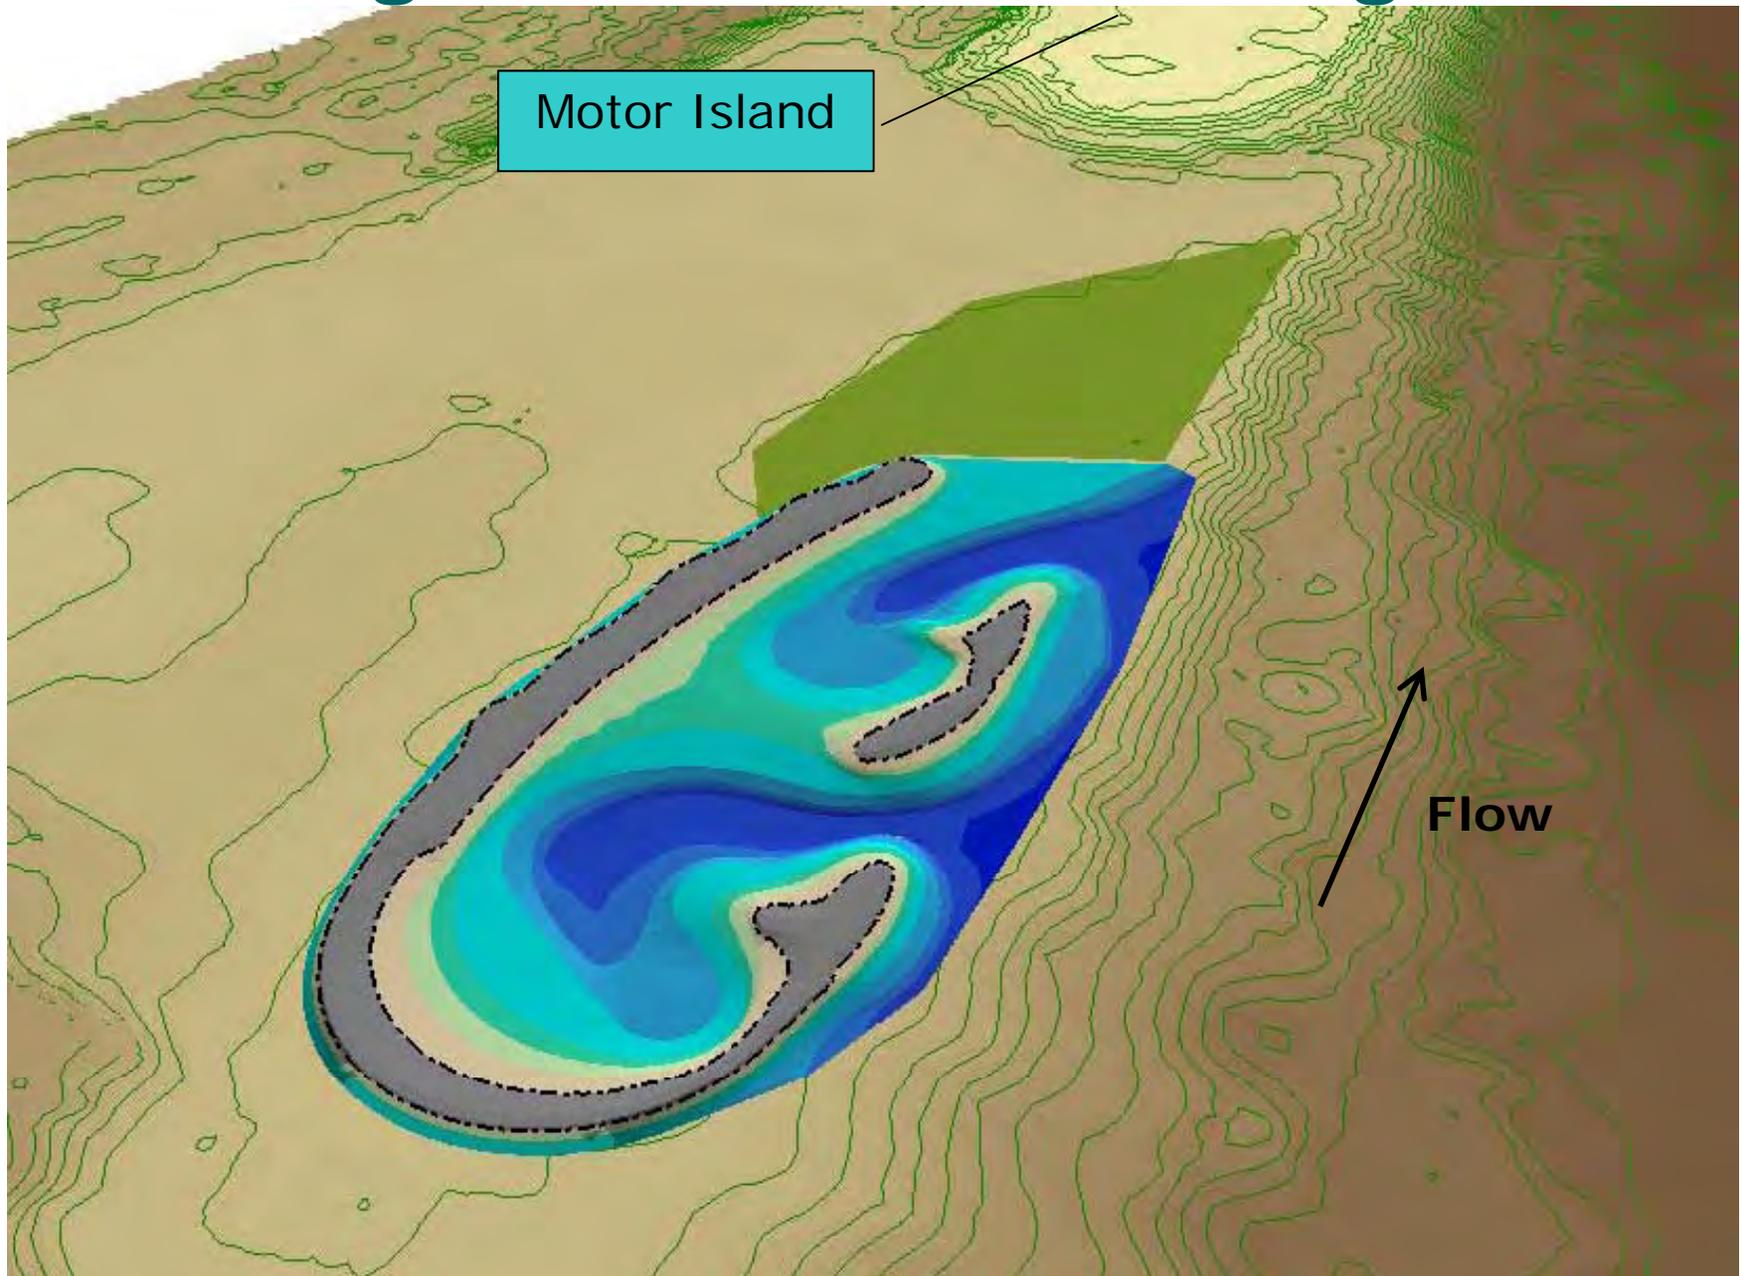
Frog Island Revised Design

- Dynamic river environment – slightly smaller main structure to adapt over time – Adaptive Management Approach
- Low-profile “crescent” with higher tolerances for change/natural disturbance cycles
 - Elevation 6” above average water level
 - Large boulders at head of island to break wave energy and shed ice
 - Flow through/flushing
- Incorporate open access from EAV to deep water and SAV habitat within breakwaters
- Maximize irregular edges and depth diversity (focus on SAV and deep emergent)

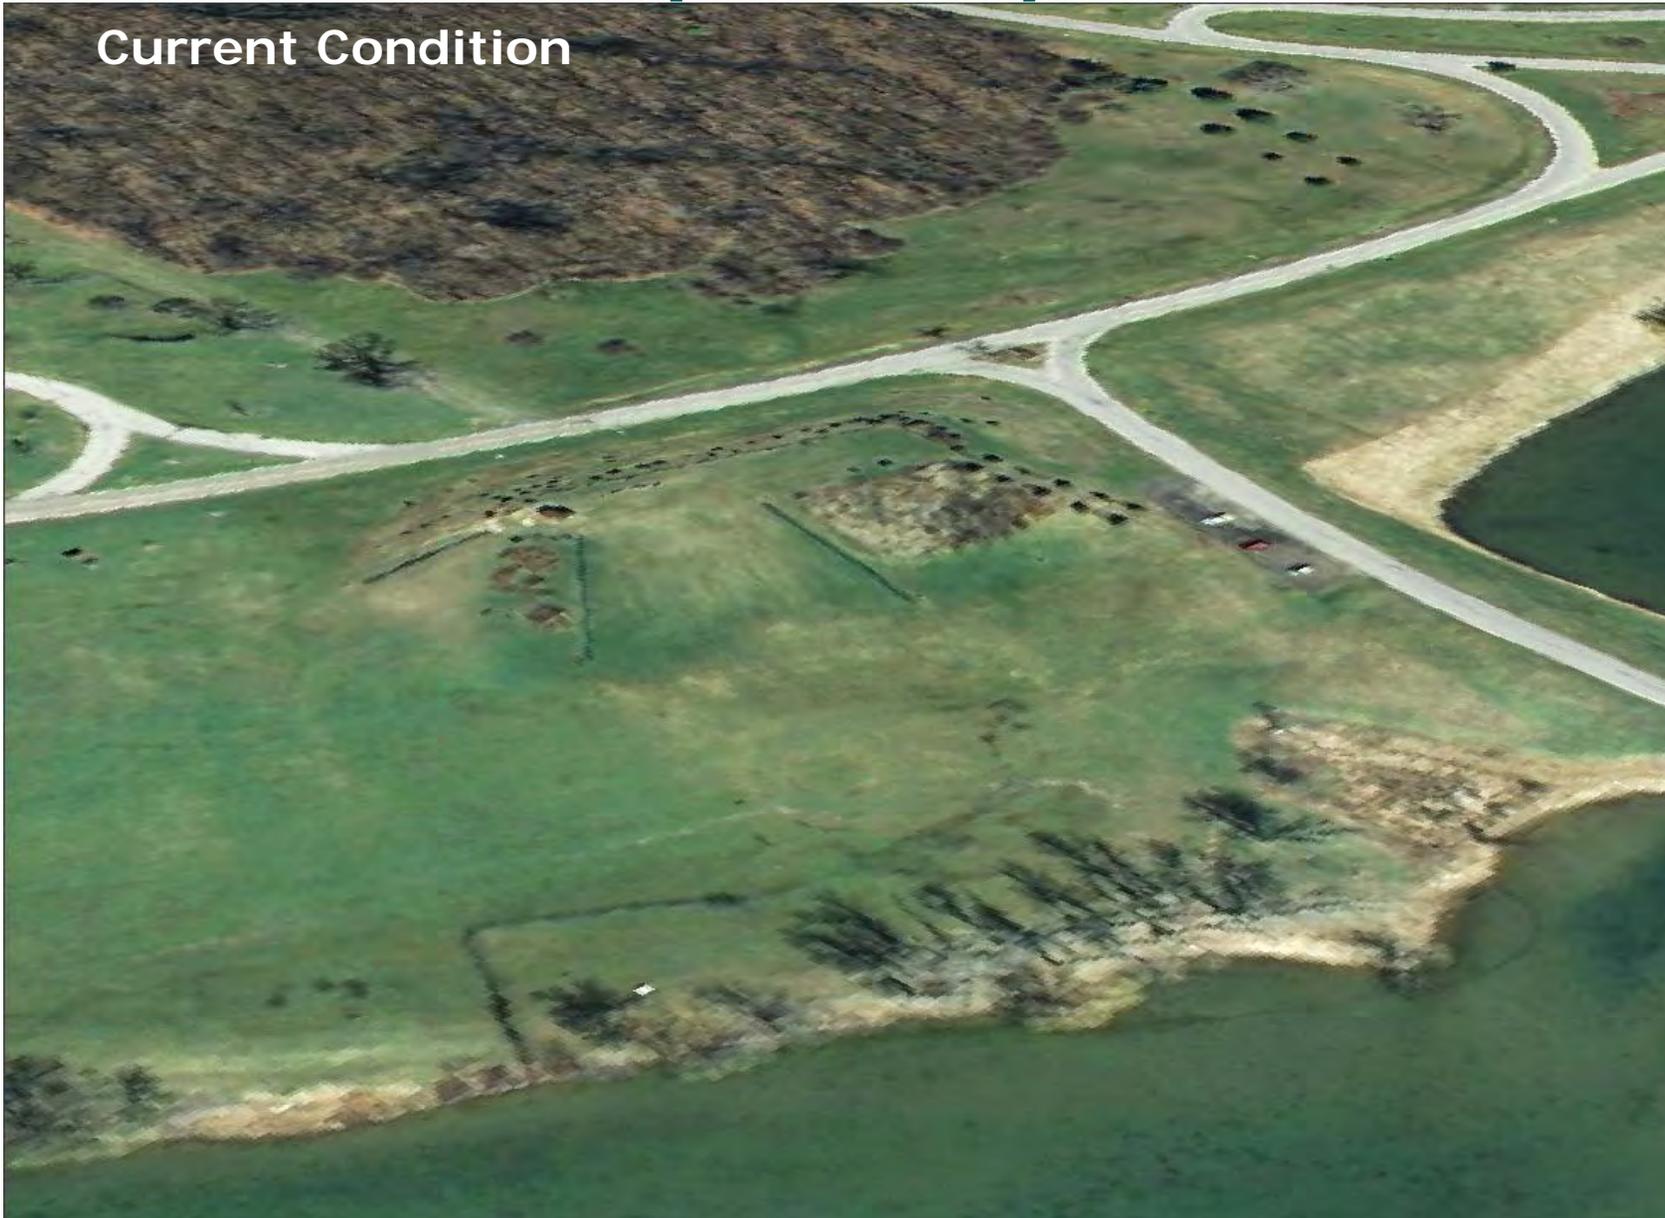
Little Beaver Island Wetland Restoration Spoils Disposal

Current Condition

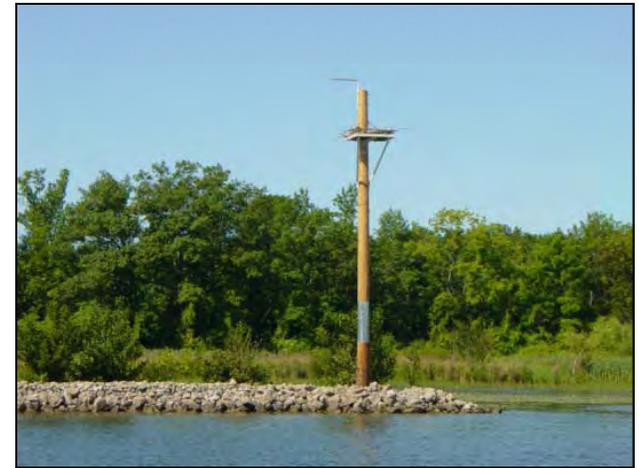
- Completed installation at East River Marsh in June
- Began monitoring of 4 Platforms (2 NYPA and 2 DEC)
- Site Selection Report – 4 additional platform locations recommended (Tifft, Adams Slip, Little Beaver Island HIP, 102nd St Landfill)
- Preliminary Site Investigation at 2 of 4 locations

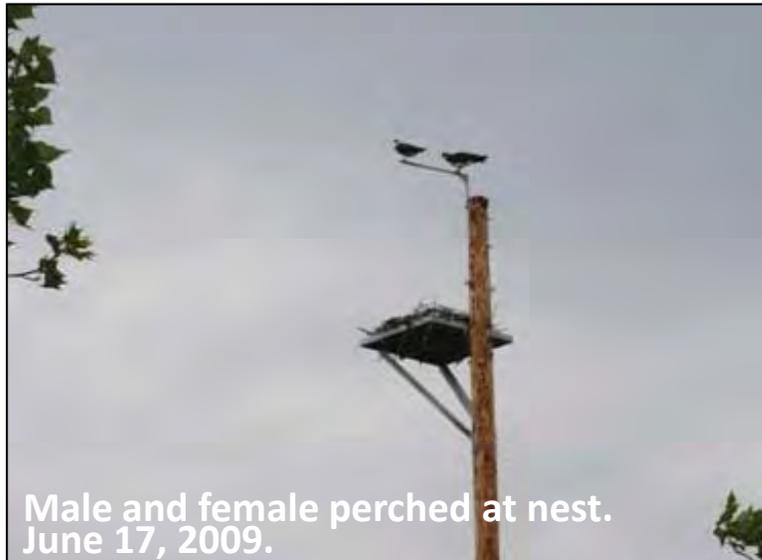
Male and female perched at nest.
June 17, 2009.

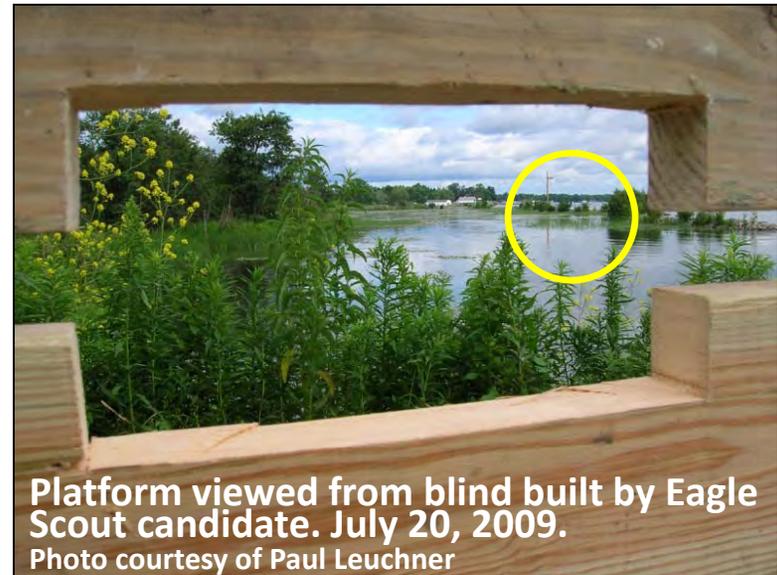
East River Marsh

Platform viewed from blind built by Eagle Scout candidate. July 20, 2009.
Photo courtesy of Paul Leuchner
