NIAGARA POWER PROJECT

RELICENSING IMPLEMENTATION

Ecological Standing Committee Meeting

November 19, 2009

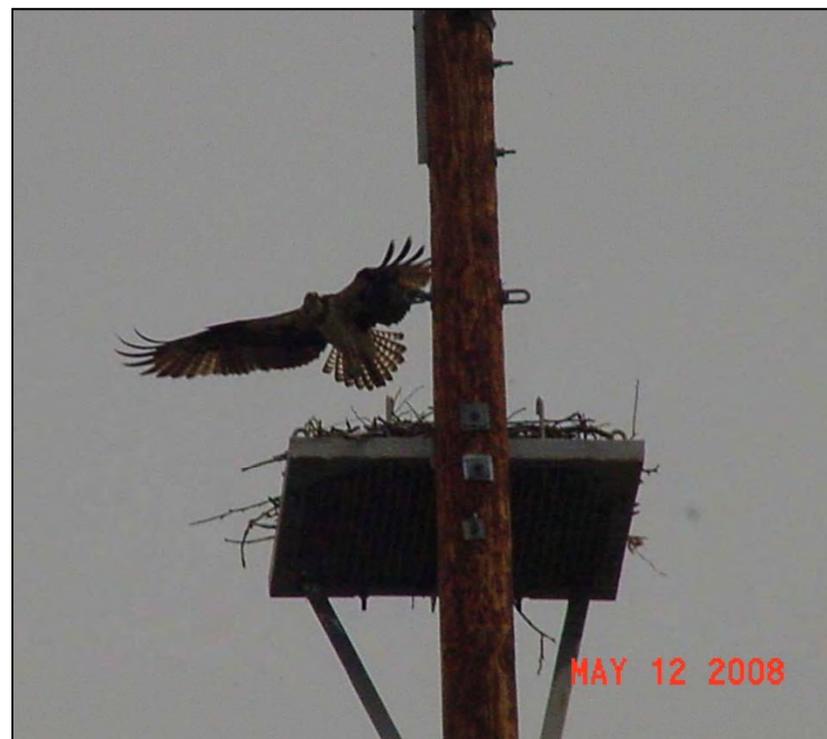
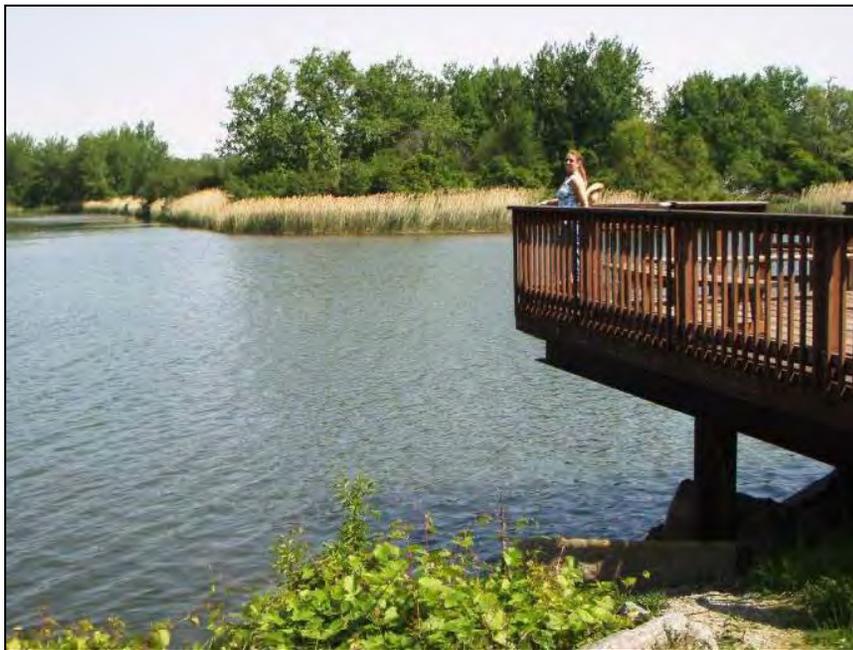
- Owned by City of Buffalo; managed by Buffalo Museum of Science
- New platform on taller pole

- Firm, dry soils on surface
- Easy access roads
- Popular nature preserve
- Some vegetation trimming, all non-native

○ Tifft Nature Preserve

- Conducted site investigations and completed designs
- Submitted drawings to City of Buffalo for approval
- RFP issued
- Anticipated to begin installation before the end of year

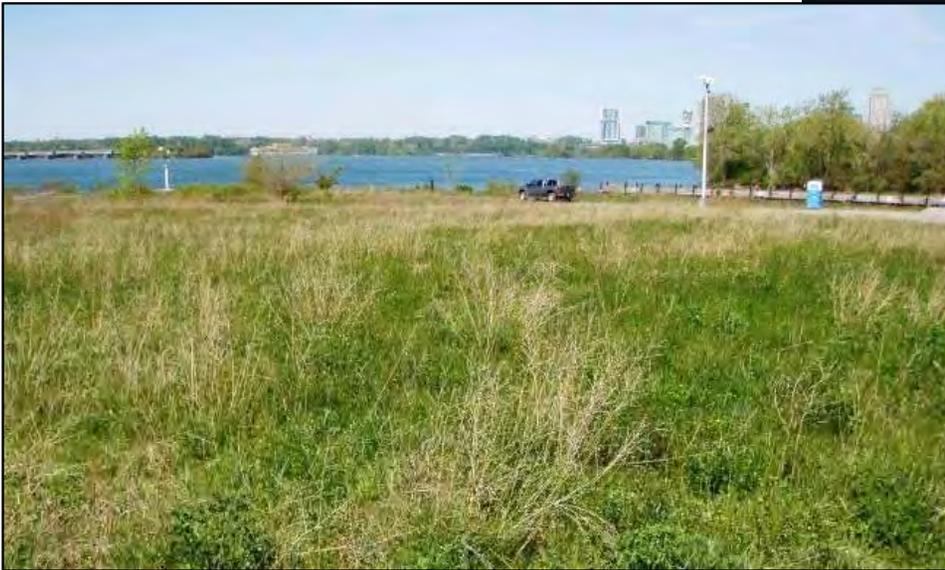
Adams Slip, NYPA boat landing

- Owned by NYPA
- Posted and patrolled
- On Robert Moses State Parkway
- Recreational trail

- Easily accessible
- Firm soil
- Excellent viewing
- Excellent foraging nearby

○ Adams Slip

- Conducted site investigations and completed designs
- Included with Tifft in bid process
- Anticipated installation in Summer 2010

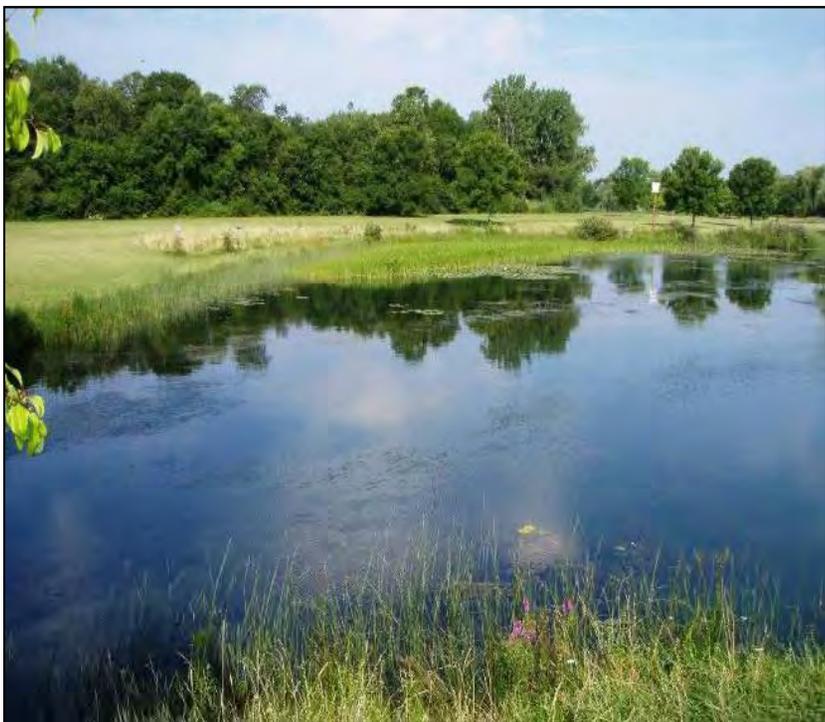
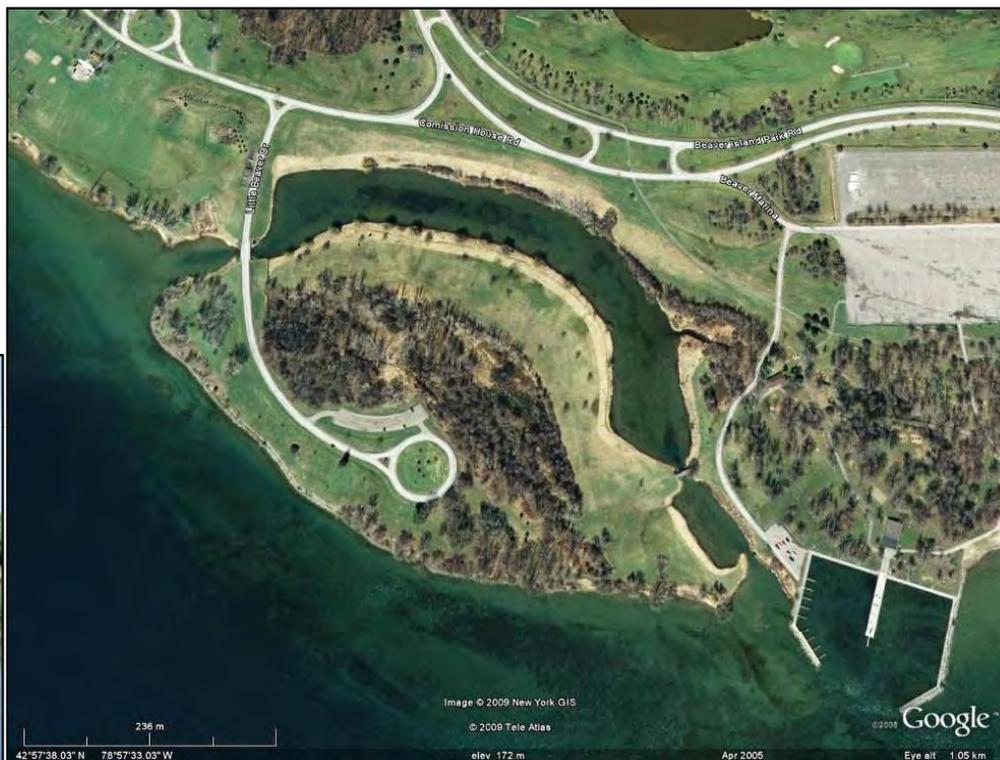
Little Beaver Island HIP

- Owned by NYSOPRHP
- Extensive wetland restoration

- Easily accessible
- Good viewing opportunities
- Excellent foraging nearby

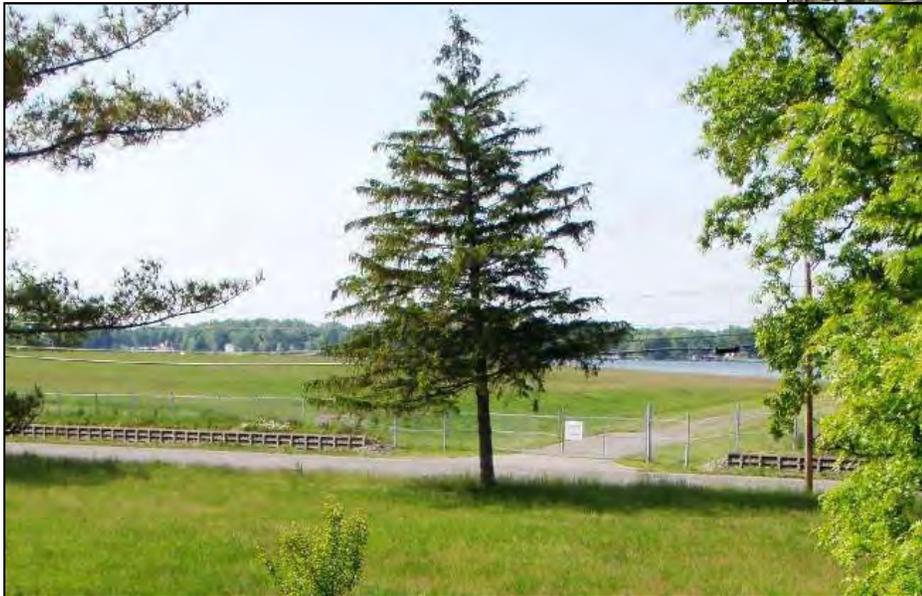
102nd Street Landfill

- Fenced, remediated, capped landfill
- Low disturbance
- Wide open habitat
- Complements restoration efforts

- Easily accessible
- Good viewing opportunities
- Tripod design to avoid subsurface excavation

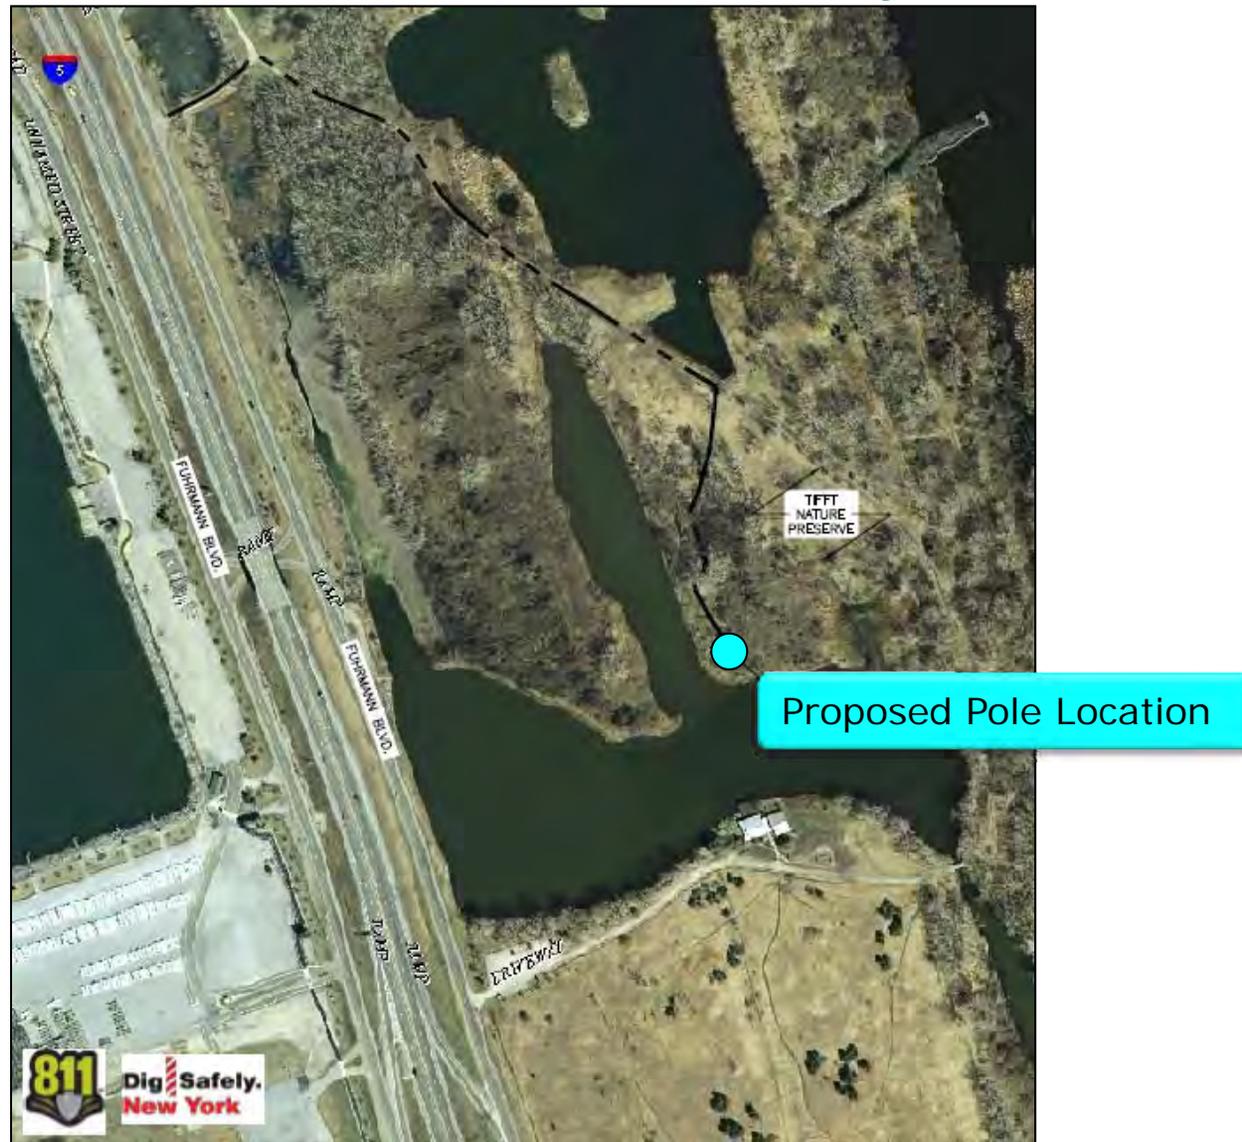
Tifft Nature Preserve – Osprey Platform

Tifft Osprey Pole Design

Soft Soils Design
Includes Concrete mat
and 12' Embedment

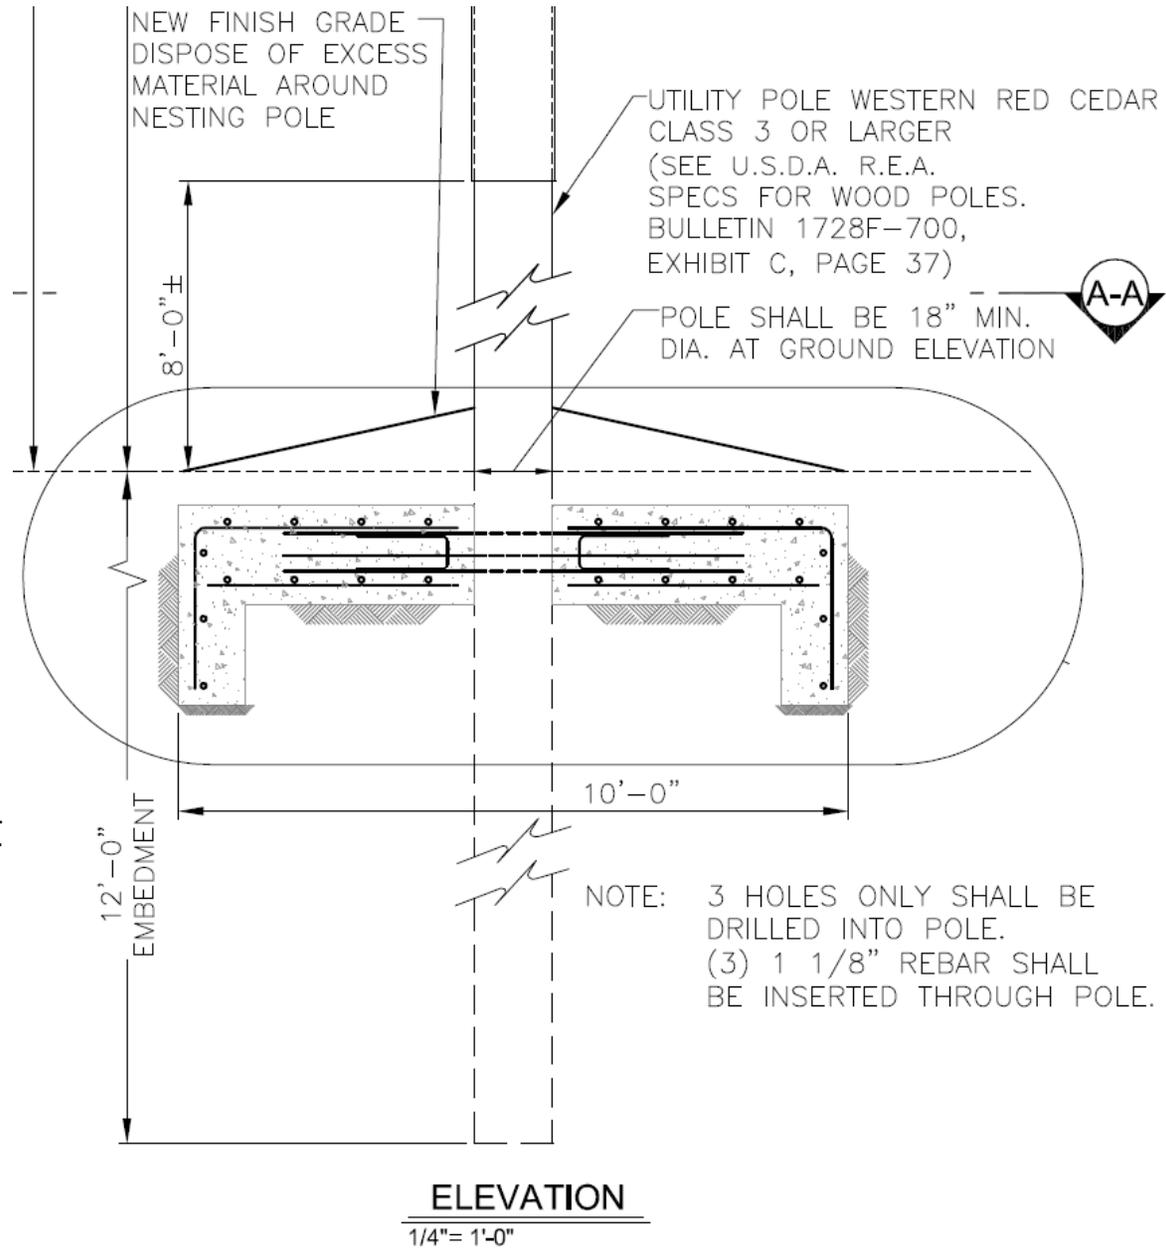
Platform 55 ft above
ground

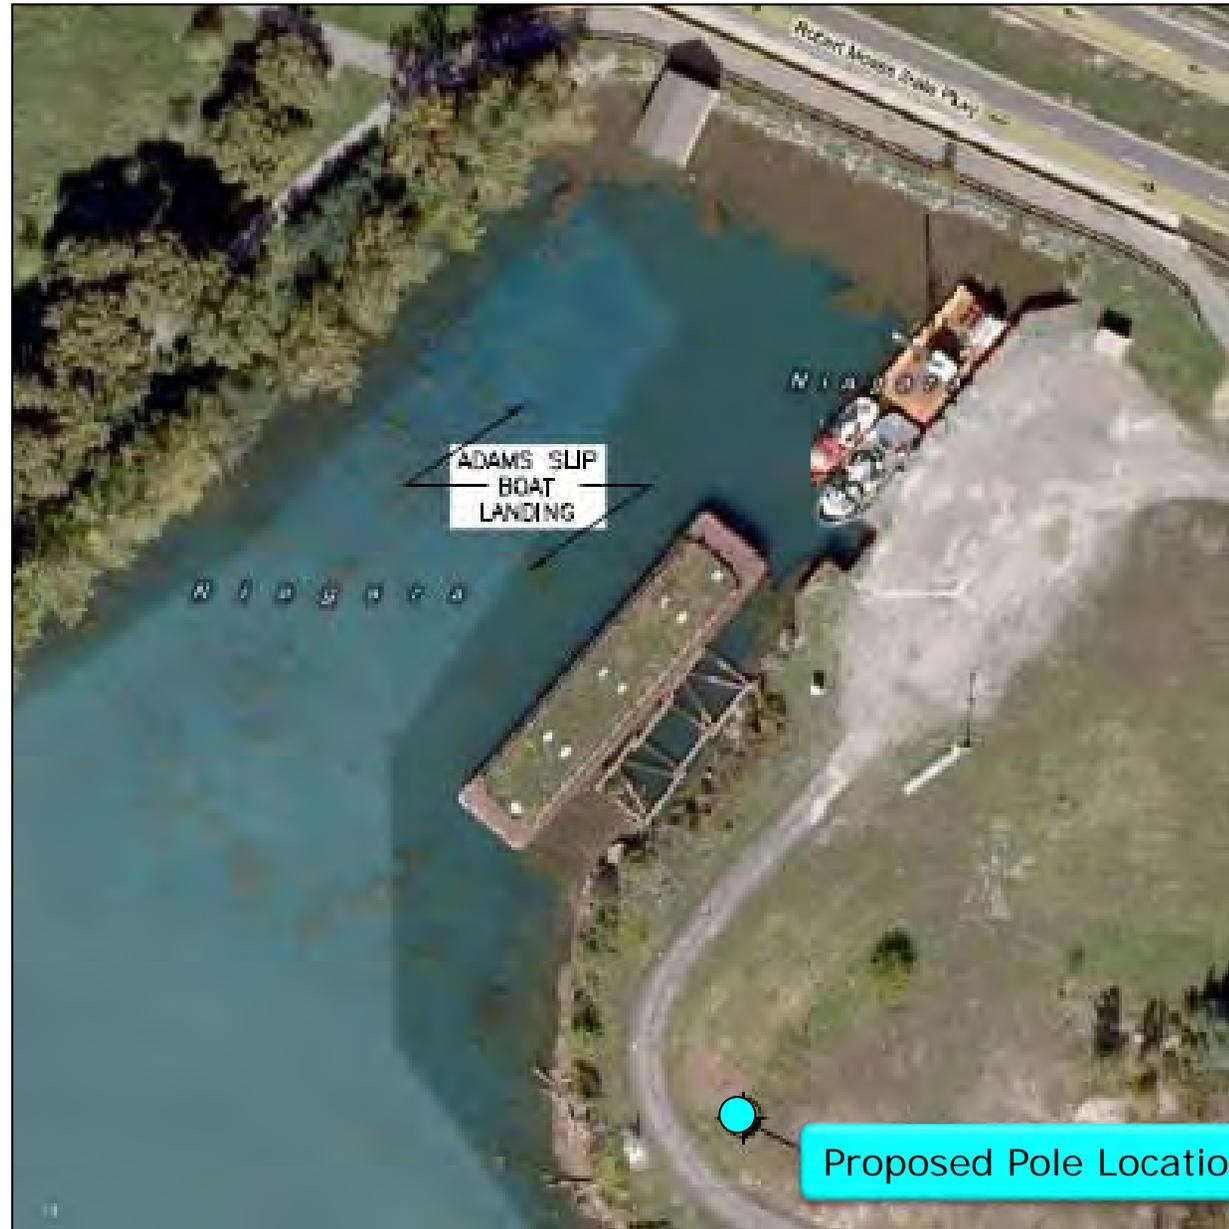
Adams Slip Osprey Pole Design

Good Soils

Simple Design

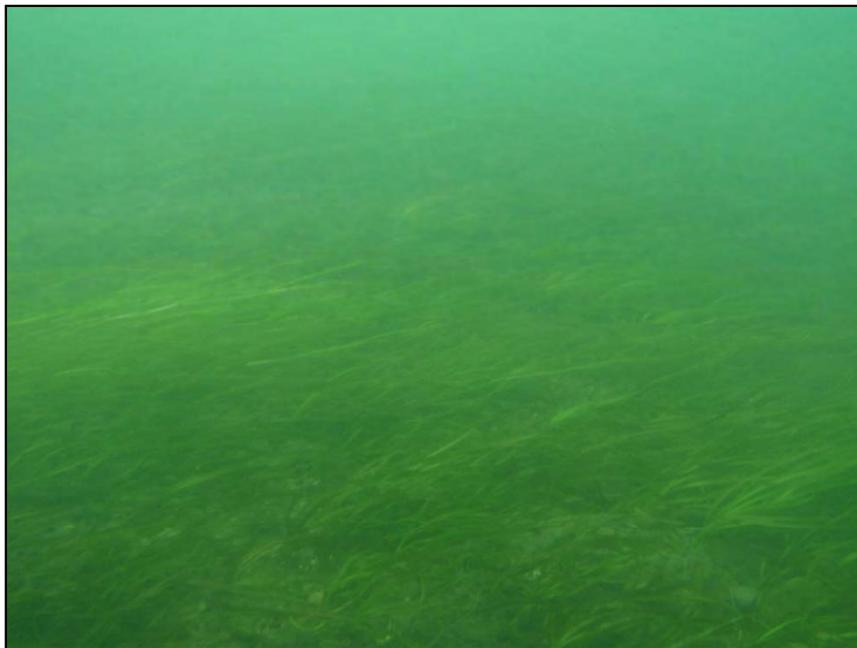
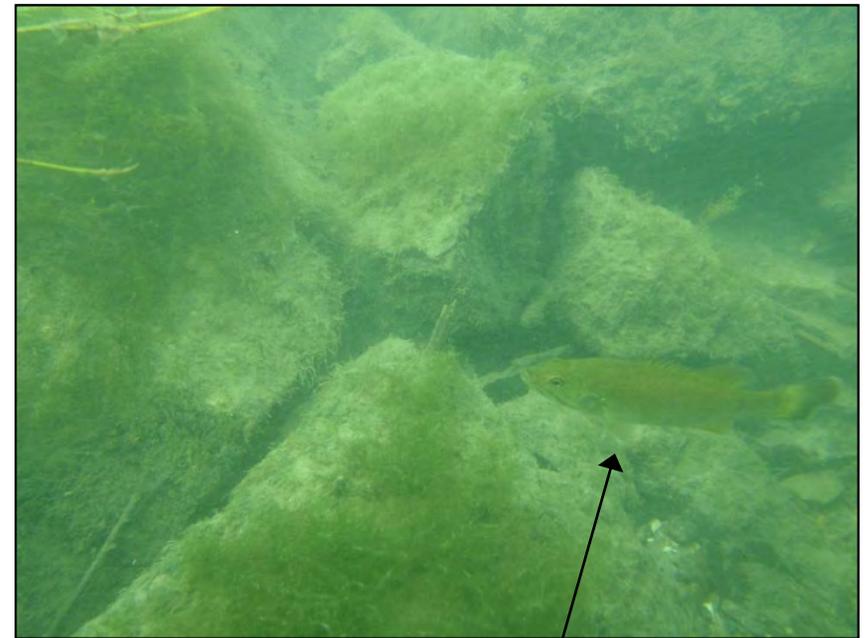
Small mouth bass at structure

Growth of submerged aquatic vegetation (edges)

- Stable after first year, good colonization by SAV
- Traps sediment
- Provides large-object cover
- All four structures utilized by both juvenile and adult fish
- Anglers observed near Gratwick structure
