**Common Tern Habitat Improvement Project:  
2012 Buffalo Harbor Tern Colony  
Enhancements and Status Assessment**

**Niagara Power Project (FERC No. 2216)**

**RIVEREDGE ASSOCIATES**

**NEW YORK POWER AUTHORITY**

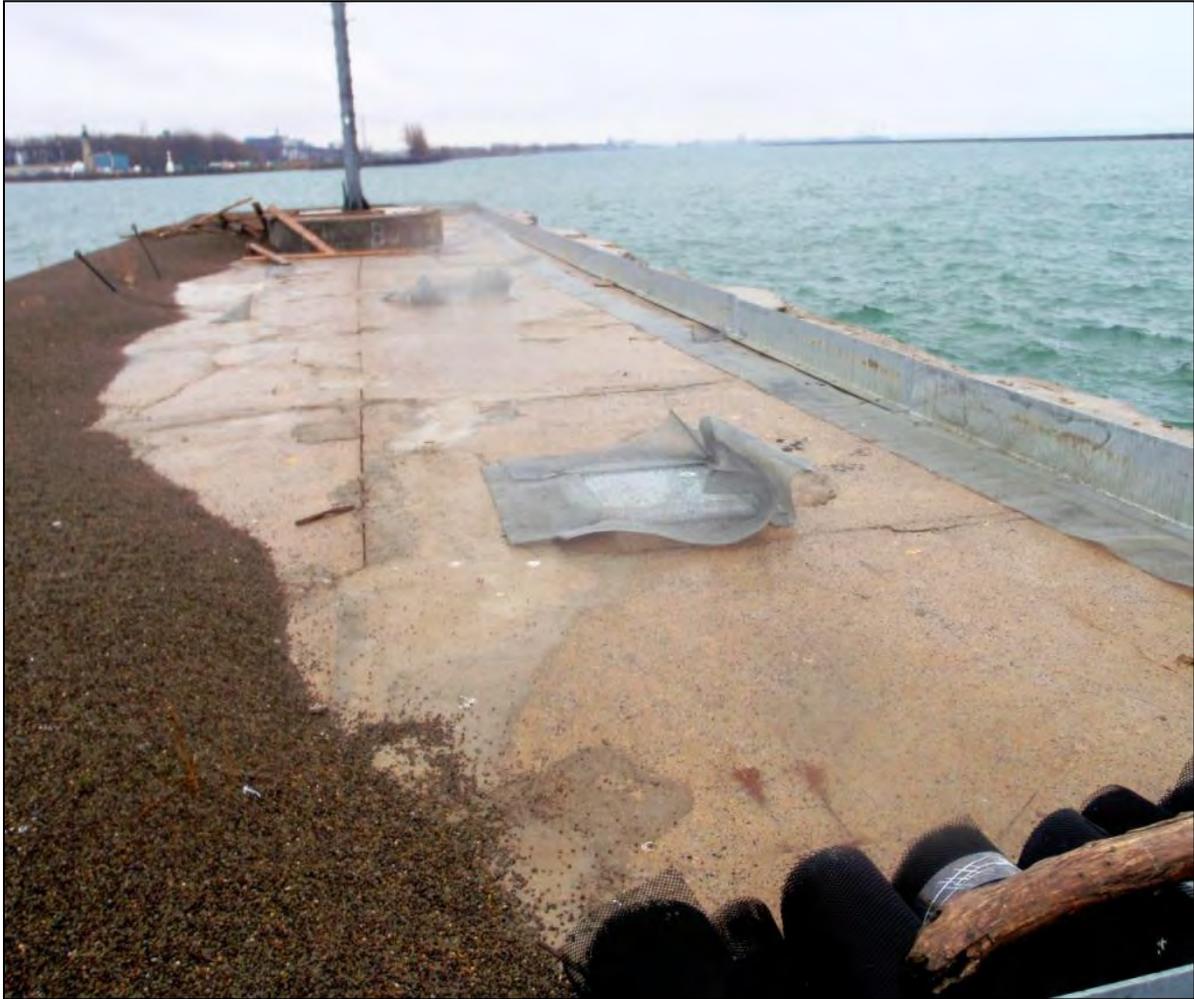
FIGURE 4-1. EARLY SPRING CONDITIONS ON NORTH BREAKWATER

The first inspection of the enhanced areas of the breakwaters was conducted on March 25, two weeks earlier than in 2011. All of the containment frames were found in good condition, although significant displacement of gravel had taken place over the winter. The amount of displaced gravel was the greatest amount since the enhancements were constructed.

On the lake side of each structure, gravel had been moved away from the containment frame by winter storms. The amount of gravel displaced ranged from little or none on the north end of the Old Breakwater North to over half of all the gravel on the North Breakwater. On the North Breakwater, approximately 60% of the enhanced area was bare cement (approximately 1,395 square feet) ([Figure 4-1](#)). Gravel was piled to the top of the 12" containment frame on the harbor side of the structure. Some gravel was likely washed off the structure as well. On the end cell at the south end of Old Breakwater North approximately 100 square feet of bare cement was exposed, and approximately 500 square feet of bare cement was exposed on Old Breakwater South ([Figure 4-2](#)).

At all four improved areas, displaced gravel was raked back over any areas of bare concrete and re-distributed to provide nesting substrate of suitable depth. During installation, the design depth for gravel (3") had been doubled to 6" to allow for the loss of material. When gravel raking had been completed on North Breakwater, at least 95% of the nesting area had gravel to a minimum depth of 3"; most of the area had 4" of gravel or more ([Figure 4-3](#)), and some areas had over 6" of gravel. Displaced gravel at the three other sites was raked back into place to a depth well above the minimum design depth, indicating that little gravel had been lost.

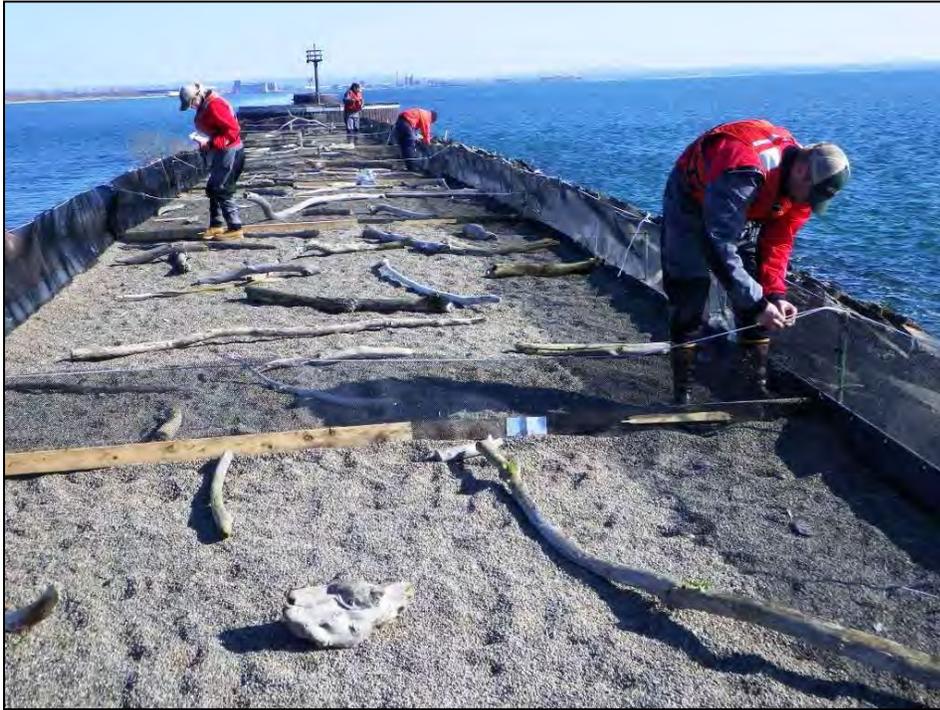
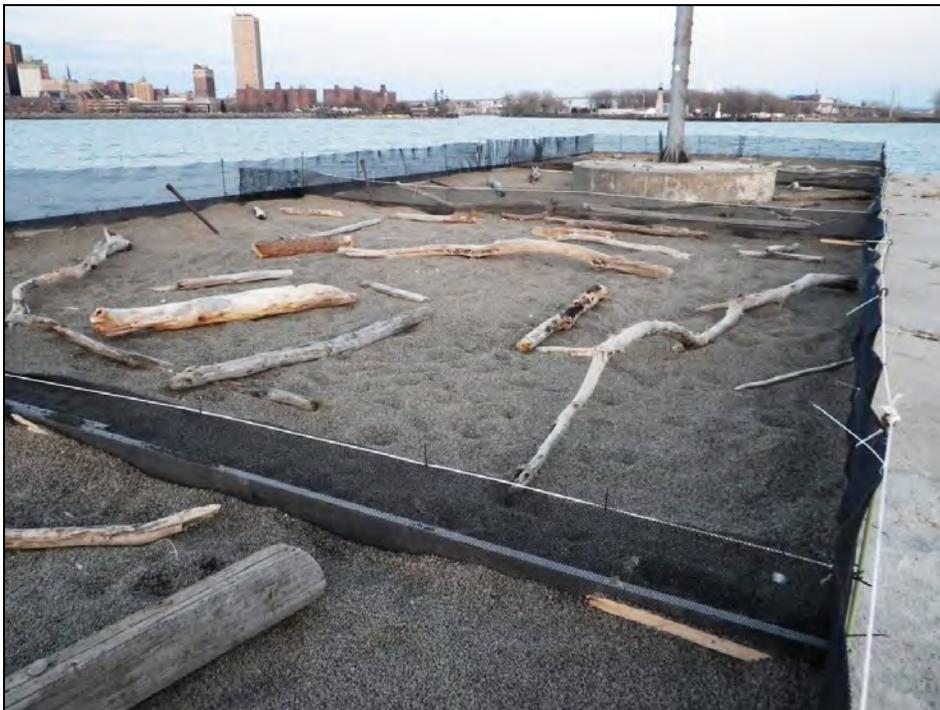
FIGURE 4-4. OLD BREAKWATER NORTH (TOP) AND NORTH BREAKWATER (BOTTOM) READY FOR TERNS

Perimeter fencing, interior fencing, and driftwood were installed at each of the enhanced areas ([Figure 4-3](#), [Figure 4-4](#)). The circular end cell on the south end of the Old Breakwater North was divided into pie-shaped sections using 2x6 lumber and plastic perimeter fencing. The north end of the Old Breakwater North was divided into 11 rectangles of approximately equal area. The enhanced area of the Old Breakwater South was divided into six sections with interior

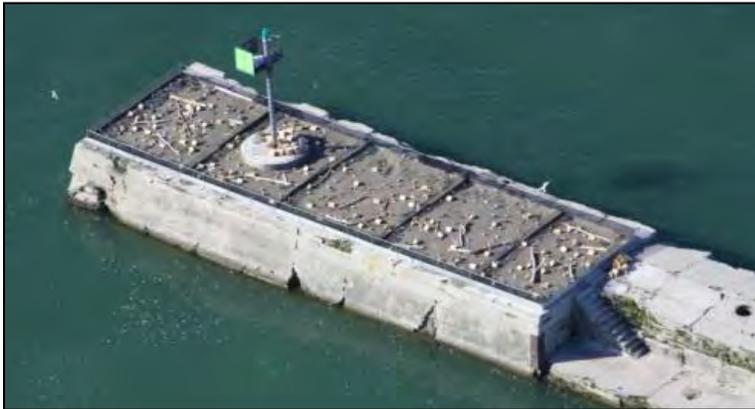
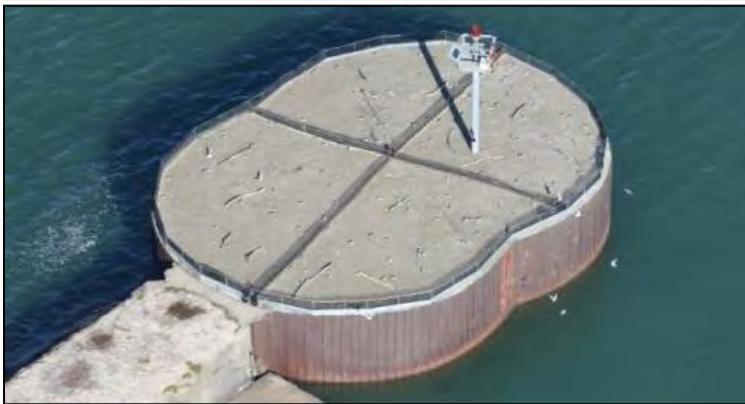
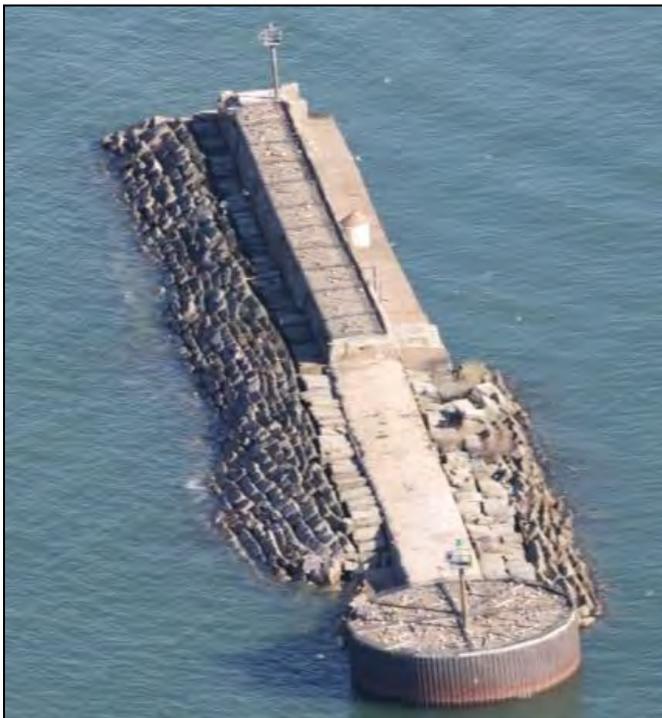
FIGURE 4-5. MAY 2011 AERIAL VIEW OF ENHANCED AREAS WITH NESTING TERNS

dividers (two more than in 2011). The rectangular enhanced area on the North Breakwater (Donnelly's Breakwater) was divided into five sections of approximately equal area. At each site, driftwood and/or chick shelters were added to provide structure and cover. The interior dividers and chick shelters were visible on publically available aerial photos on the internet (such as those at [www.bing.com](http://www.bing.com) taken in April 2011) and in photos taken from a chartered plane in May 2011 ([Figure 4-5](#)). All fencing was installed by April 15.

North (Donnelly's) Breakwater (2011)

Old Breakwater South (2011)  
(South Breakwater; divided in six  
sections in 2012)

Old Breakwater North (2011)  
(Short Breakwater)

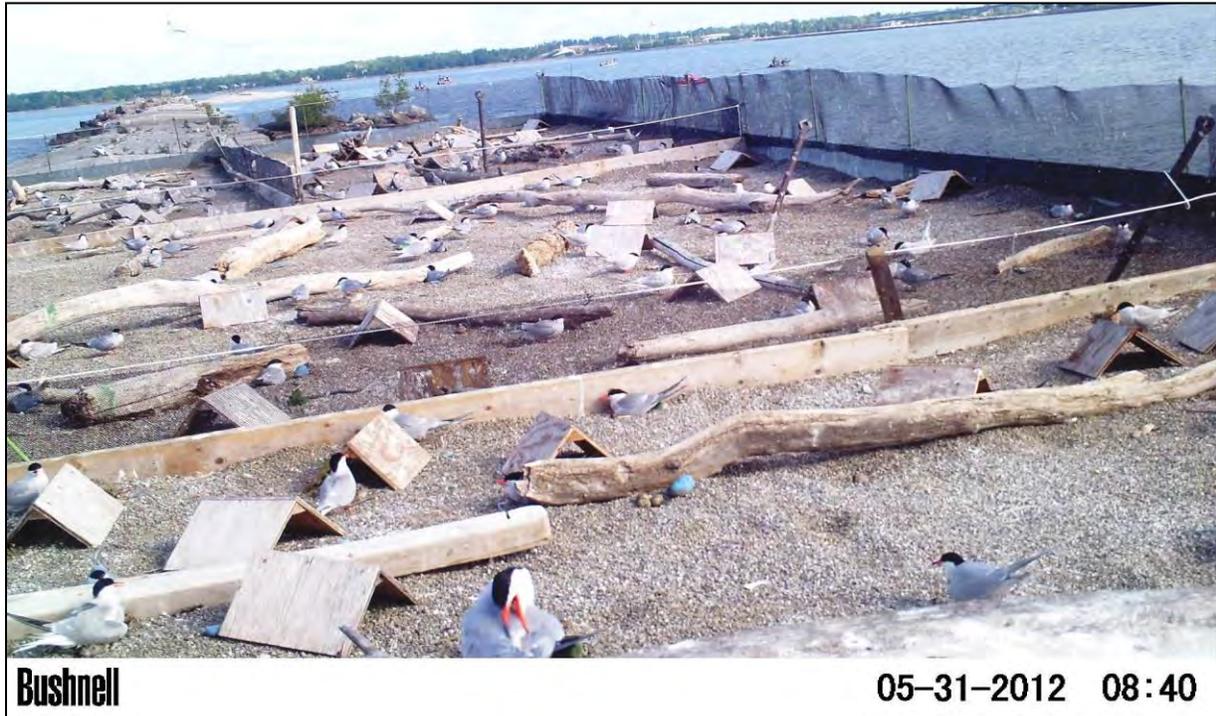
FIGURE 4-6. TERNS INCUBATING EGGS ON NORTH BREAKWATER AS RECORDED BY A MOTION-TRIGGERED MONITORING CAMERA

Monitoring of tern nests, productivity, and chick survivorship on the enhanced areas was also conducted with the use of time-lapse and/or motion-triggered cameras. These cameras were deployed in an effort to identify the predator or predators that have lowered tern breeding productivity in previous years ([Riveredge, 2010](#), [2011](#), [2012](#)). Mink have been observed on one or more of the Buffalo Harbor breakwaters annually since 2010 and are known to prey on tern eggs and chicks on the breakwaters ([Riveredge, 2011](#), [2012](#)). In an effort to limit mink depredation on terns, NYSDEC issued a nuisance mink permit and mink traps were deployed on two breakwaters.

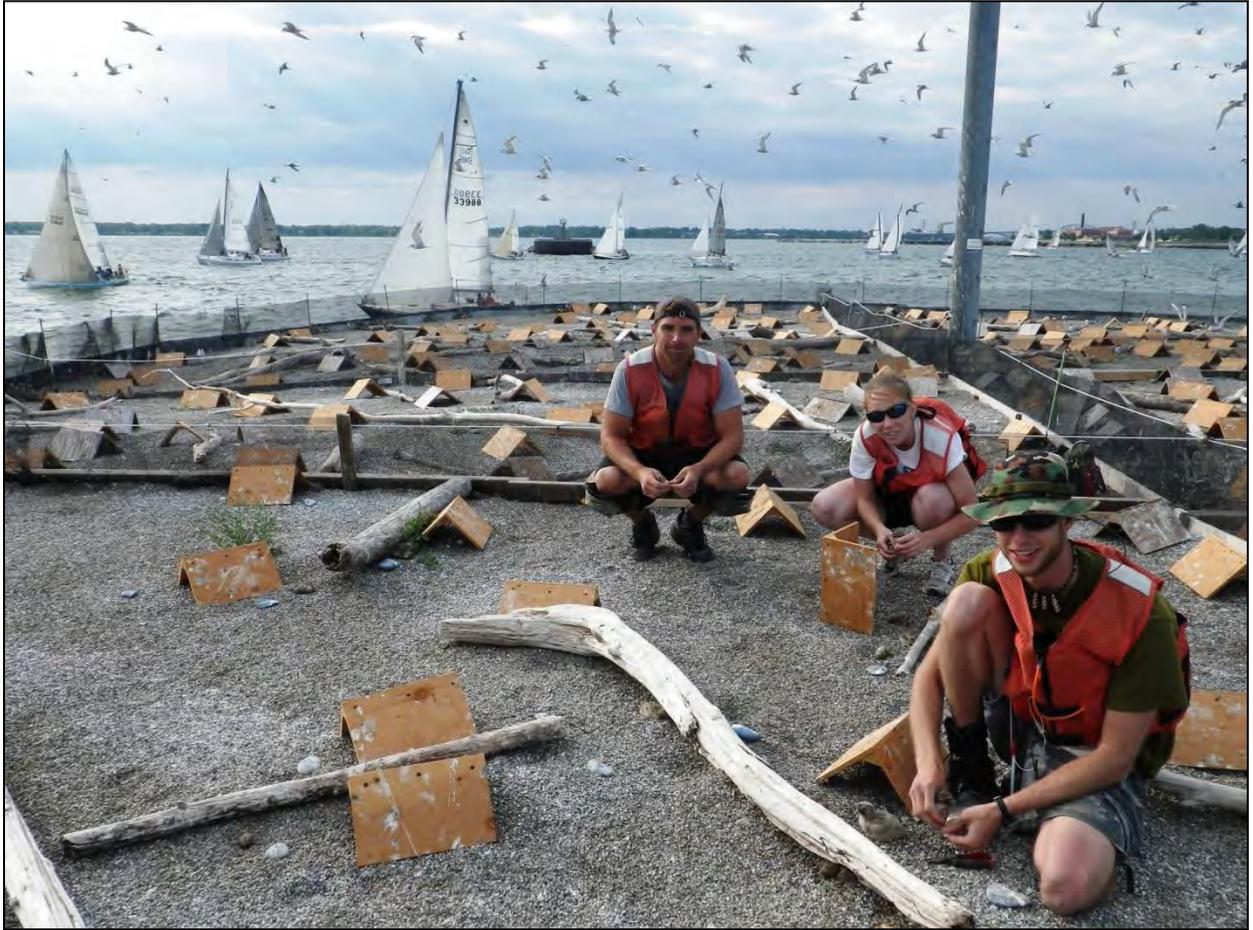
FIGURE 4-8. MONITORING TERN NESTS ON BUFFALO HARBOR BREAKWATERS

Productivity and factors that could potentially affect productivity were monitored through nest surveys (Figure 4-8), chick banding, and predator monitoring using cameras and traps. The peak period of tern hatching occurred in late May and early June, similar to 2010 and 2011. Hatching was delayed on the North Breakwater, and, as in 2011, the behavior of terns on this breakwater suggested disturbance by a mammalian predator.
