Niagara Greenway Habitat Conservation Strategy

Phase II Year 1 Update

Kerrie Gallo
December 2, 2013

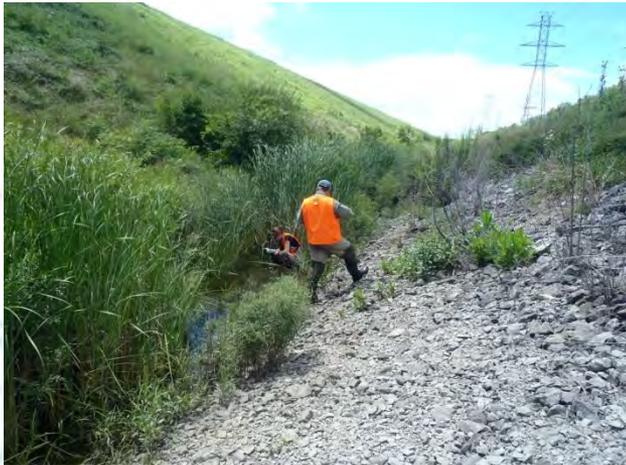
- Stream Visual Assessments

Stream Visual Assessment

- Completed by Buffalo State College
- 348 stream reaches assessed on 12 streams
- Collected 8 SVAP parameters
- Collected water quality data at each reach
- Completed QA/QC

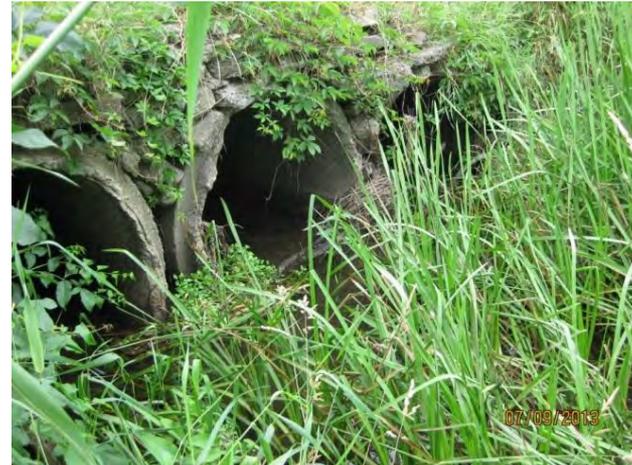
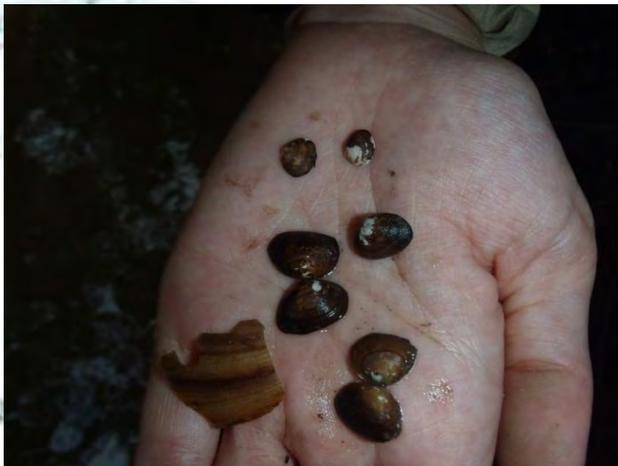
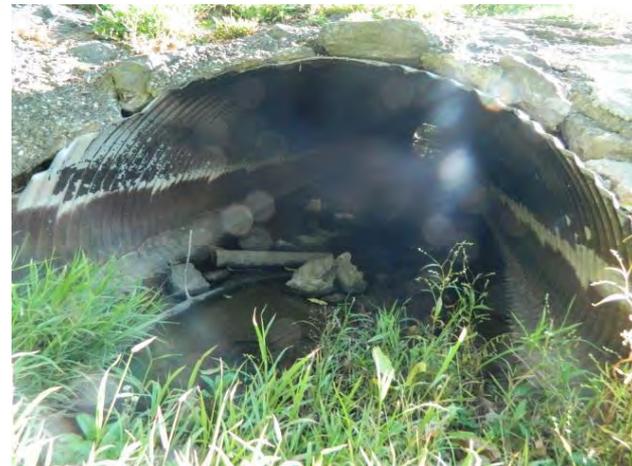
- Fish Barrier Analysis

- Investigation took place along 14 perennially flowing tributaries in the Greenway (completed by E&E)
- Building off of work completed during Phase 1
 - Determined 2nd and 3rd barriers
- Recommend mitigation measures and priorities for implementation
- Outreach and possible implementation will be completed in Year 2

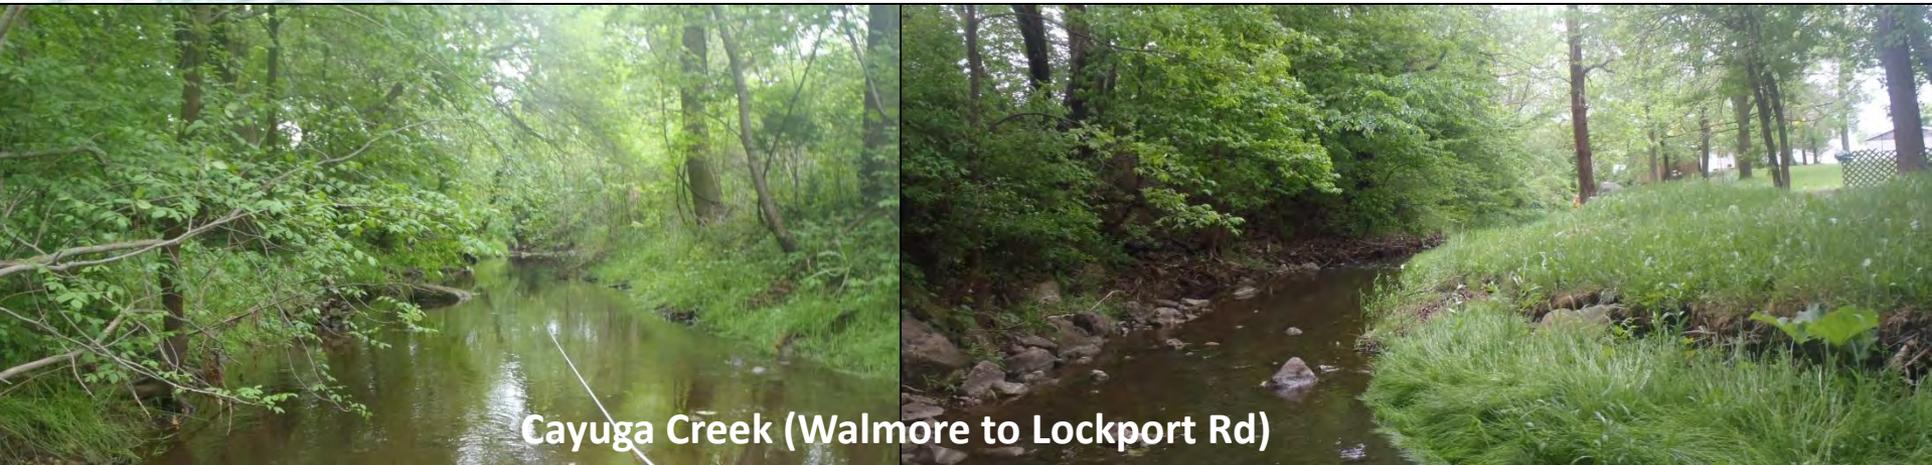
Cayuga Creek (Walmore to Lockport Rd)

- In-stream Fish Cover scores around 4-5
 - 3-5 cover types available, including LWD, overhanging vegetation, undercut banks, dense macrophyte beds
- Pool scores varied, but at least shallow pools were present in most reaches
- Canopy Cover scores were correlated with Riparian Zone scores

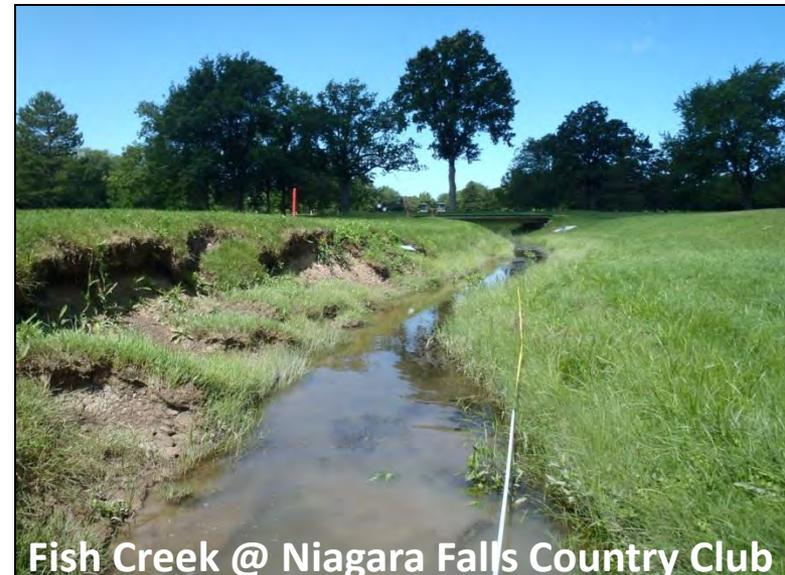
- Restoration
 - Major → reaches in Cayuga Creek, Fish Creek, Two Mile Creek
 - Minor → RZ restoration Gill Creek, Cayuga Creek, Bergholtz Creek
- Landowner education opportunities
- Invasive species management

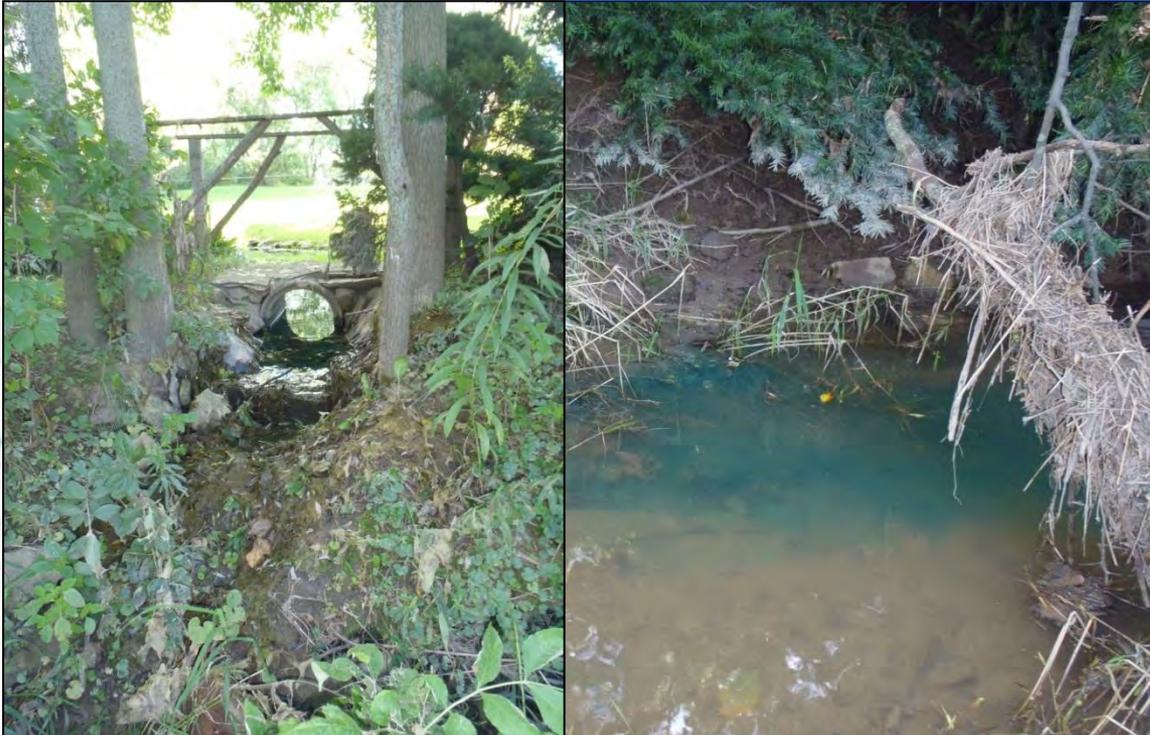
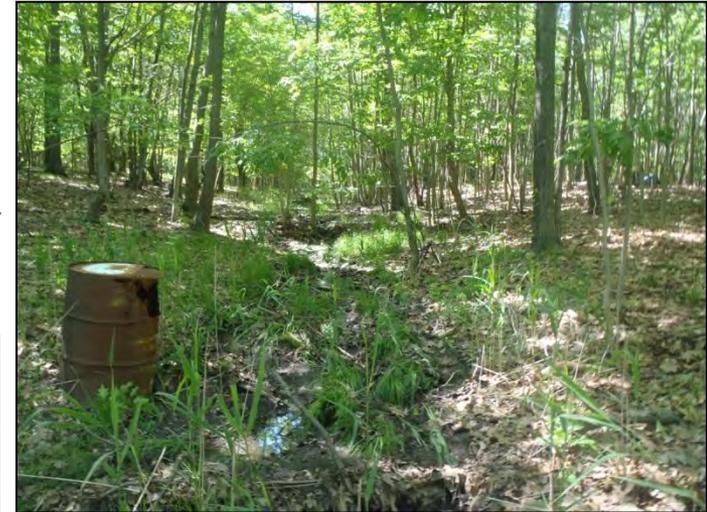
- Two Mile Creek upstream of Veteran's Memorial Park: stream piped underground and empty drums found along stream →

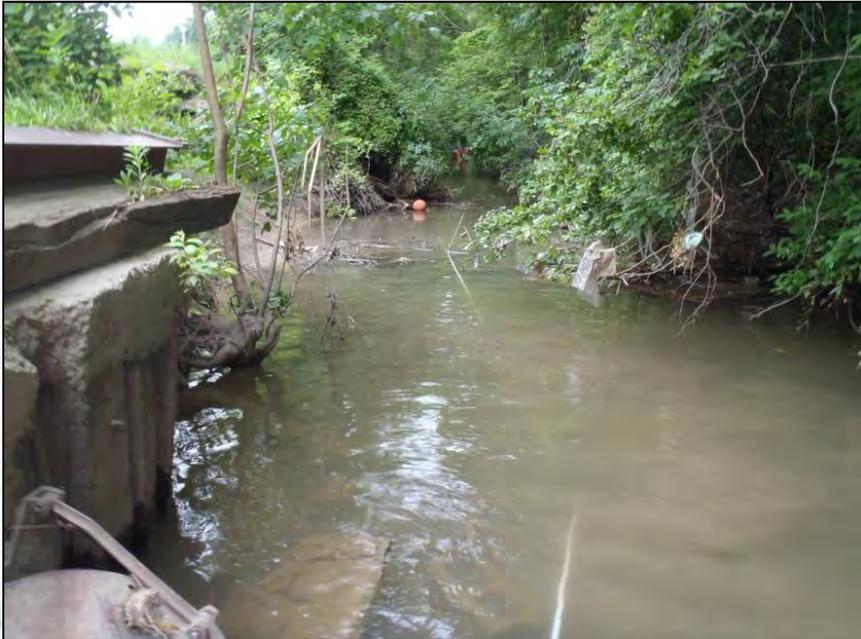
- Cayuga Creek, Porter to Trailer Park: pipes discharging into creek and excessive amounts of debris, crew also stepped in possible oil plume

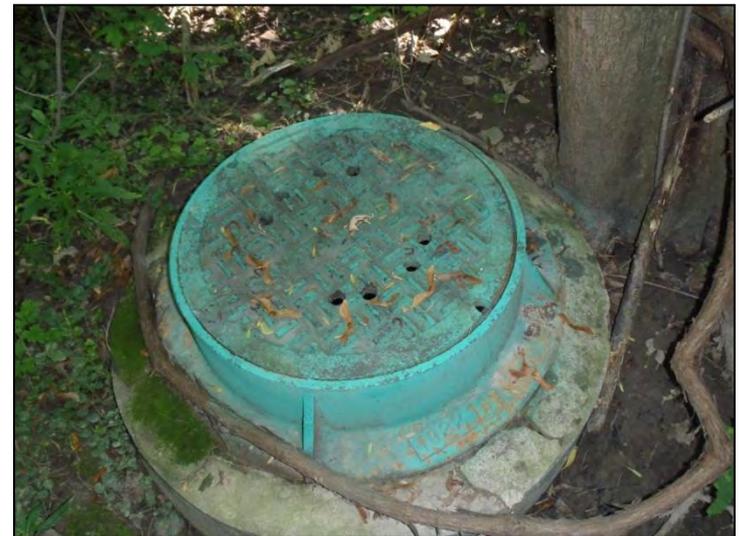
- Fish Creek, Military to Lewiston Rd: untreated sewage discharged to creek after large storm event

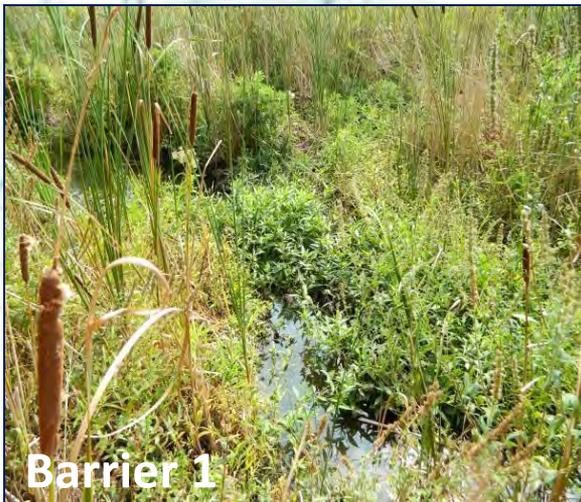
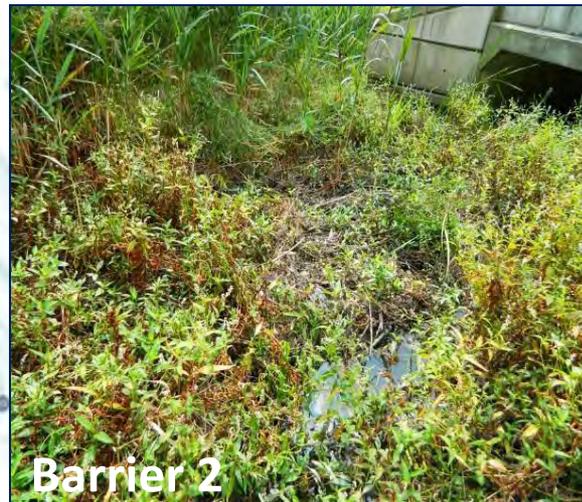
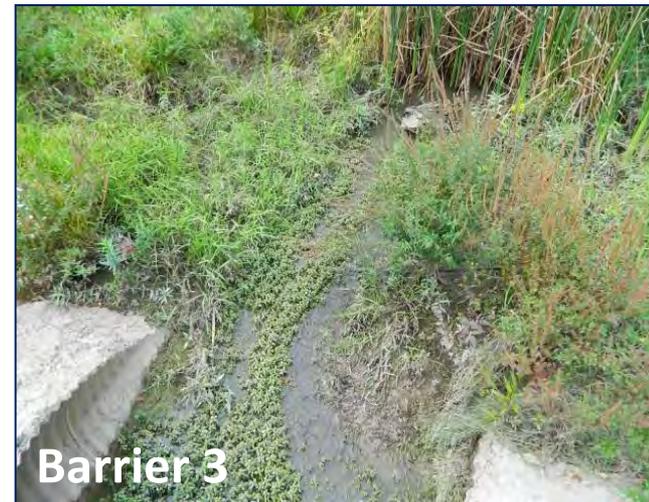
- Spicer Creek:

- Three barriers identified resulted from vegetation jams and low water depths
- Retrofits: creation of a defined low water channel and vegetation removal (depending on habitat/functional values)
- This would increase depth and velocity, thereby inhibiting vegetation growth and increasing sediment transport

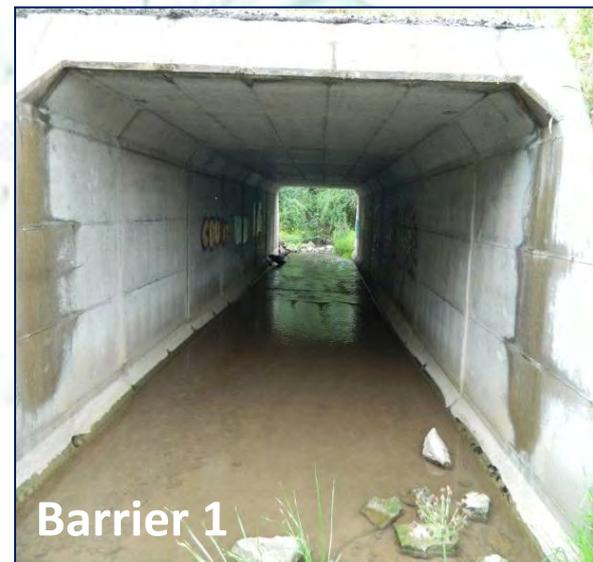
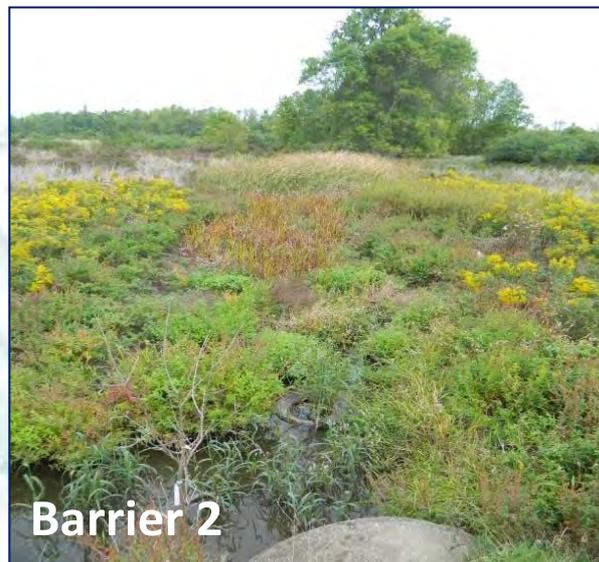
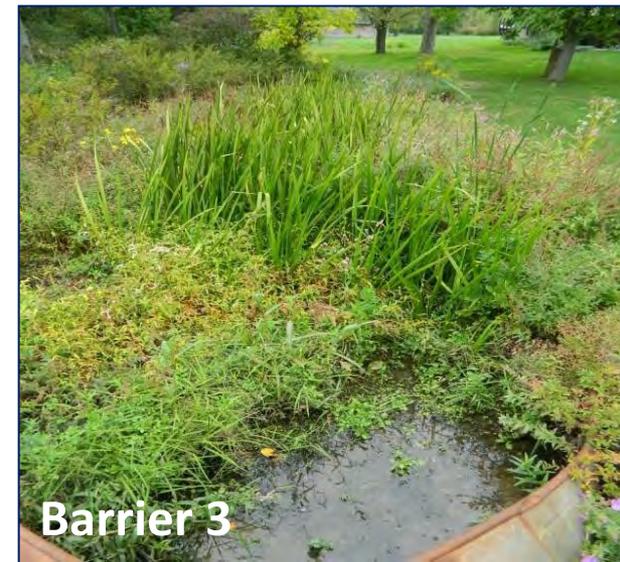
- Big Sixmile Creek:

- First barrier is a four-sided box culvert at Whitehaven Rd
- Retrofit: Baffle installation
 - Would provide roughness in culvert, resulting in reductions in velocities while creating resting cover for fish
- Second and third barriers are vegetation jams which could be remedied by creating a low water channel and veg. removal
