Fish Attraction Structure Habitat Improvement Project: 2012 Monitoring Report

Niagara Power Project (FERC No. 2216)

**KLEINSCHMIDT ASSOCIATES AND
RIVEREDGE ASSOCIATES**

February 2013

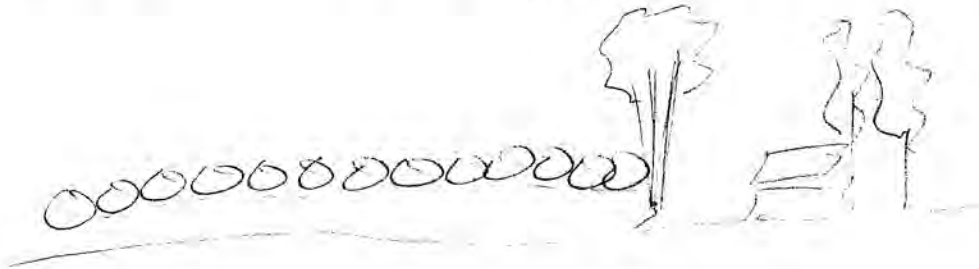
photo 132-2828

Structure located \perp to upstream^{most} poured
concrete slab along gratework shoreline

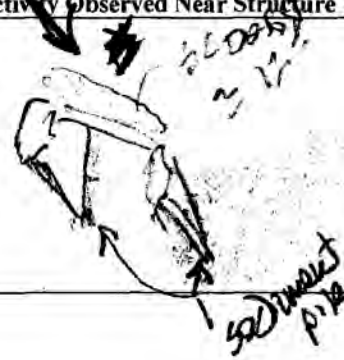
Swim clockwise for video
Zebra mussel shells fill in most spaces of pile but top down a little
Not undisturbed by SCORP
- milk bottle, rubber boot - not much
- no BTV around structure
