RECREATION FACILITY REHABILITATION ASSESSMENT

Niagara Power Project FERC No. 2216

New York Power Authority

August 2005

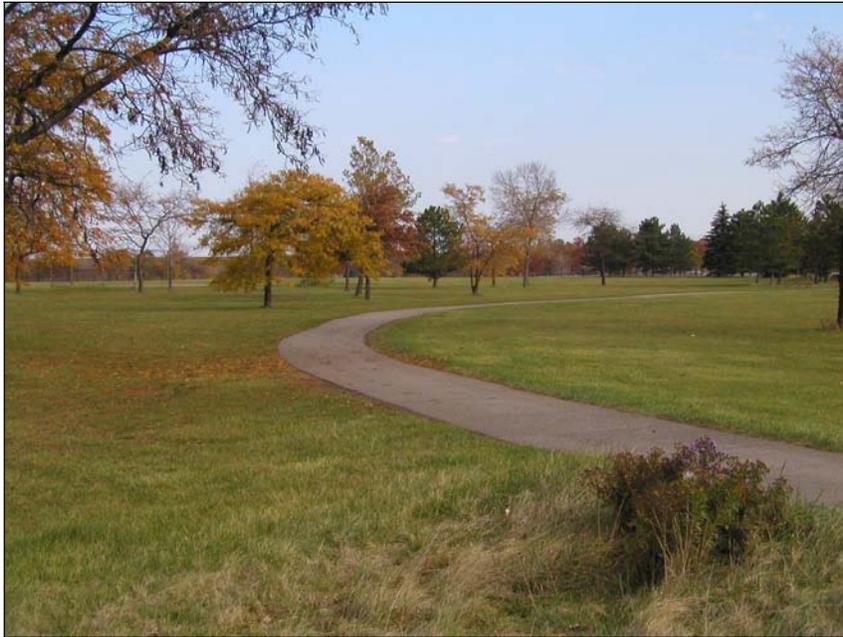
FIGURE 2.1.1.5-1

Emergency Access Road

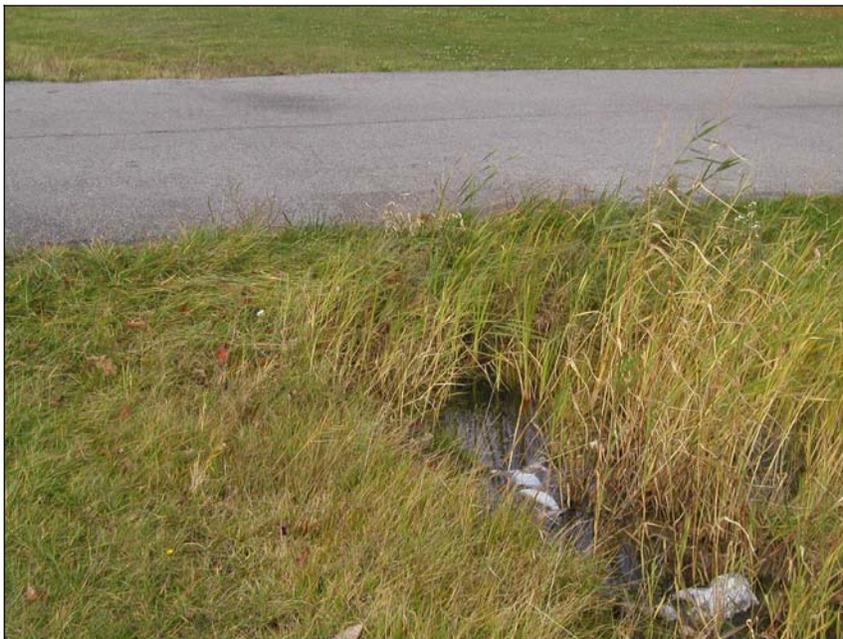
Site Drainage

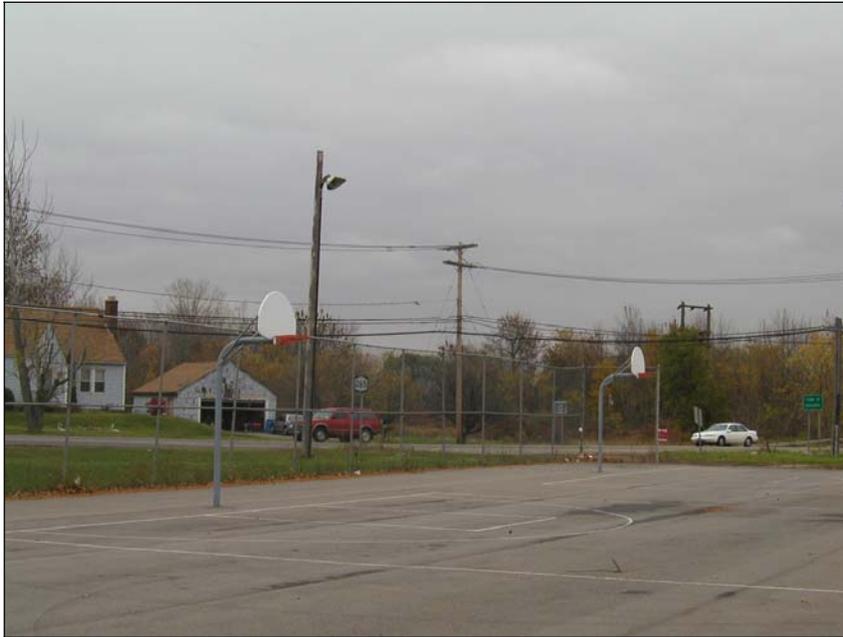
**FIGURE 2.1.1.7-1
BASKETBALL COURT AND PICNIC AREA, RESERVOIR STATE PARK**

Basketball Court Lighting

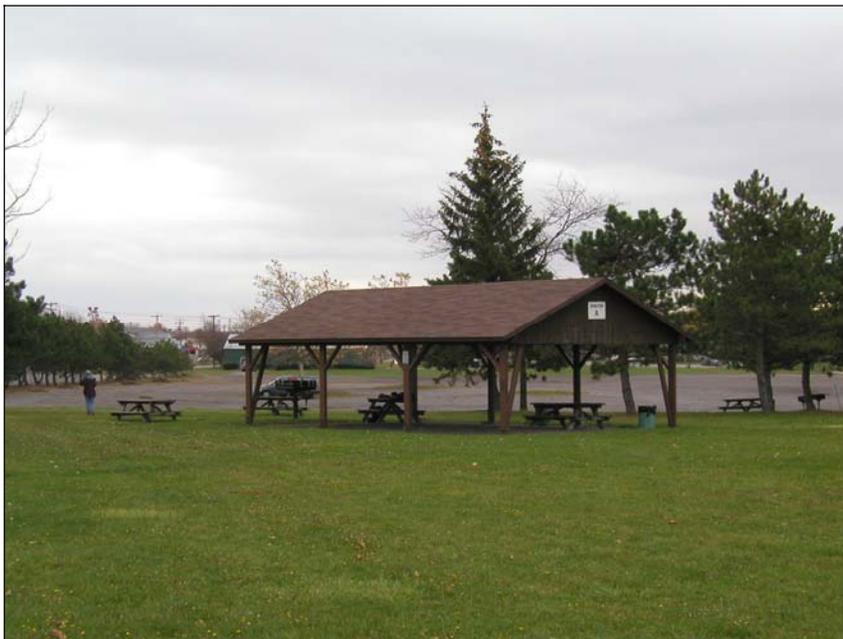
Picnic Area

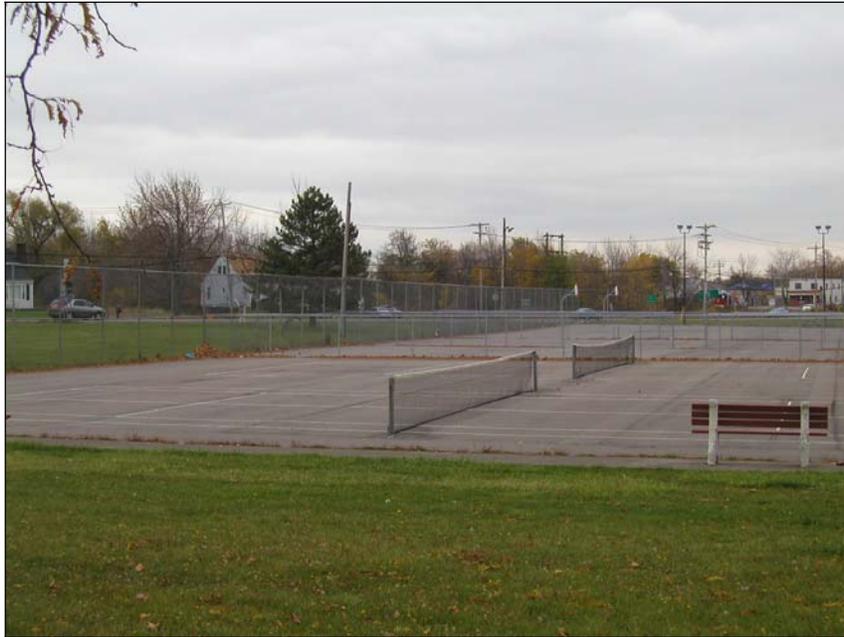
FIGURE 2.1.2.2-1

Basketball/Tennis Courts

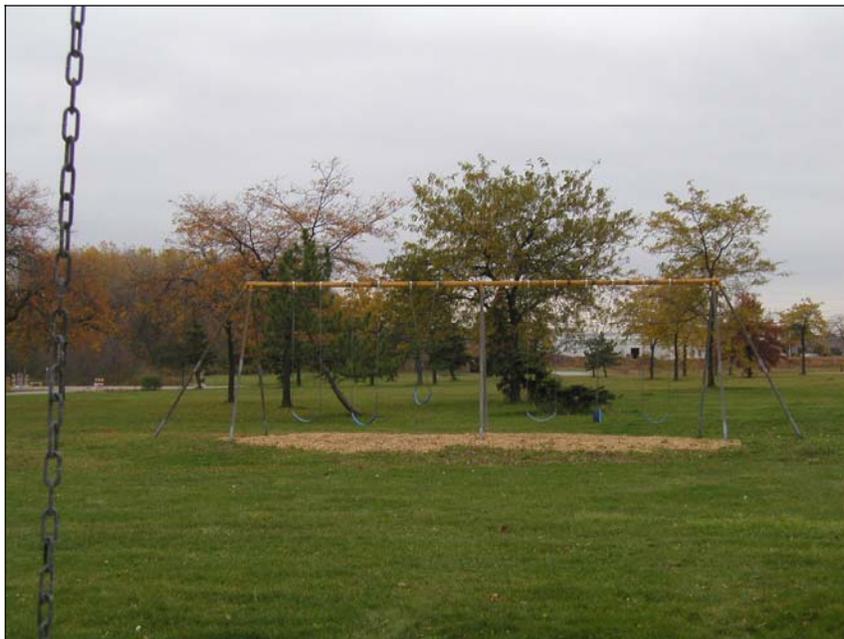
Playground - Swingset

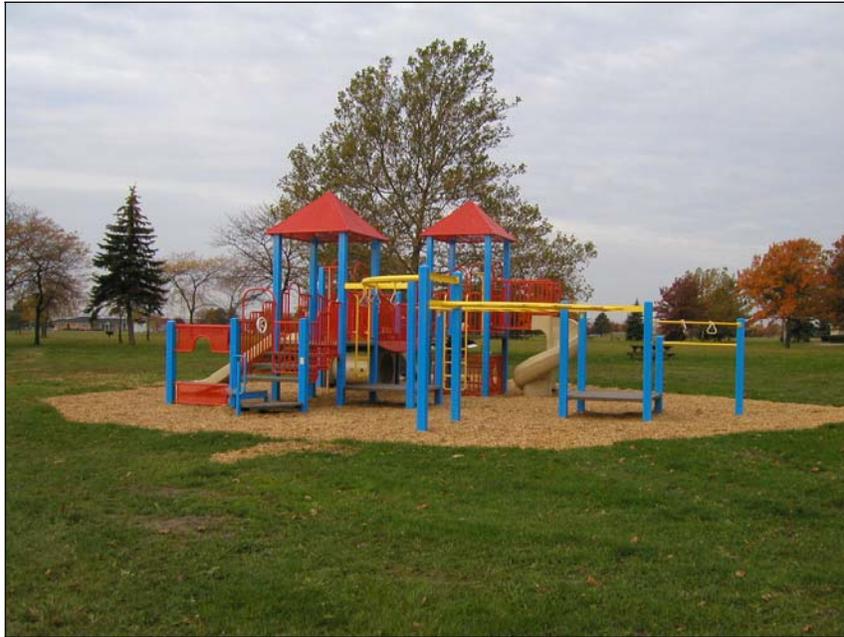
**FIGURE 2.1.2.3-1
PLAYGROUND AND SOFTBALL FIELD, RESERVOIR STATE PARK**

Playground – Play Area

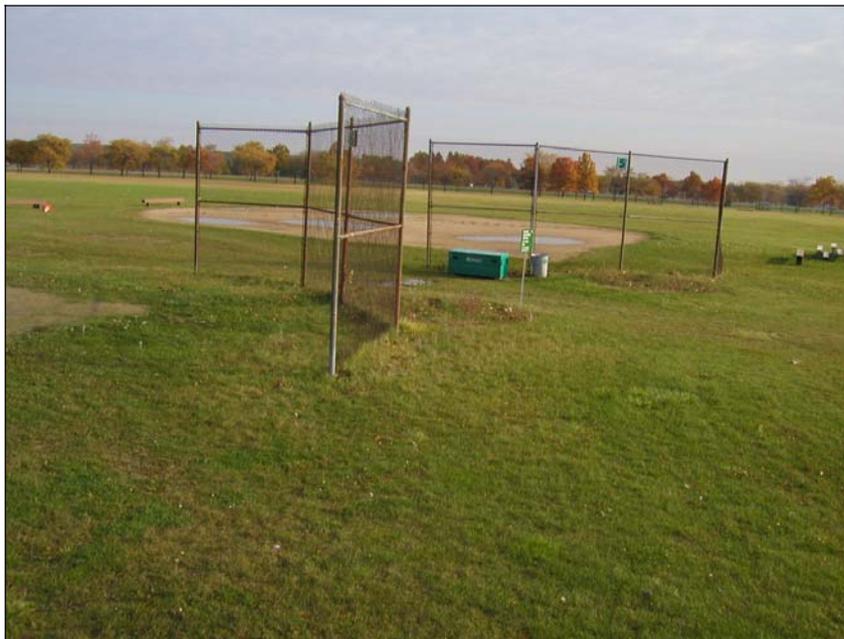
Softball Field

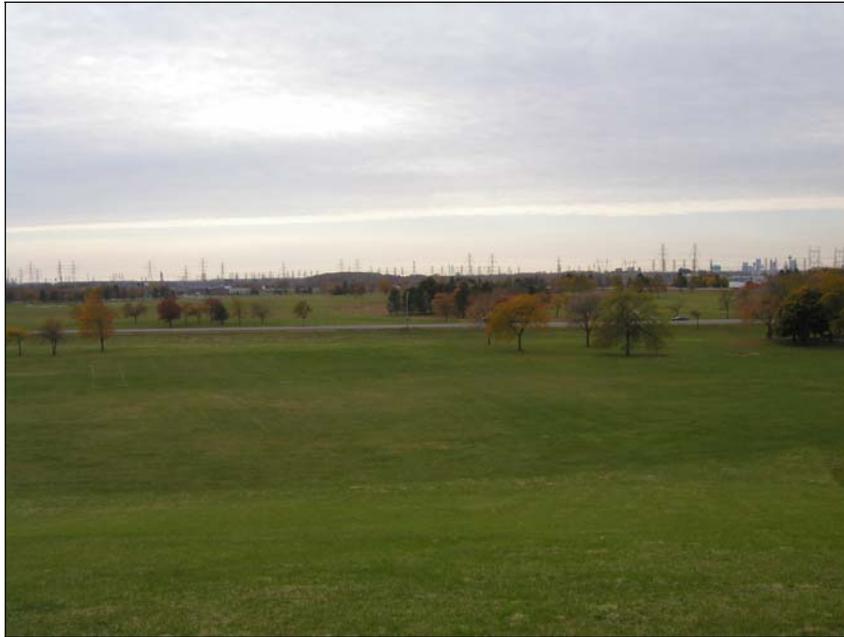
**FIGURE 2.1.2.5-1
SOCCER FIELDS AND SLEDDING HILL, RESERVOIR STATE PARK**

Soccer Fields

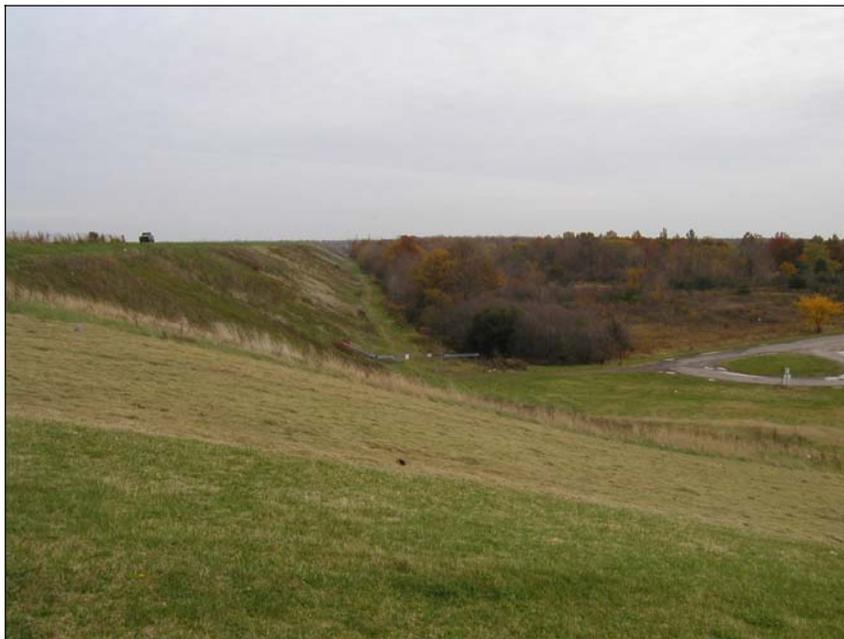
Sledding Hill

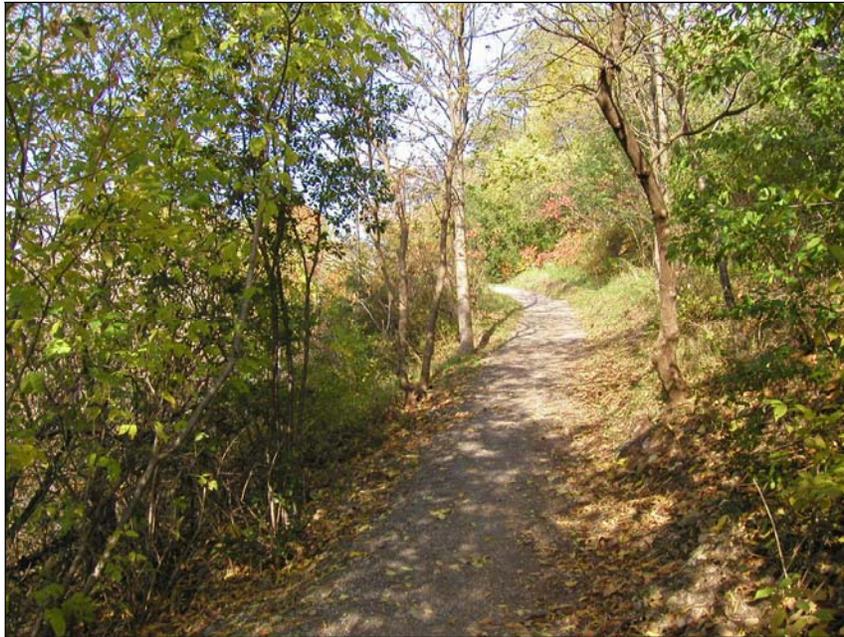
FIGURE 3.1.2.1-2

Lewiston Branch Gorge Trail

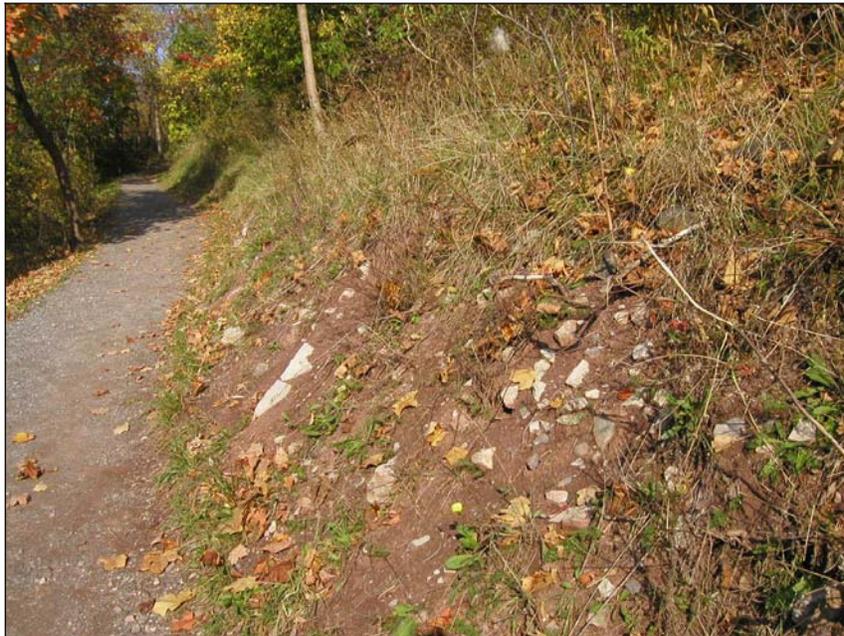
Erosion alongside Lewiston Branch Gorge Trail

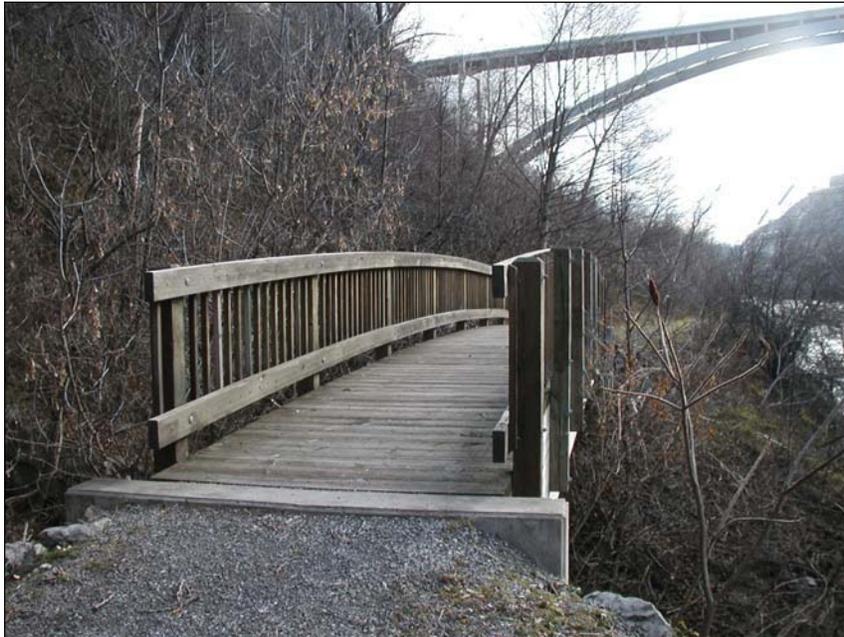
**FIGURE 3.1.2.1-3
TIMBER BRIDGE AND EL, ARTPARK**

Timber Bridge

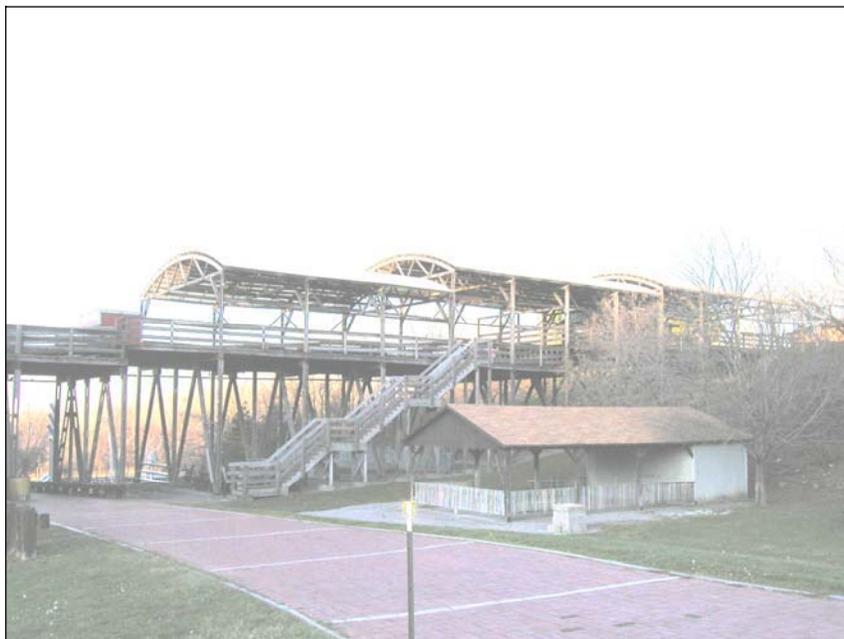
The El from the South

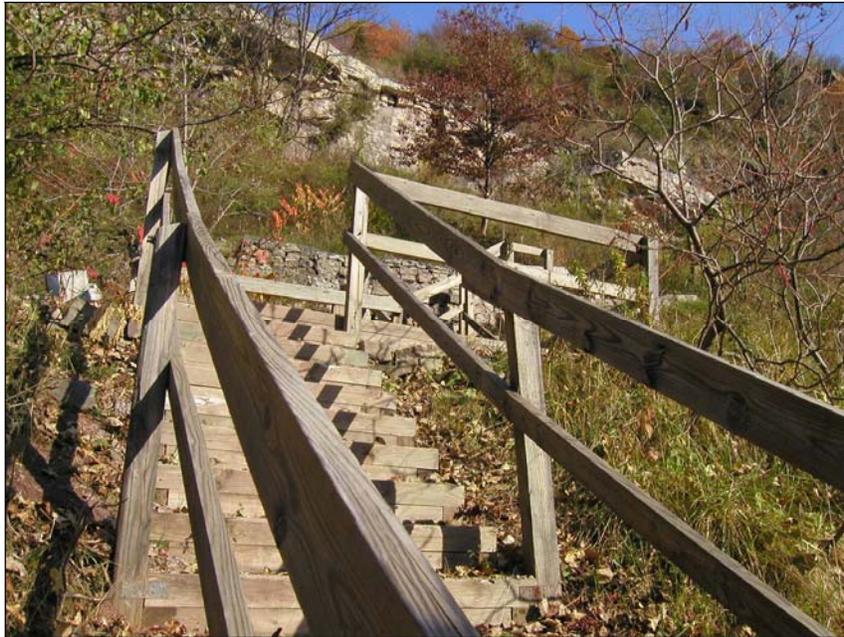
**FIGURE 3.1.2.2-1
VIEWS OF STAIRCASE 1, ARTPARK**

Portion of Staircase 1

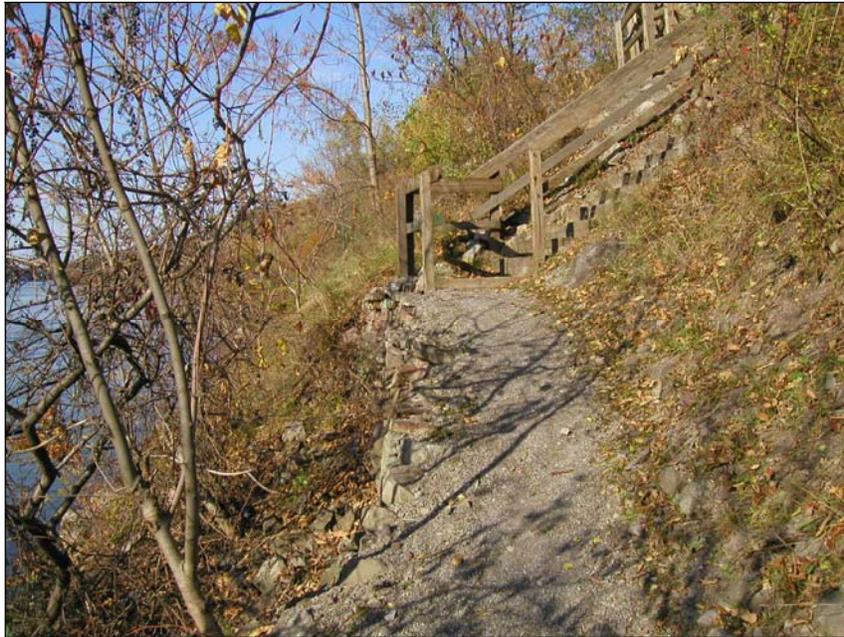
**FIGURE 3.1.2.2-3
VIEWS OF STAIRCASES 2 AND 3, ARTPARK**

Foot of Staircase 2

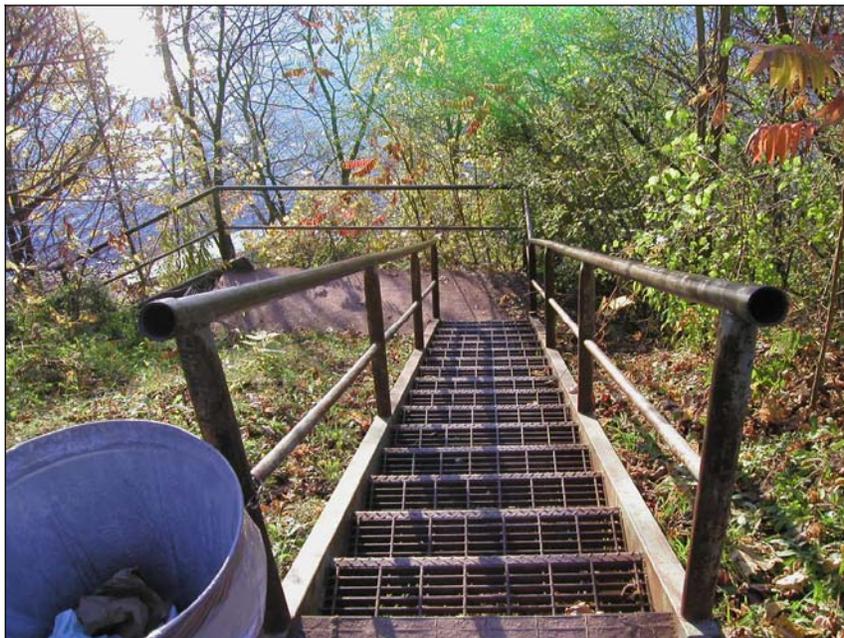
Head of Staircase 3

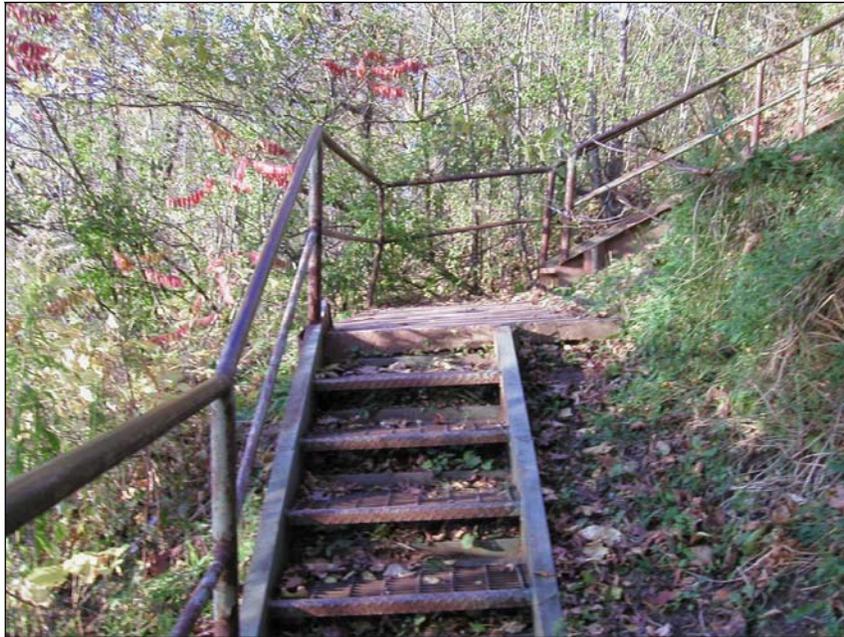
**FIGURE 3.1.2.2-4
VIEWS OF STAIRCASE 3, ARTPARK**

Portion of Staircase 3

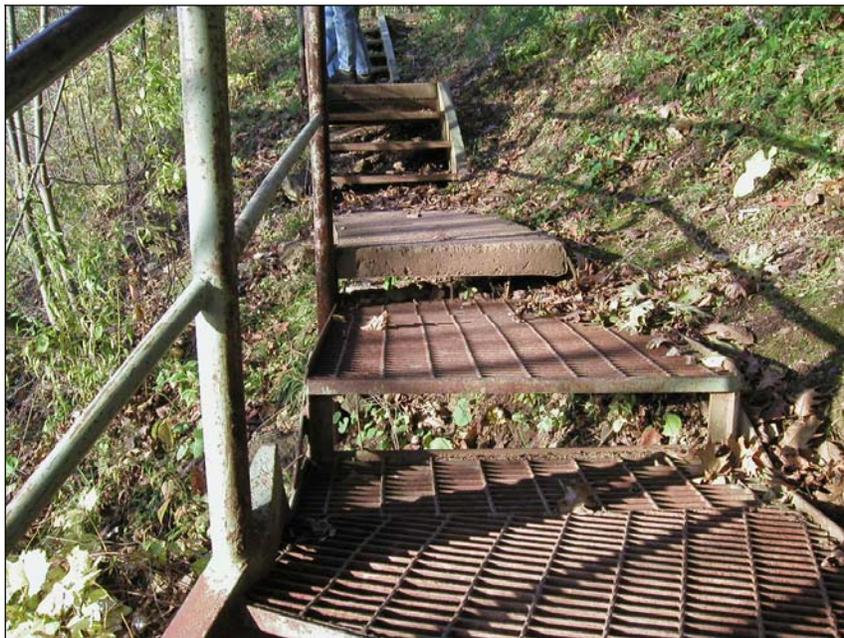
Staircase 3 Showing Series of Landings

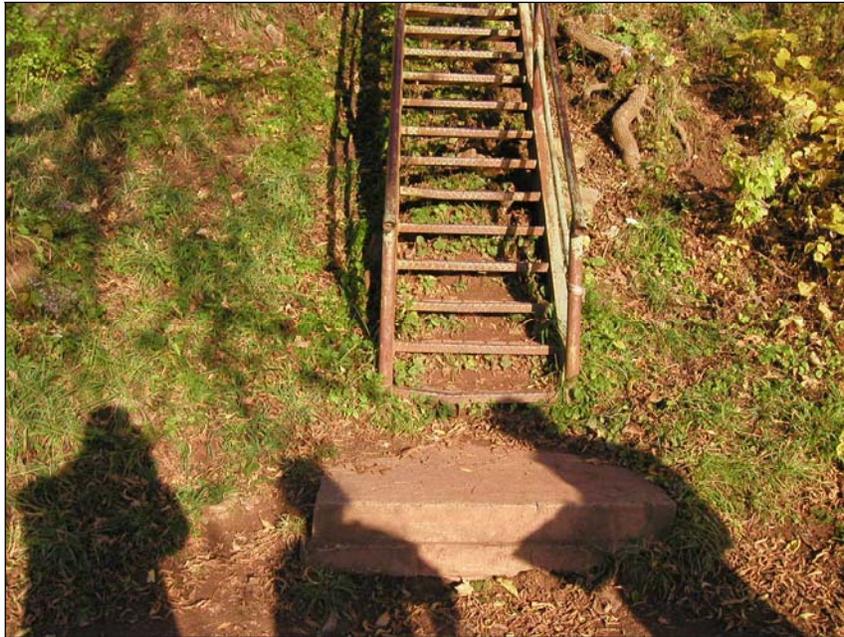
**FIGURE 3.1.2.2-5
FOOT OF STAIRCASE 3, ARTPARK**

Foot of Staircase 3 Showing Concrete Base

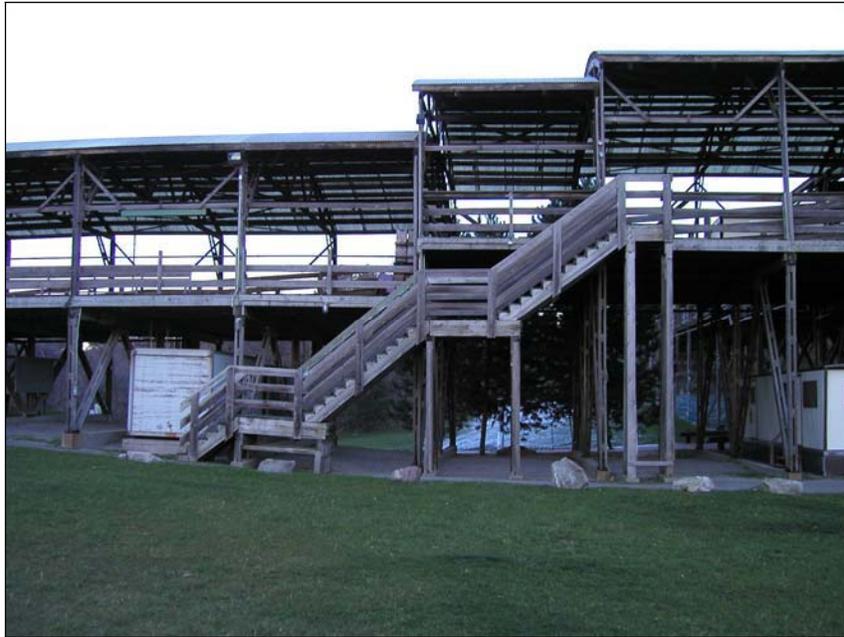
**FIGURE 3.1.2.3-3
VIEWS OF THE EL, ARTPARK**

The West Stairway of the El

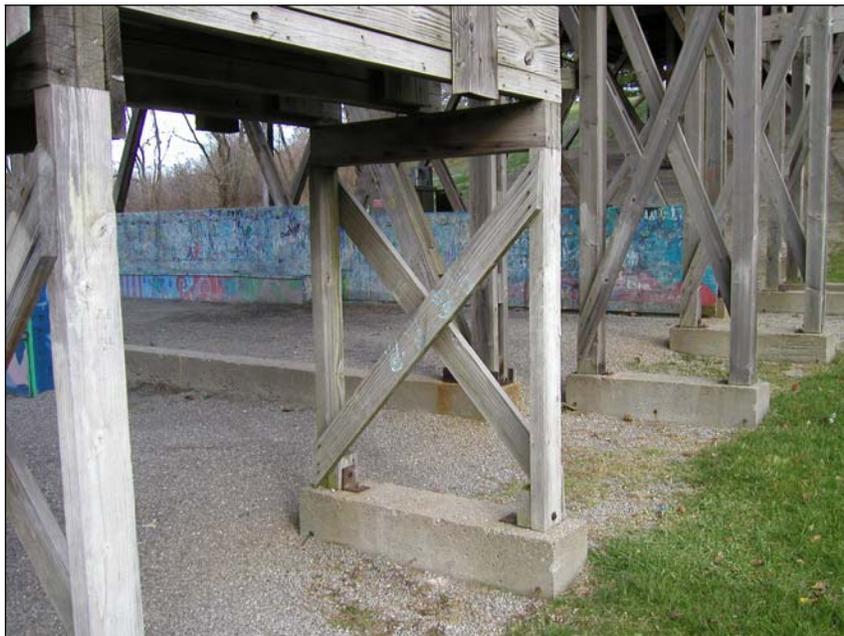
Support Columns under the El

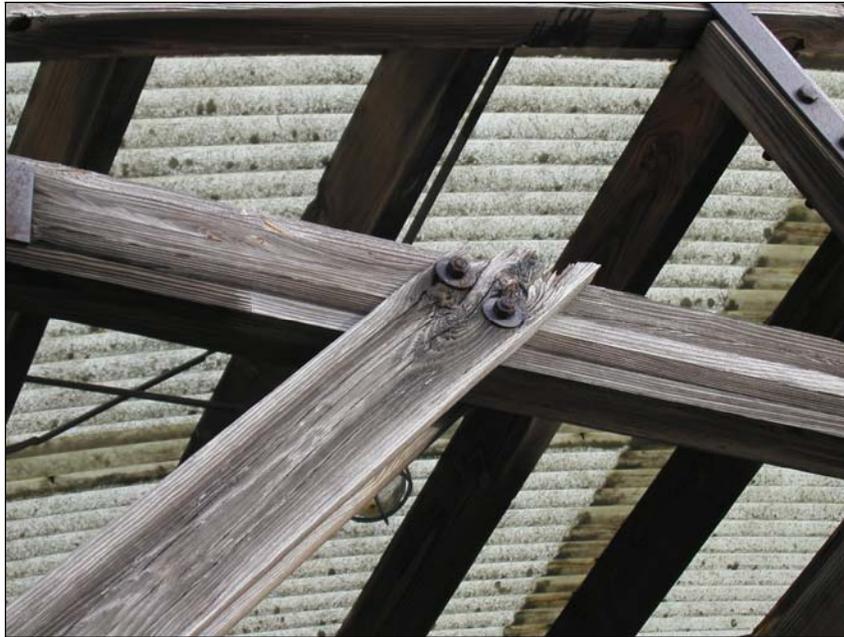
**FIGURE 3.1.2.3-4
DETAILS OF EL CONSTRUCTION I, ARTPARK**

Roof Support in the El

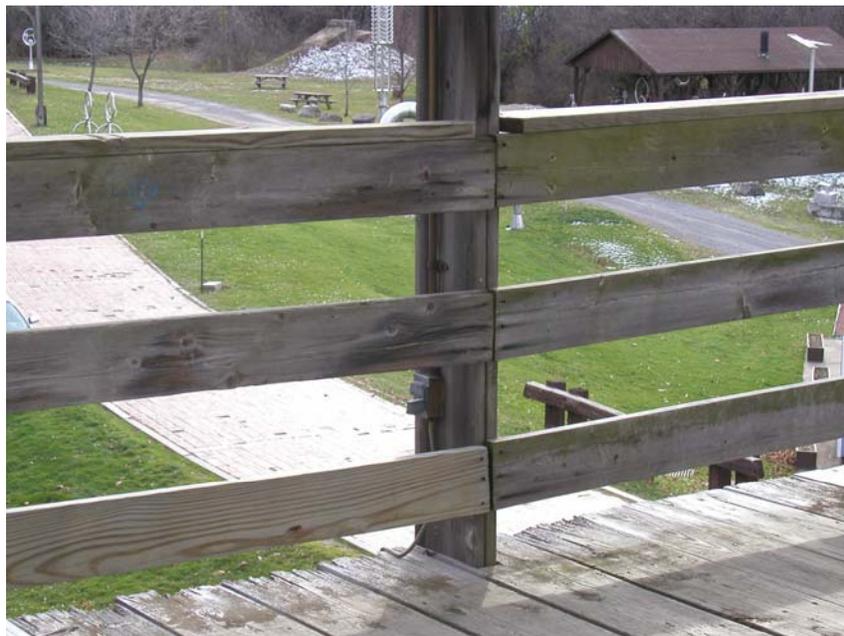
**FIGURE 3.1.2.3-5
DETAILS OF EL CONSTRUCTION II, ARTPARK**

Railings Along the Deck of the El

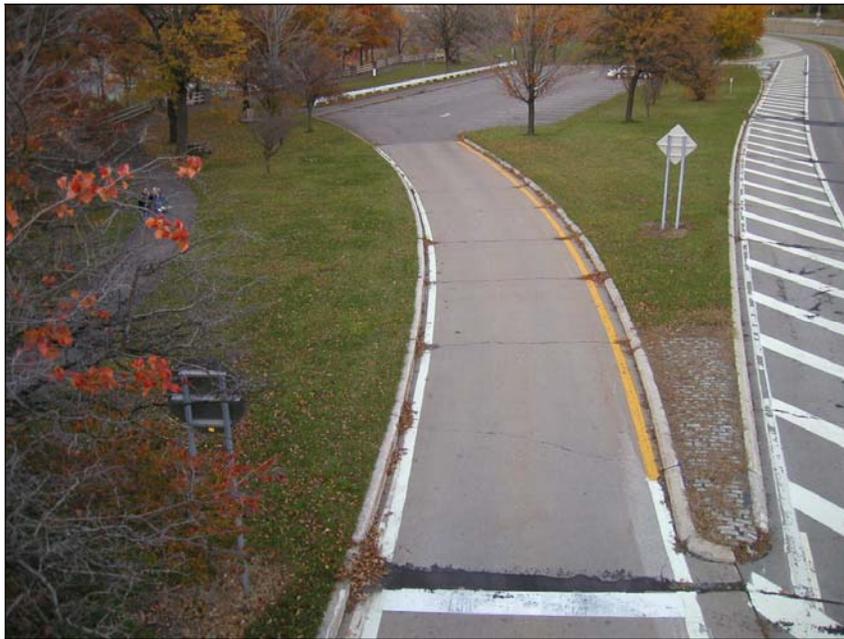
FIGURE 4.1.1.1-1

Parking Area Exit Driveway

It is recommended that the main parking area, as well as the entrance and exit driveways be reconstructed. The parking lot pavement should be removed and replaced with 3-inch pavement. Driveways should be repaved with 4-inch pavement. The new surface should be graded to drain to existing catch basins. Walkway pavement and curbing should be replaced. ADA curb cuts, appropriate striping and security lighting should be incorporated in this reconstruction. In addition, the wood barrier bordering the walkway has no apparent function and may be removed.

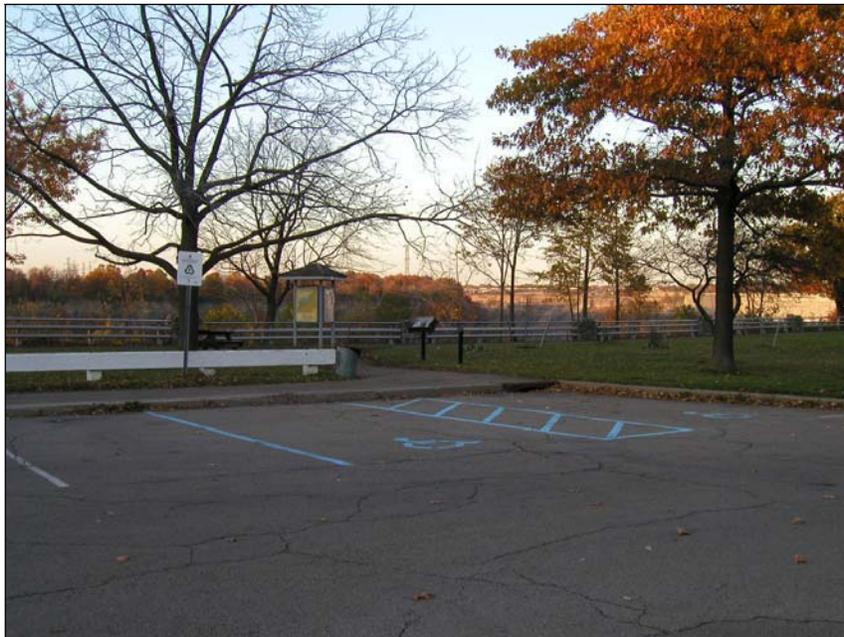
**FIGURE 4.1.1.1-2
PARKING AREAS, DEVIL'S HOLE STATE PARK**

The parking lot is crowned in the center; surface drainage flows to a curb line on the west side of the lot and is directed to a subsurface drainage system. Pavement surface appears to be 10 to 15 years old with moderate surface cracking; it is in fair condition. No heaving of the pavement in the parking area was evident at the time of assessment, suggesting that the gravel base is not frost active.

ADA Parking Space

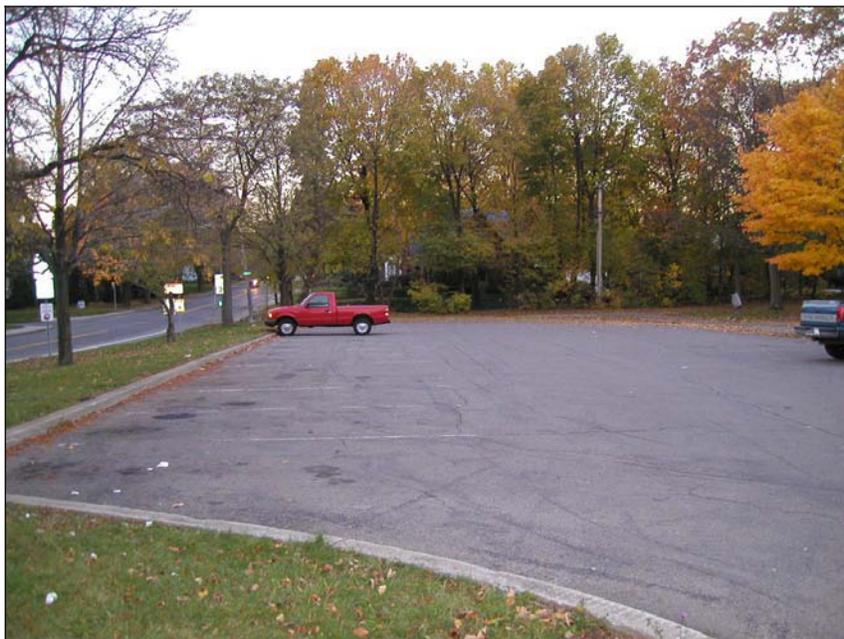
Pavement surface in the parking area appears to be 10 to 15 years old with moderate surface cracking; it is in fair condition. No heaving of the pavement in the parking area is evident, suggesting that the gravel base is not frost active. Surface drainage flows across the lot to a subsurface drainage system located in the southwest corner of the lot.

A paved walkway on the west side of the lot leads to a NYSDOT pedestrian bridge which connects this area to the main lot. The parking lot is bounded by concrete curbing which is in fair condition.

Secondary Parking Area

It is recommended that the secondary parking lot be reconstructed. The parking lot pavement should be removed and replaced with new 3-inch pavement. The entrance driveway should be repaved with 4-inch pavement. Curbing and walkway pavement should be replaced. ADA curb cuts and appropriate striping should be incorporated. Security lighting should be installed.

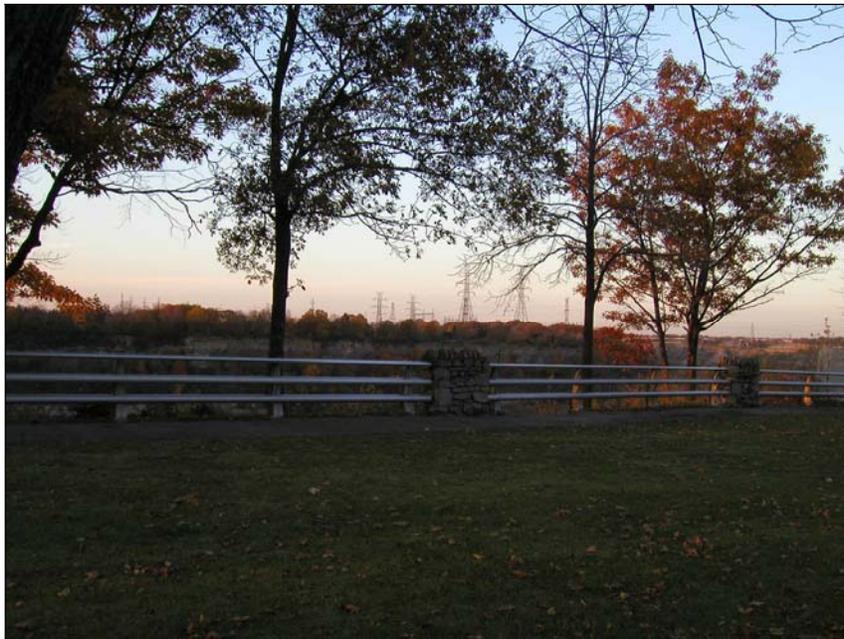
**FIGURE 4.1.1.3.1-1
VIEWS OF GORGE RIM, DEVIL'S HOLE STATE PARK**

The fencing is in good condition, but is not building code compliant. Park Officials stated that the aluminum rail portion of the fencing, installed in the 1960's, looks dated and does not sustain the historic look they would like at the park. The aluminum portion of the fence is nearing 50 years old., Park Officials would like to replace it with fencing which would blend with the historic stone piers, and other park features.

Gorge Rim Fencing

It is recommended that the aluminum portion of the gorge fencing be replaced with a barrier that meets building code regulations, and reflects the historic theme desired by Park Officials. To meet code, the proposed fence should be no less than 42 inches high. Balusters, up to 34 inches high, should be arranged to prevent passage of a 4-inch diameter sphere between them; from 34 inches and upward, the balusters should be arranged to prevent passage of an 8-inch diameter sphere. Although it is not required by code, it is recommended that the new fence should not be climbable; the main purpose of this recommendation is to enhance safety for small children.

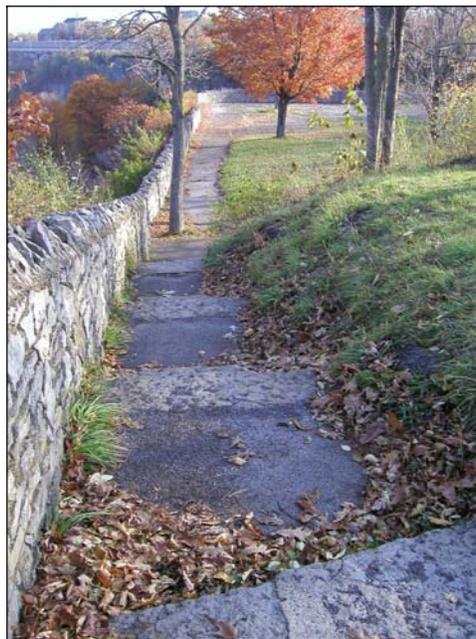
The walkway width varies, but it is generally 8-foot wide. It is paved with asphalt and is in good to fair condition. Ramped areas to the NYSDOT pedestrian bridge are in poor condition due to a delaminating skim coat of asphalt.

The existing walkways do not have an expected 30-year life remaining. However, they are not currently in need of replacement and may serve for several more years with proper maintenance.

Gorge Rim Walkway

It is recommended that the walkway system be rehabilitated to achieve ADA accessibility to major site amenities and facilities from either parking lot. An ADA-compliant walkway should be installed to access the stone-paved viewing area, and the men's restroom. Some degraded areas in the

walkways should be removed and replaced with new three-inch pavement. Much of the pavement is still in good condition, which could be maintained by application of crack sealants and coatings. Such treatments should be applied as necessary, based on the findings of maintenance inspections.

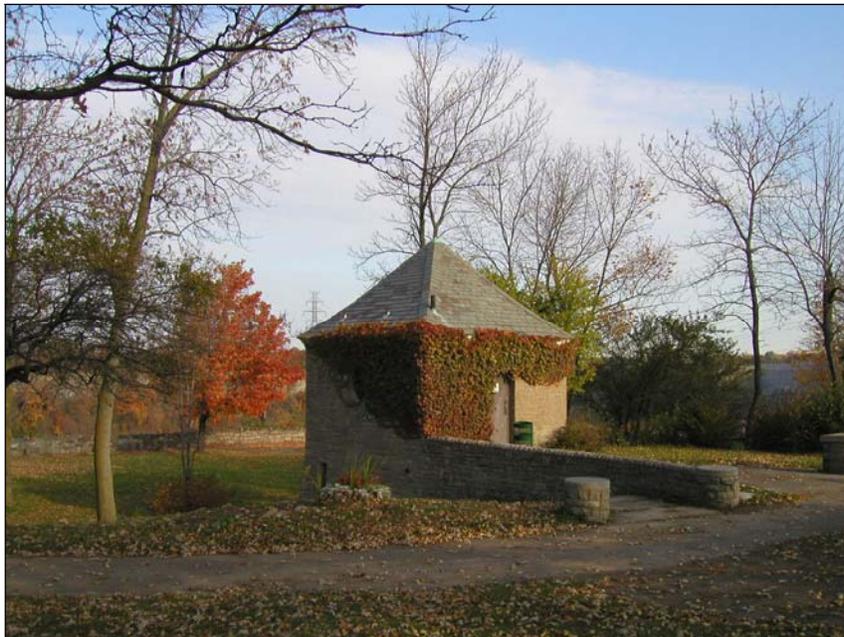
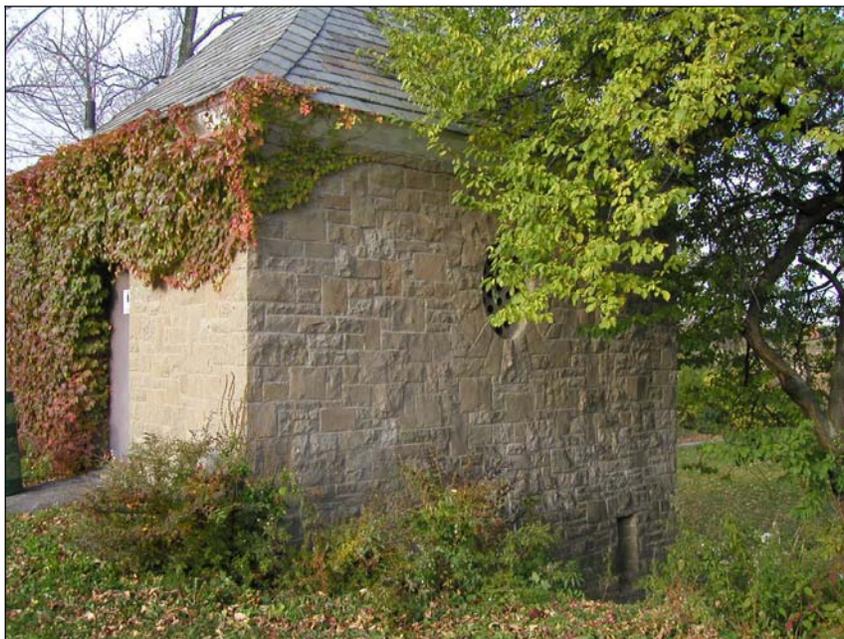
FIGURE 4.1.2.4-1

Day-to-day maintenance and repair at the park have been well done. The lawn area, trees and stone masonry work are visually appealing. The restroom is a Romanesque Revival style stone masonry building that is well-sited in the landscape.

Restroom Building

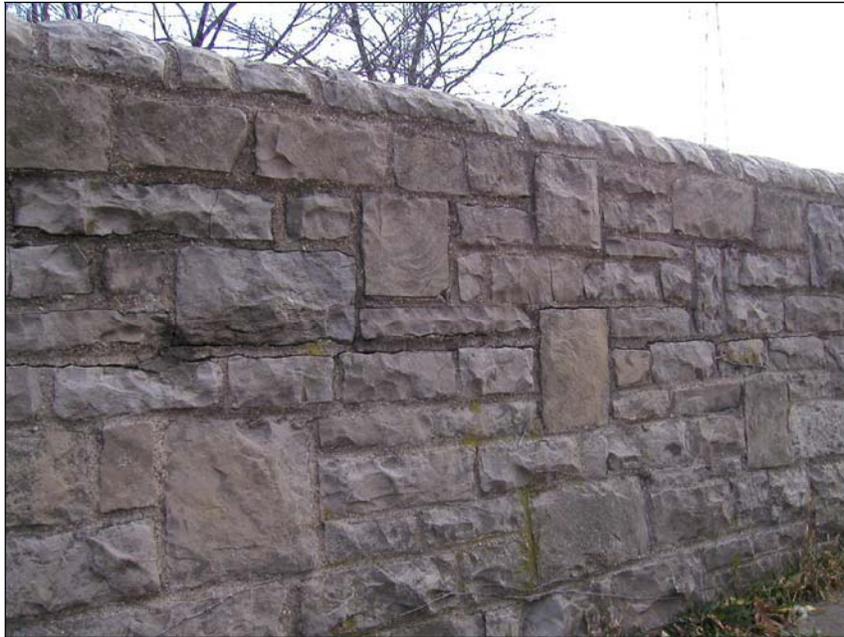
FIGURE 4.1.2.4-4

Stone Wall

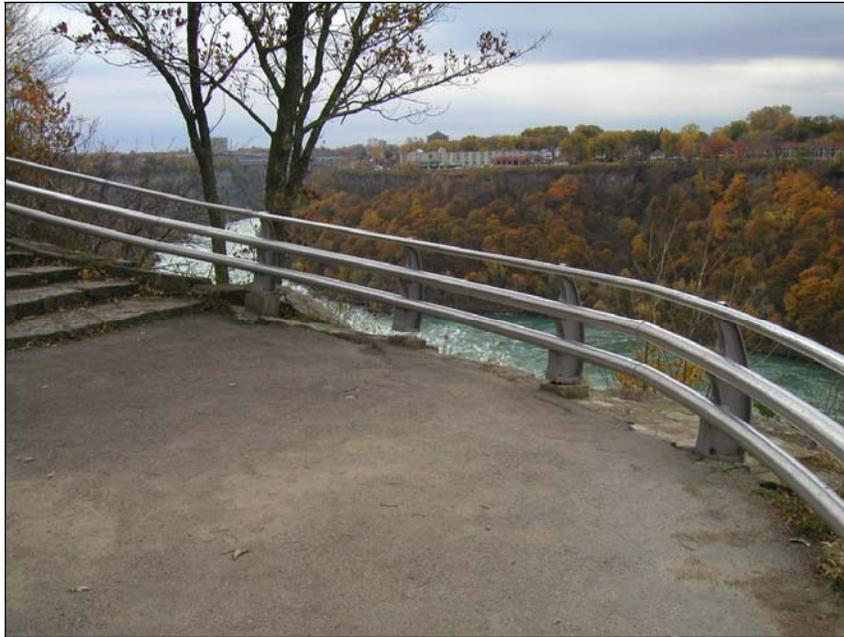
Gorge Rail Fencing

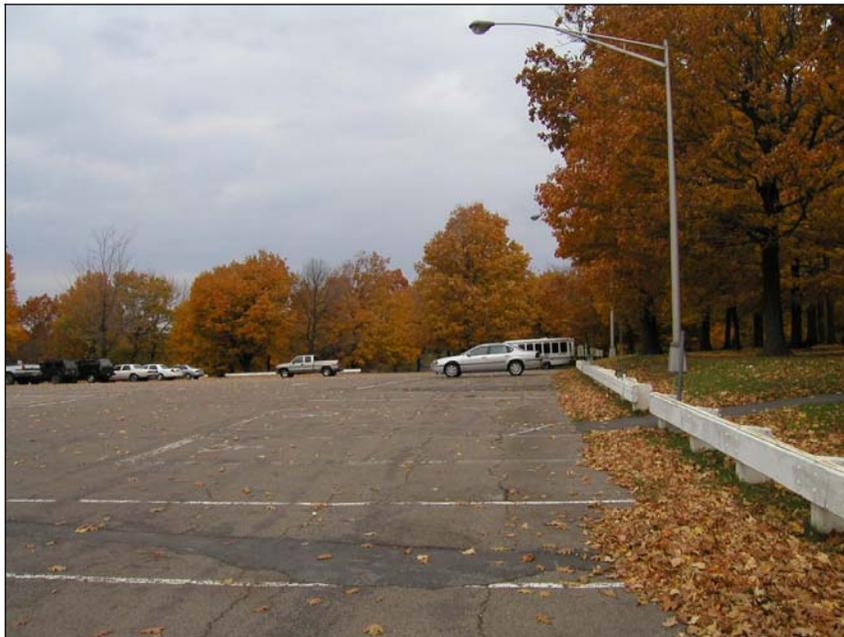
The parking lot is surfaced with asphalt pavement that is over 15 years old and is in fair to poor condition. It has extensive cracking, but there is no evidence of vertical movement.

Parking Area

It is recommended that the parking lot be stripped and resurfaced with 3-inch pavement. The parking lot surface should be pitched for appropriate drainage. The access driveway may be expected to serve 30 more years with appropriate inspection and maintenance; currently it should be sealed for protection. The wood and concrete bumpers could be painted brown to match the rustic theme of the park. These bumpers cannot be expected to serve a 30-year life, but they may be removed when they are no longer serviceable. Work on the bumpers is optional. Erosion at the south end of the parking lot should be repaired; this repair should include tilling and seeding.

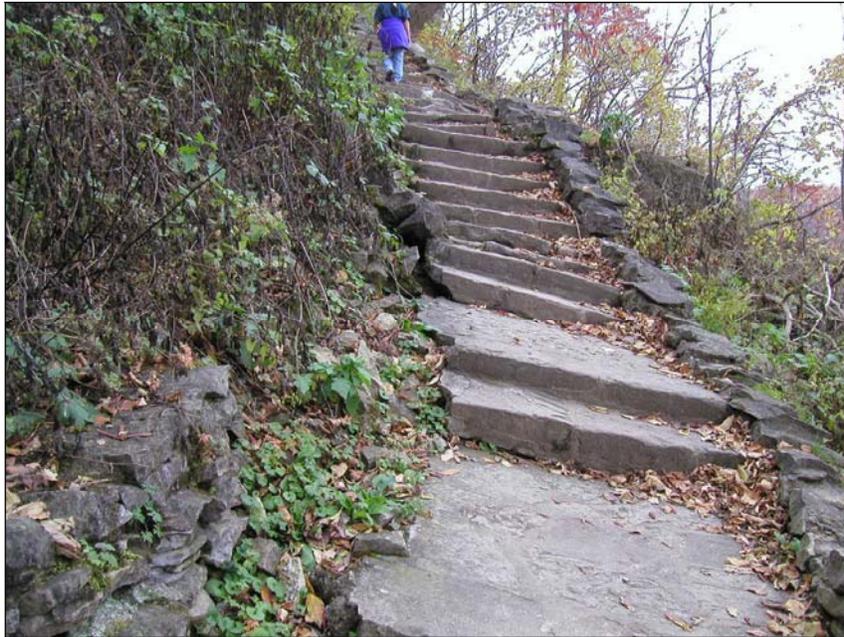
Portion of Concrete Fishing Access Stairs

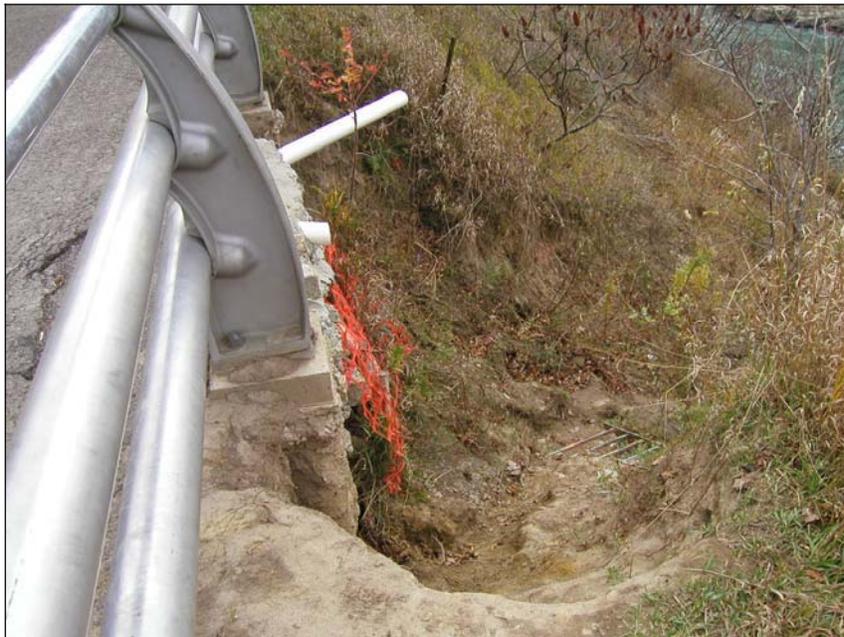
There are several issues with site erosion. There is some erosion around the picnic area due to foot traffic. An area of erosion near the south end of the parking lot appears to have been instigated by vehicle traffic, and compounded by runoff; water is beginning to cut rivulets and carry soil from this location. Erosion along the gorge rim is creating deep cuts in the embankment, and is exposing the foundations of the gorge rim fencing.

Erosion around Base of Gorge Rail Fencing

It is recommended that erosion issues be addressed at all appropriate locations throughout the park. These issues are described, and recommendations are made, on a site-specific basis in the following discussions.

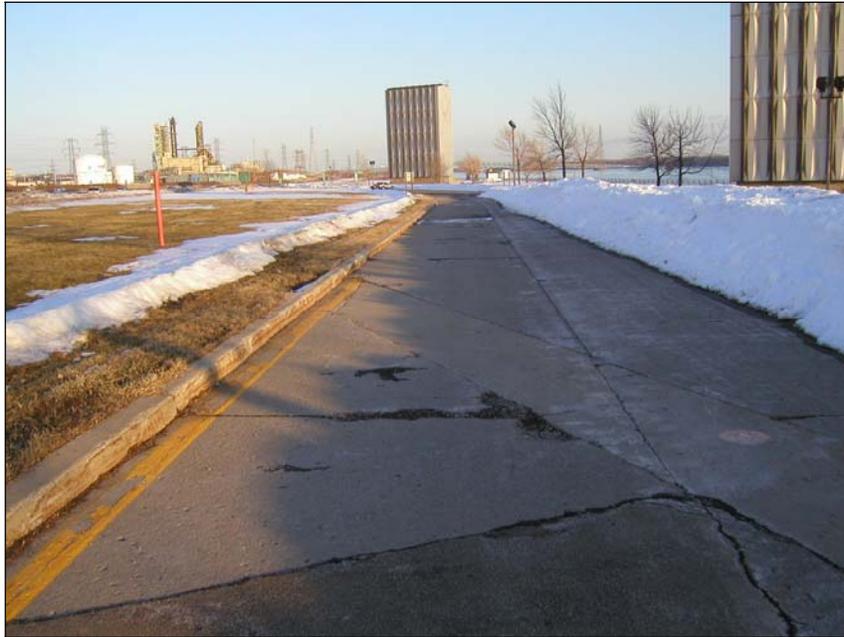
Entrance Driveway

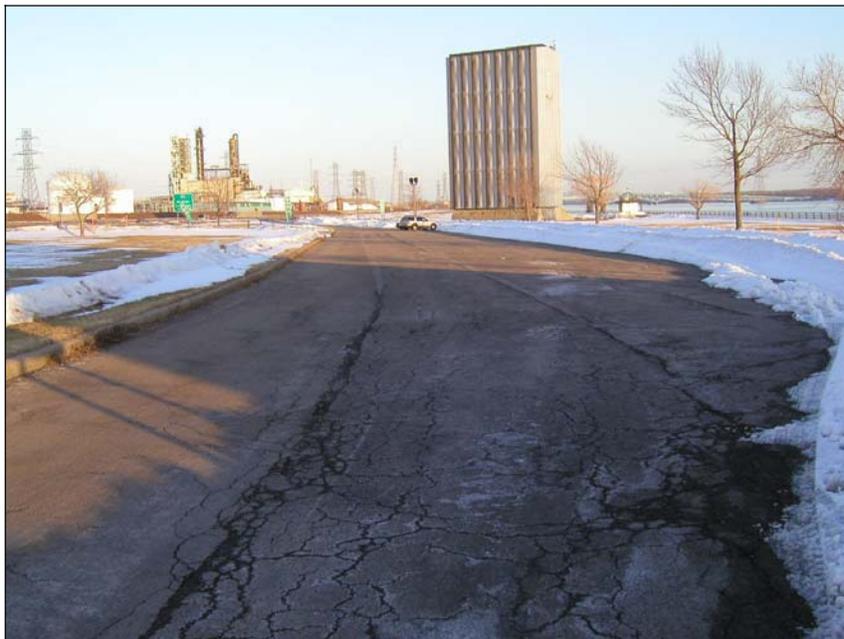
The asphalt surface of the parking area is in poor condition with extensive surface cracking ([Figure 8.1.1.1-1](#)). There is no evidence of vertical movement, indicating that the soils under the parking lot are not frost-active.

Parking Area

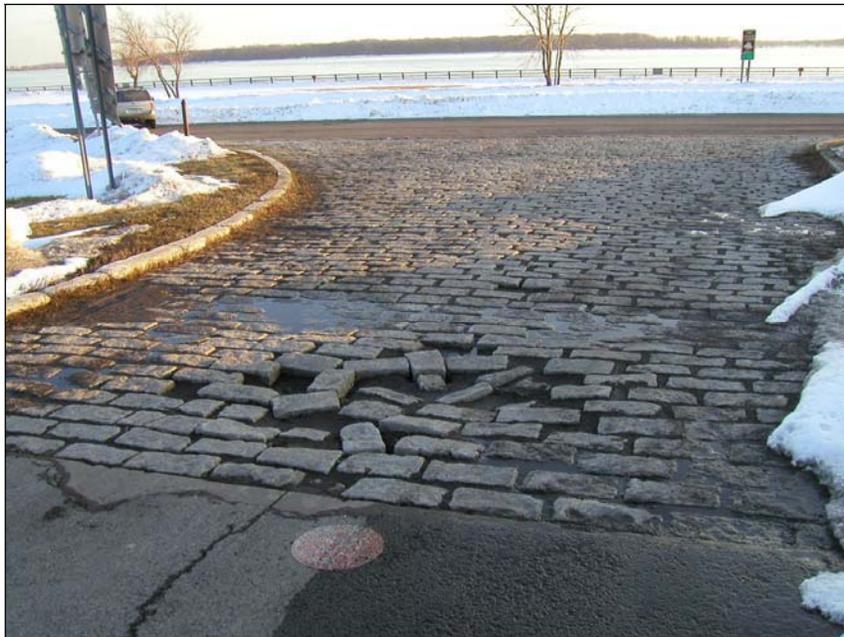
The portion of the driveway which extends from the southbound lanes of the Parkway to the north side of the parking lot has two surface types. The northern portion of the driveway is surfaced with asphalt; the rest is surfaced with cobblestones. The asphalt portion is in poor condition with some cracking. The cobblestone portion is also in poor condition. Near the transition from asphalt to cobblestone, there is a depression where several cobblestones are missing, and others have shifted out of place ([Figure 8.1.1.1-2](#)). Water ponds in this depression and continues to damage the cobblestone surface of the driveway.

Cobblestones on Perpendicular Driveway
