RECREATION FACILITY REHABILITATION ASSESSMENT

Niagara Power Project FERC No. 2216

New York Power Authority

August 2005

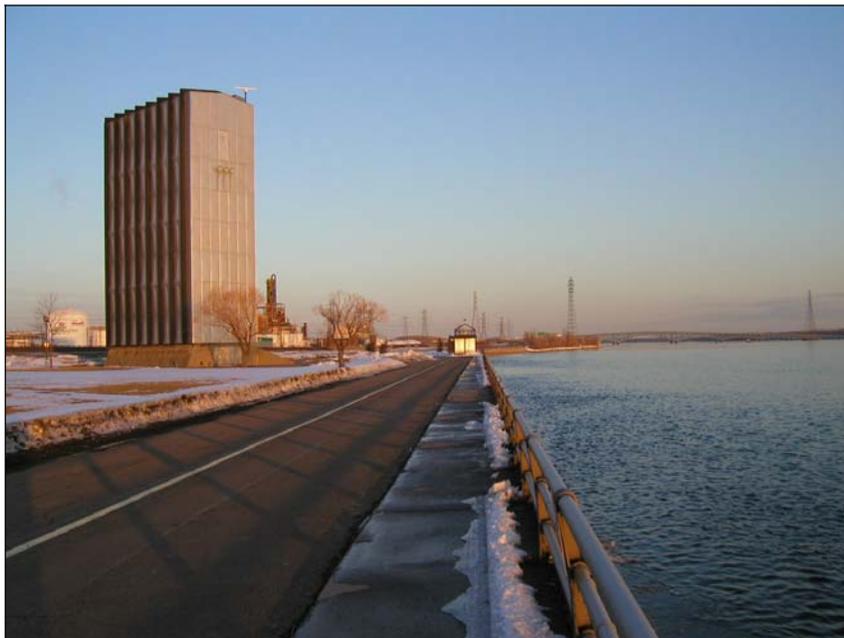
Riverfront Walkway and Access Roadway/Walking/Biking Trail
